## **TEST REPORT**

Fire resistance test in accordance with AS1530.4-2014 of various pipes and cables services protected with variuos of BOSS penetration protection systems in a 118mm fire rated wall system

49527300.2

12 July 2018

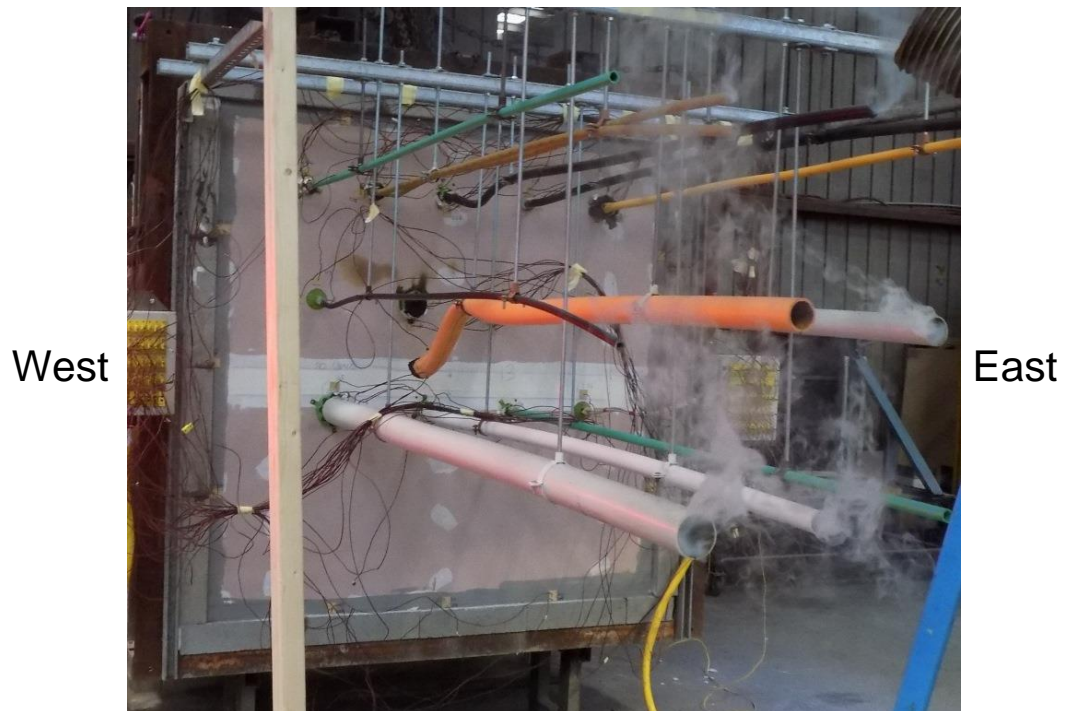
Figure A6.3: Unexposed face of specimen at the end of the test.

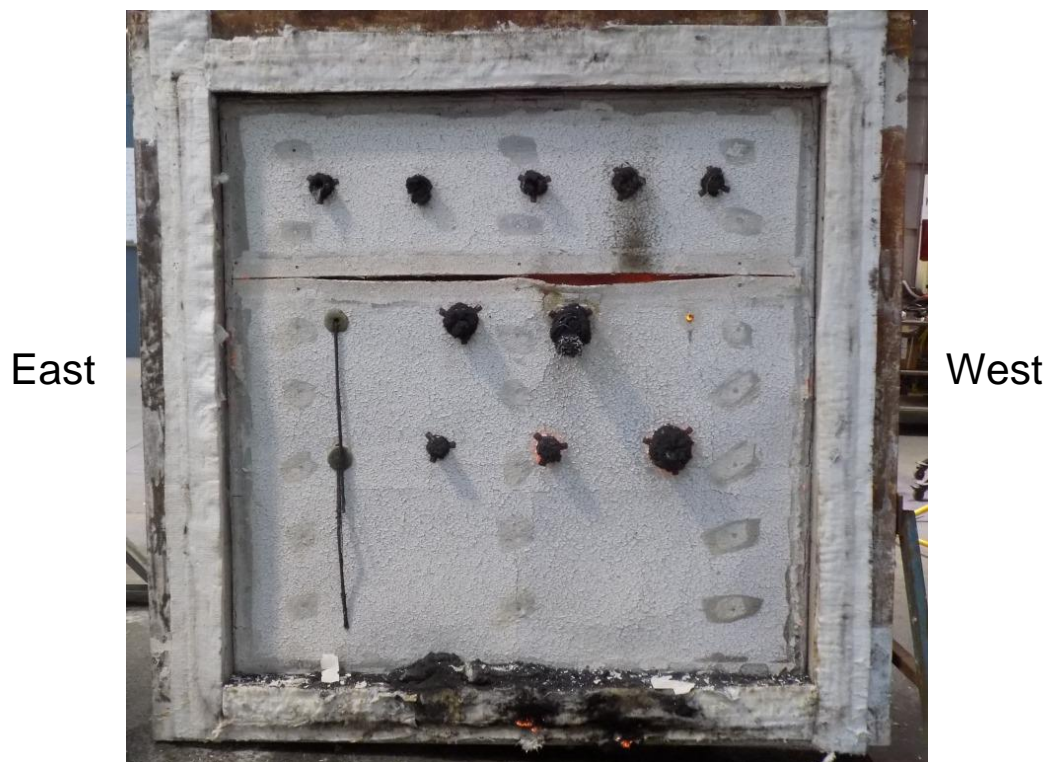
Figure A6.4: Exposed face of specimen at the end of the test.
