TEST REPORT

Fire resistance test in accordance with AS1530.4-2014 of various pipe and cable services in a 137mm thick CLT wall system protected by various sealants and collars

54783400.1

26 April 2018

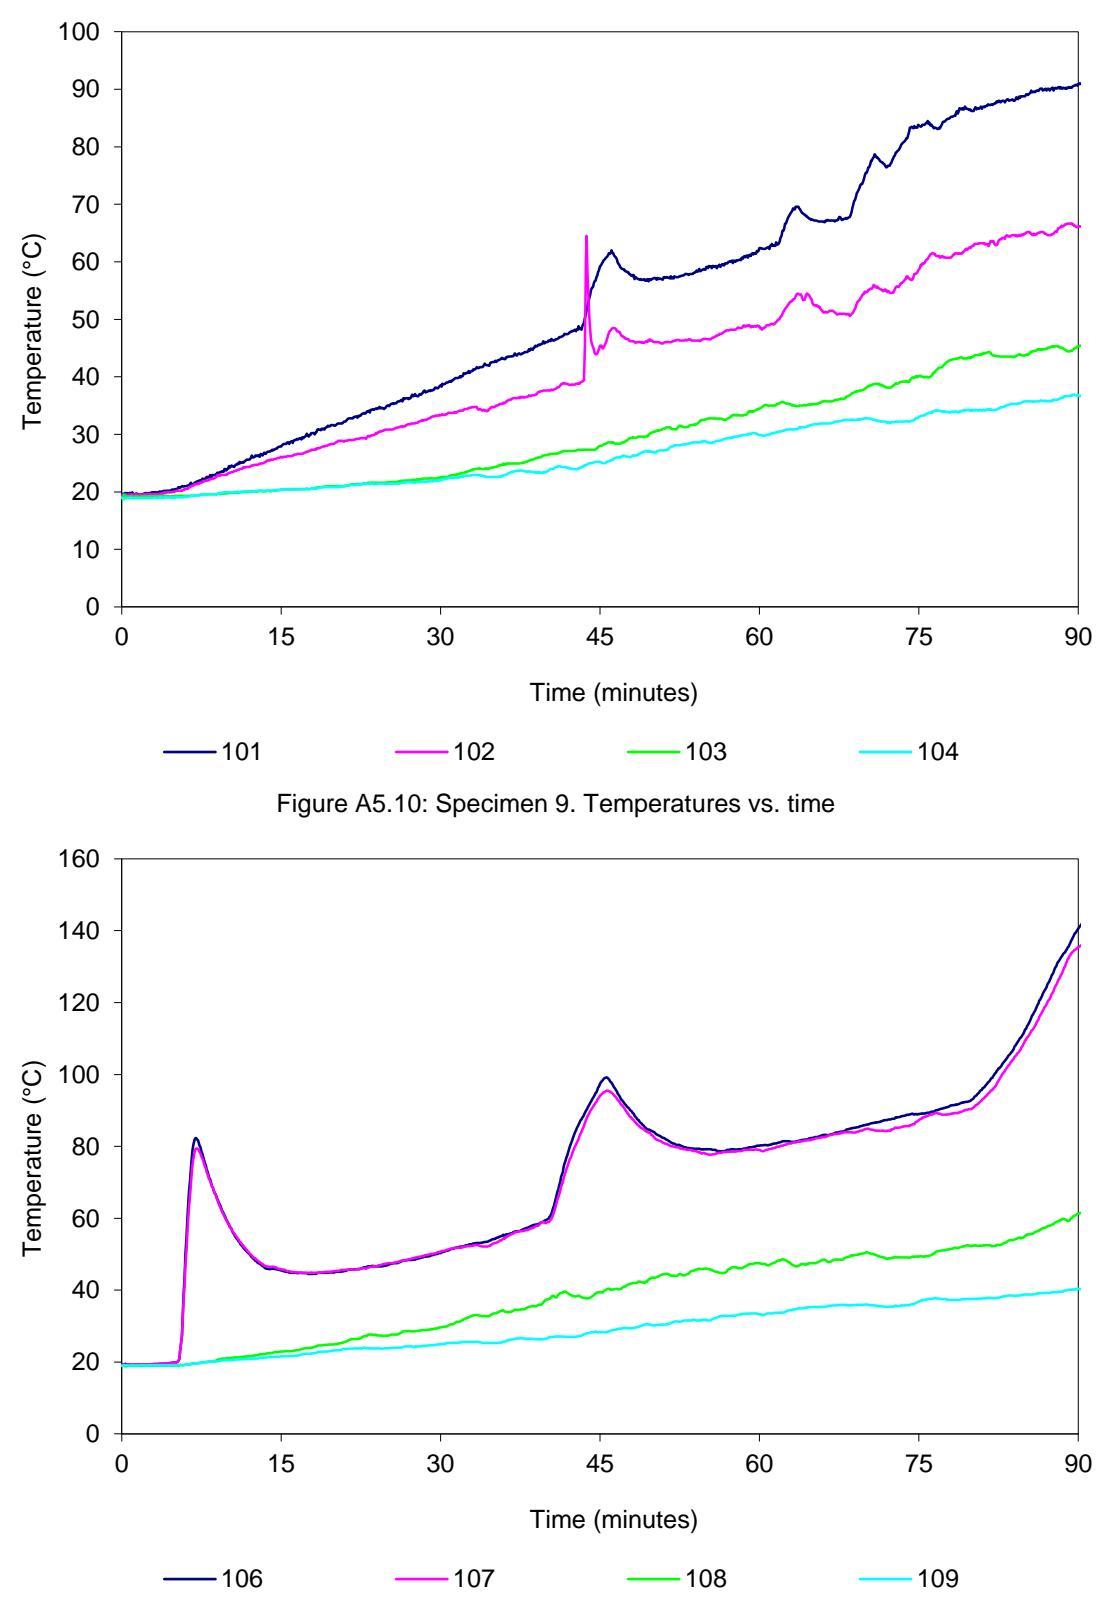
Service	Criteria	Result
	Structural Adequacy	Not applicable
10	Integrity	No failure at 91 minutes
10	Insulation	Failure at 61 minutes
	FRL	-/90/60

Figure A5.11: Specimen 10. Temperatures vs. time

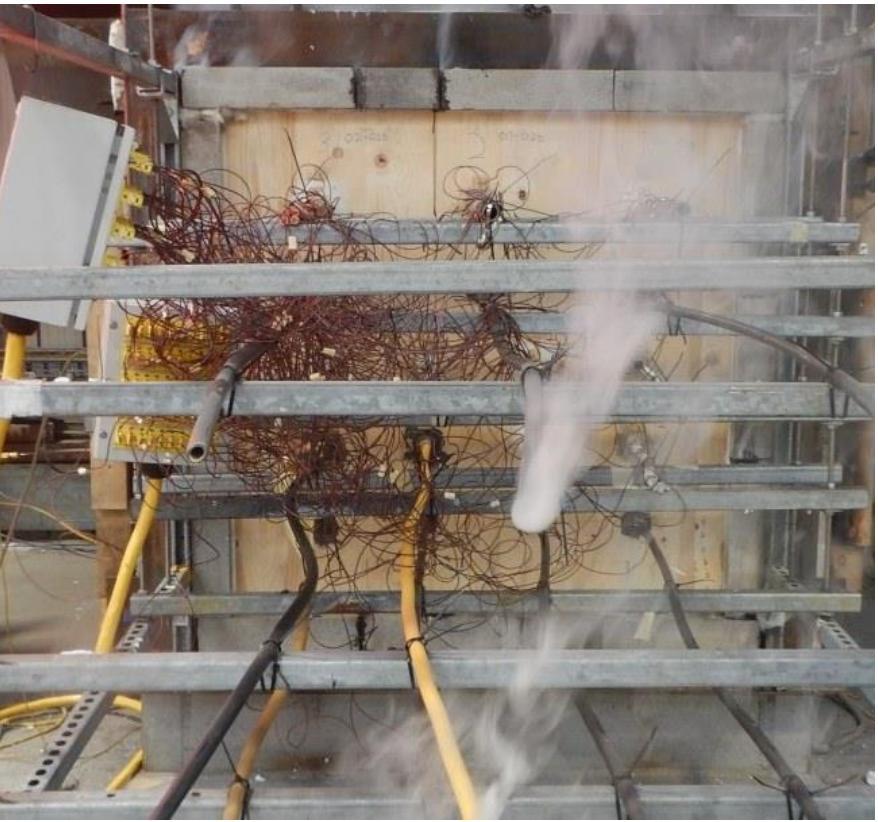
Figure A6.3: Unexposed face of specimen at the end of the test.

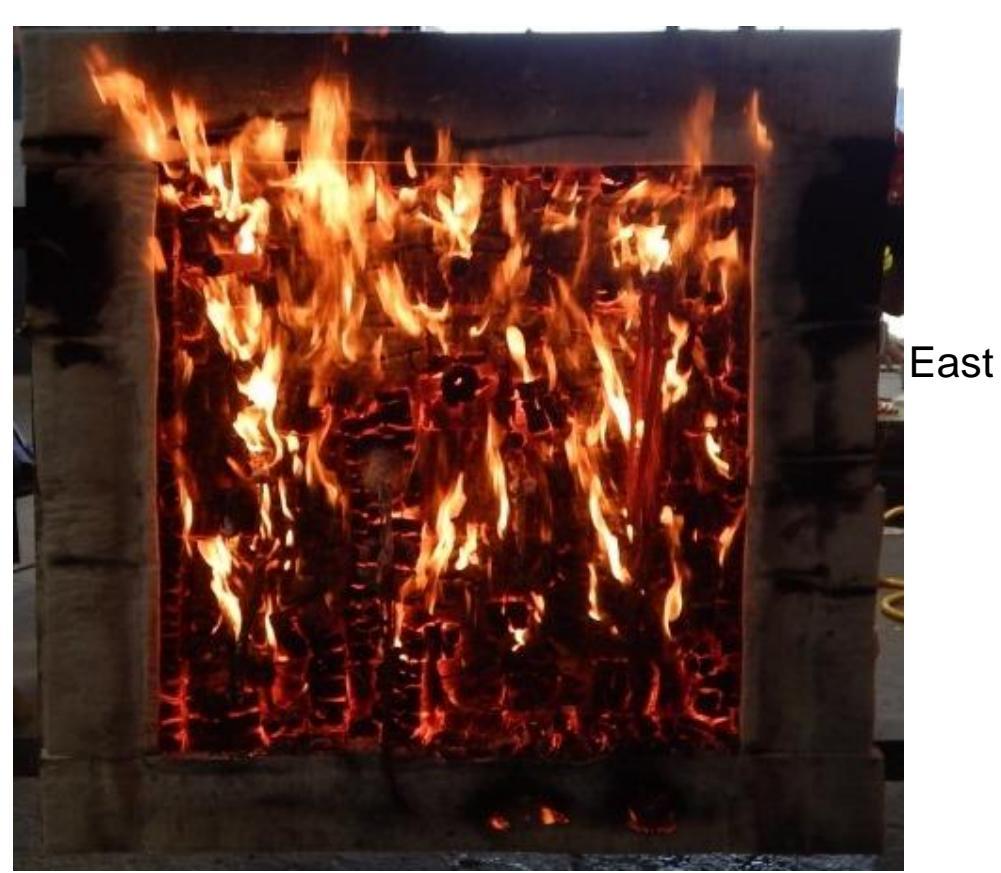
Figure A6.4: Exposed face of specimen at the end of the test.
