# Future Proofing Scott Base Research Station, Antarctica

High value properties, such as scientific research centres, always require careful planning to design the most effective fire-protection systems. But when that property is 3,000km away from the civilization in one the harshest climates on earth, finding the absolute best system that's sure to work when required just gets more critical. Mark Prior, CEO of BOSS Passive Fire, discusses the challenges at Scott Base Research Station in Antarctica.

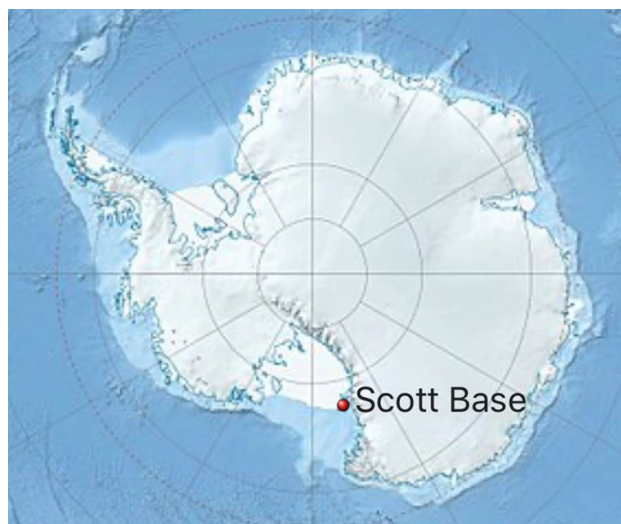
Due to the remote location and possible  $-57^{\circ}\text{C}$  temperatures, fire sealants were wrapped with special thermal products to ensure they didn't freeze during transportation.

Scott Base presented another good reason to think carefully about unseen risks. With the design complete and fire testing carefully analysed, there was still a major hurdle to jump; temperatures in transit can reach  $-57^{\circ}\text{C}$ . Temperature-controlled vessels can assist during shipping, but overland transport, once moving the products to site, was a major risk factor. Contractors had complained of sealants and mastics arriving on site frozen, meaning important products were ruined and unable to be used. The application of fire mastics is as critical as their performance, and when fire sealants are frozen and thawed, the water content separates, rendering the mastic unusable.

Fortunately, BOSS Fire had experience in shipping fire products into Scandinavia, where similar temperatures are commonplace. Creative packaging solutions were implemented, where BOSS' other thermally insulative products were used to isolate cold in the same way they are normally used to protect from heat, and ultimately contractors were pleased when the FireMastic arrived in perfect condition, despite the sub-zero temperatures.

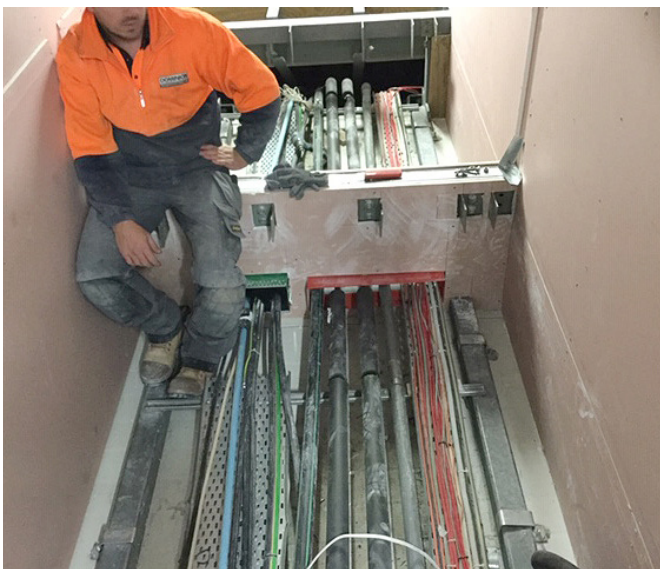
The use of BOSS Multi-Service Transit Devices enabled an easy retrofit solution to existing services.

The concept of BOSS's multi-service transit boxes has revolutionized the fire-stopping concept for applications with large bundles of services in confined spaces, such as data centres, apartment entry and underfloor cable ducts, where all services are bundled together, passing through a single aperture. Made from a steel outer chassis with high-pressure-exerting intumescent sash inlay's that expand in a fire scenario, the transit box concept then closes off the aperture around all the different services, protecting and insulating for up to 120mins. Electrical and comms cables, a wide variety of plastic and metal pipes suitable for plumbing, and HVAC services such as lagged air-conditioning and hotwater pipes are all examples of services that have been tested to pass through a single transit box.

BOSS Fire Transit Boxes were used to retrofit and feed new and existing services through the fire-rated transit boxes. The boxes were installed in conjunction with the high-performance fire

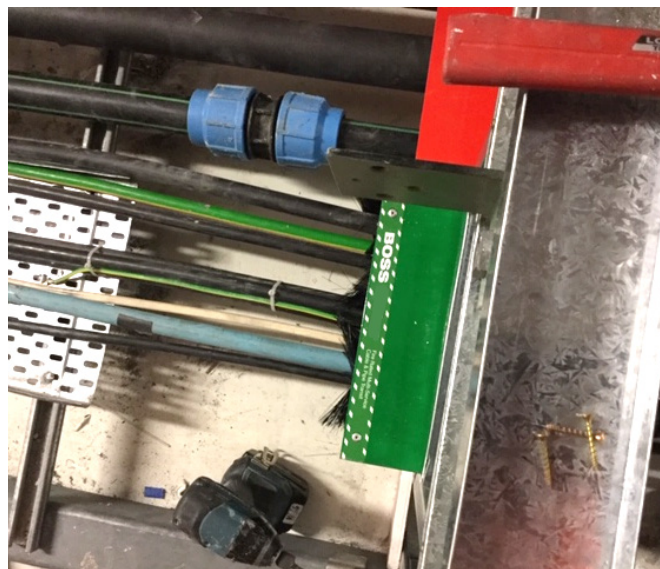
The BOSS Fire Transit Box during construction, certified to AS/NZS 1530.4 for a variety of mixed service combinations.

and later Dominion Contractors and Fire & Emergency NZ, they presented a relatively new concept for managing multiple bundles of mixed services – the BOSS Fire Transit Box.
