Fire-resistance test on services penetrating a Shaftliner wall system

Test Report

Author: Peter Gordon
Report number: FSP 2073
Date: 28 April 2020

Sponsored Investigation No. FSP 2073

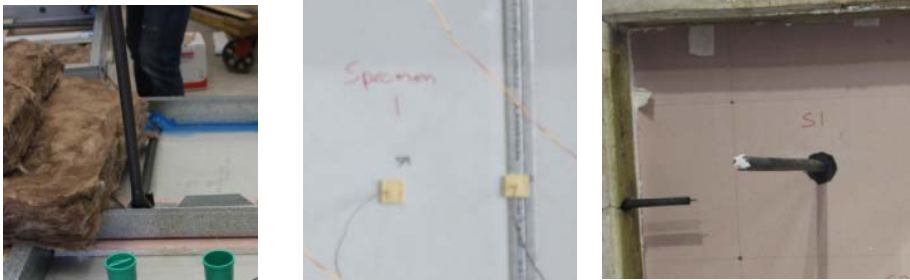
Specimen 1 – A 20-mm diameter PE-Xa Rehau Rautitan pipe penetrating a 55-mm aperture on the exposed face sealed with FireMastic-HPE sealant.

SEPARATING ELEMENT	
The Knauf Shaftliner wall system comprised 25-mm thick Knauf Shaftliner on the exposed side and two layers of 2 x 13-mm thick Knauf FireShield on the unexposed side of the 102-mm x 0.55 BMT CH-wall studs. The cavity of the wall was filled with 75-mm thick Knauf Earthwool. The FRL of the Knauf Shaftliner wall system had not been verified by the test sponsor.	
TYPE AND SIZE OF CONSTRUCTION	
A 55-mm diameter aperture on the exposed side of the 128-mm thick wall.	
PENETRATING SERVICE	
Description	A single PE-Xa Rehau Rautitan pipe incorporating a 90° elbow joint.
Size	A 20-mm OD pipe with 2.8-mm wall thickness incorporating a Rehau PX No.12 90 Degree elbow. The pipe extended 500-mm away from the exposed face and approximately 500-mm upwards inside the wall cavity.
End conditions	The pipe was plugged on the exposed side with ceramic fibre and left open inside the wall cavity.
Supports	Internally to the unexposed wall face at the elbow joint.

FIRE STOPPING SYSTEM	
Name	FireMastic-HPE
Description	FireMastic-HPE is a graphite-based, thixotropic, one part acrylic emulsion.
Application	Inside the wall cavity on the unexposed side a 200-mm high x 600-mm wide piece of 13-mm FireShield plasterboard was fixed to the Shaftliner using 10-mm x 38-mm laminating screws at 300-mm centres. Steel angles, 200-mm long x 50-mm x 50-mm x 0.7 BMT were fixed to the two centre C-studs using four screws. A 600-mm long piece of 0.8mm BMT J-track was then fixed to the two angles using 10g X 16-mm flat top drill point tek screws. The 20-mm PE-Xa pipe was then fixed at the elbow joint to the J-track with an Auspex Clip and a 25-mm metal tek screw. The annular gap between the pipe and FireShield plasterboard wall on the fire side was sealed with FireMastic-HPE to a depth of approximately 26-mm and finished flush with the wall.
Photograph

<div style="display: flex; justify-content: space-around; margin-top: 5px;"> Inside the wall cavity Unexposed face Exposed face </div>

Specimen 1 – A 20-mm diameter PE-Xa Rehau Rautitan pipe penetrating a 55-mm aperture on the exposed face sealed with FireMastic HPE sealant.

Structural adequacy	-	Not applicable
Integrity	-	no failure at 121 minutes
Insulation	-	no failure at 121 minutes

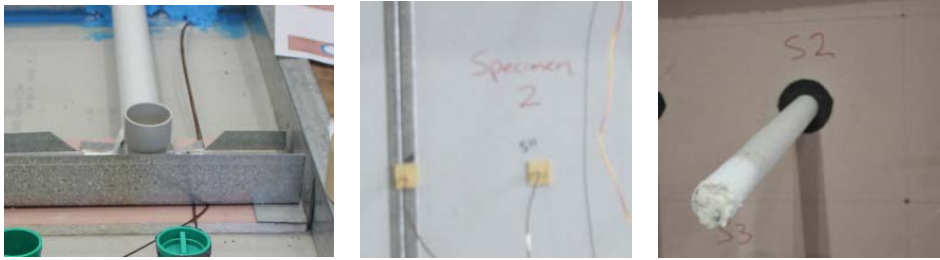
Specimen 2 – A 43-mm diameter PVC pipe penetrating a 90-mm aperture on the exposed face sealed with FireMastic-HPE sealant.

SEPARATING ELEMENT	
The Knauf Shaftliner wall system comprised 25 mm thick Knauf Shaftliner on the exposed side and two layers of 2 x 13-mm thick Knauf FireShield on the unexposed side of the 102 mm x 0.55 BMT CH-wall studs. The cavity of the wall was filled with 75-mm thick Knauf Earthwool. The FRL of the Knauf Shaftliner wall system had not been verified by the test sponsor.	
TYPE AND SIZE OF CONSTRUCTION	
A 90-mm diameter aperture on the exposed side of the 128-mm thick wall.	
PENETRATING SERVICE	
Description	A single Vinidex PVC pipe incorporating a 90° elbow.
Size	A PVC pipe with 43-mm OD and 2.3-mm wall thickness incorporating a 90° PVC elbow. The pipe extended 500-mm away from the exposed face and approximately 500-mm upwards inside the wall cavity.
End conditions	The pipe was plugged on the exposed side with ceramic fibre and left open inside the wall cavity.
Supports	Internally to the unexposed wall face at the elbow joint.

FIRE STOPPING SYSTEM	
Name	FireMastic-HPE
Description	FireMastic-HPE is a graphite-based, thixotropic, one part acrylic emulsion
Application	Inside the wall cavity on the unexposed side a 200-mm high x 600-mm wide piece of 13-mm FireShield plasterboard was fixed to the Shaftliner using 10-mm x 38-mm laminating screws at 300-mm centres. Steel angles, 200-mm long, 50-mm x 50-mm x 0.7 BMT were fixed to the two centre C-studs using four screws. A 600-mm long piece of 0.8mm BMT J-track was then fixed to the two angles with 10g X 16-mm flat top drill point tek screws. The 43-mm PVC pipe was then fixed at the elbow joint to the J-track with a nylon coated metal saddle flush clip and 10g x 16-mm flat top drill point tek screws. The annular gap between the pipe and FireShield plasterboard wall on the fire side was sealed with FireMastic-HPE to a depth of approximately 26-mm and finished flush with wall.

<div style="display: flex; justify-content: space-around; margin-top: 5px;"> Inside the wall cavity Unexposed face Exposed face </div>
Drawing	Drawing Titled “Knauf Service Penetration Pilot Fire test SP4436 FRL -/90/90 Shaft Wall System with 2x13mm FireShield”, dated 5 September 2019 by Knauf Plasterboard Pty Ltd.

Specimen 2 – A 43-mm diameter PVC pipe penetrating a 90-mm aperture on the exposed face sealed with FireMastic HPE sealant.

Structural adequacy	-	Not applicable
Integrity	-	no failure at 121 minutes
Insulation	-	no failure at 121 minutes

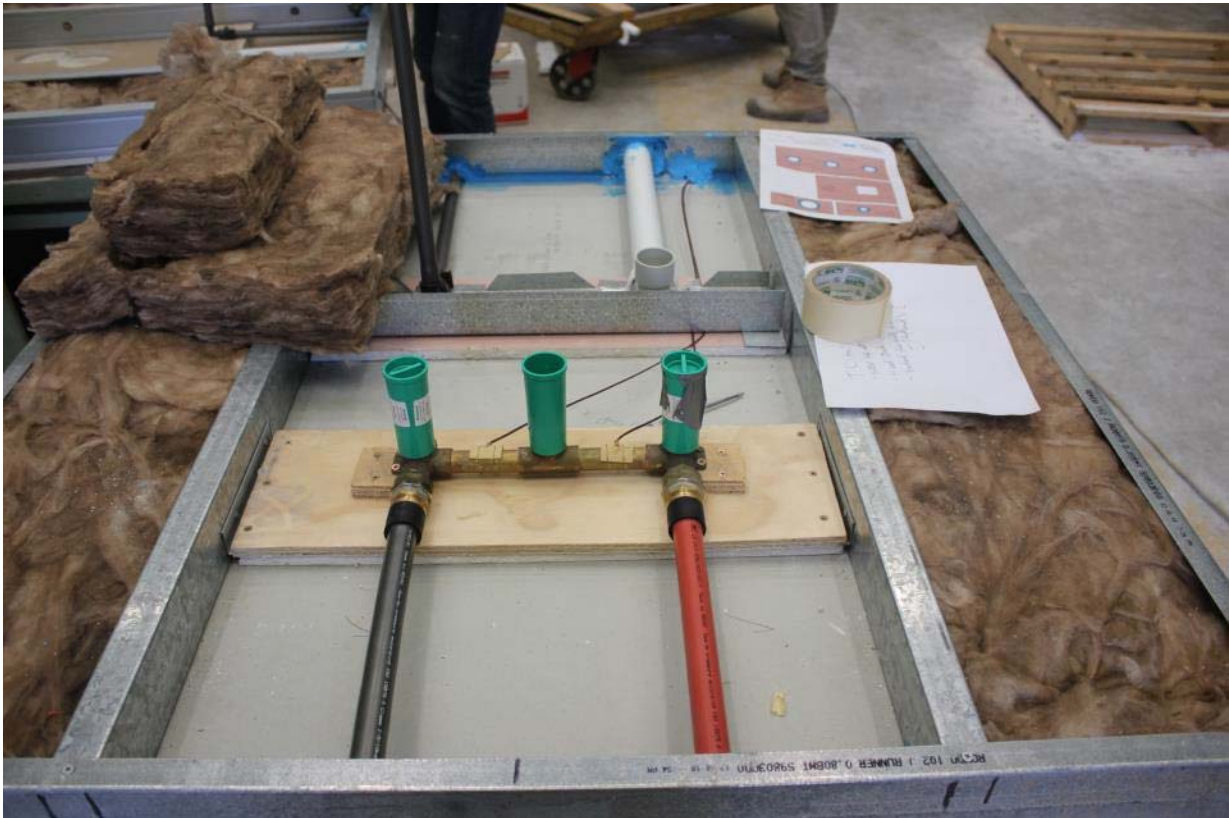
PHOTOGRAPH 1 –SPECIMEN DURING CONSTRUCTION PRIOR TO TESTING

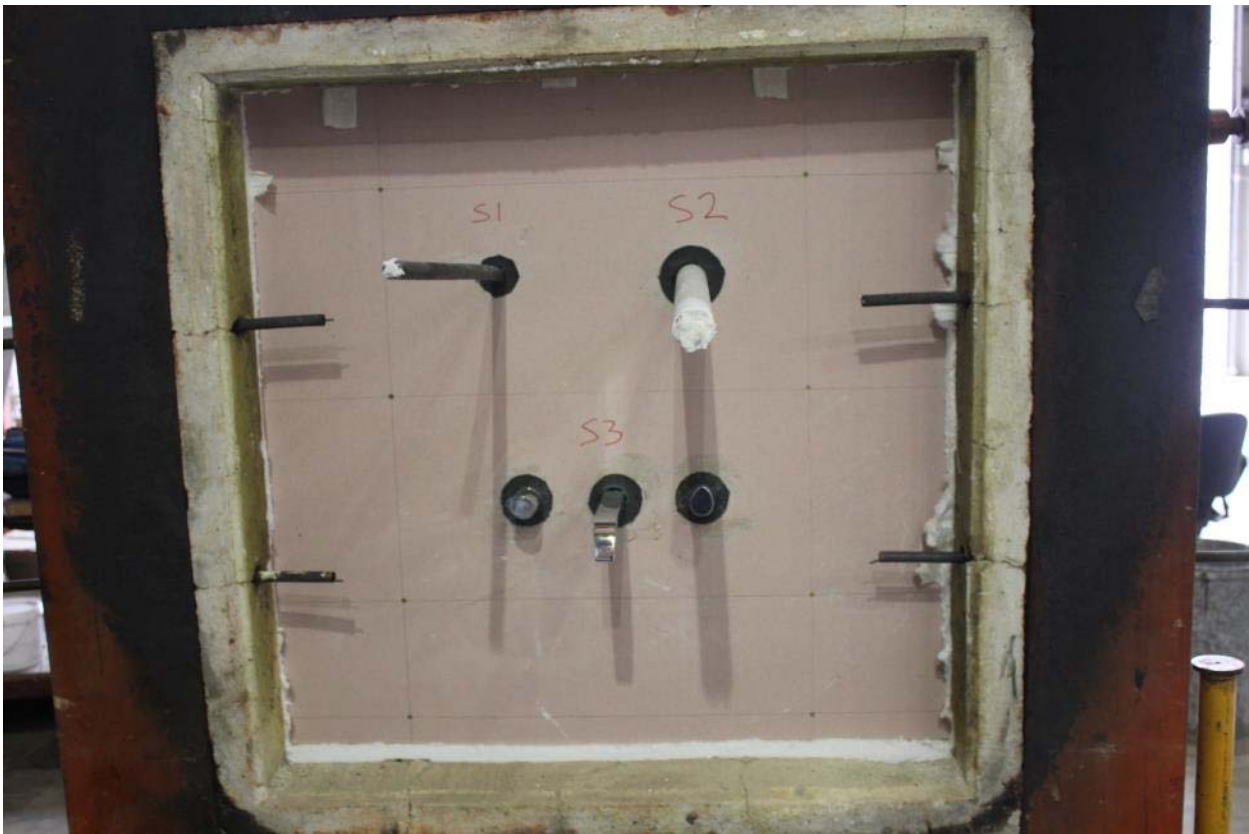
PHOTOGRAPH 2 – EXPOSED SIDE OF SPECIMEN PRIOR TO TESTING

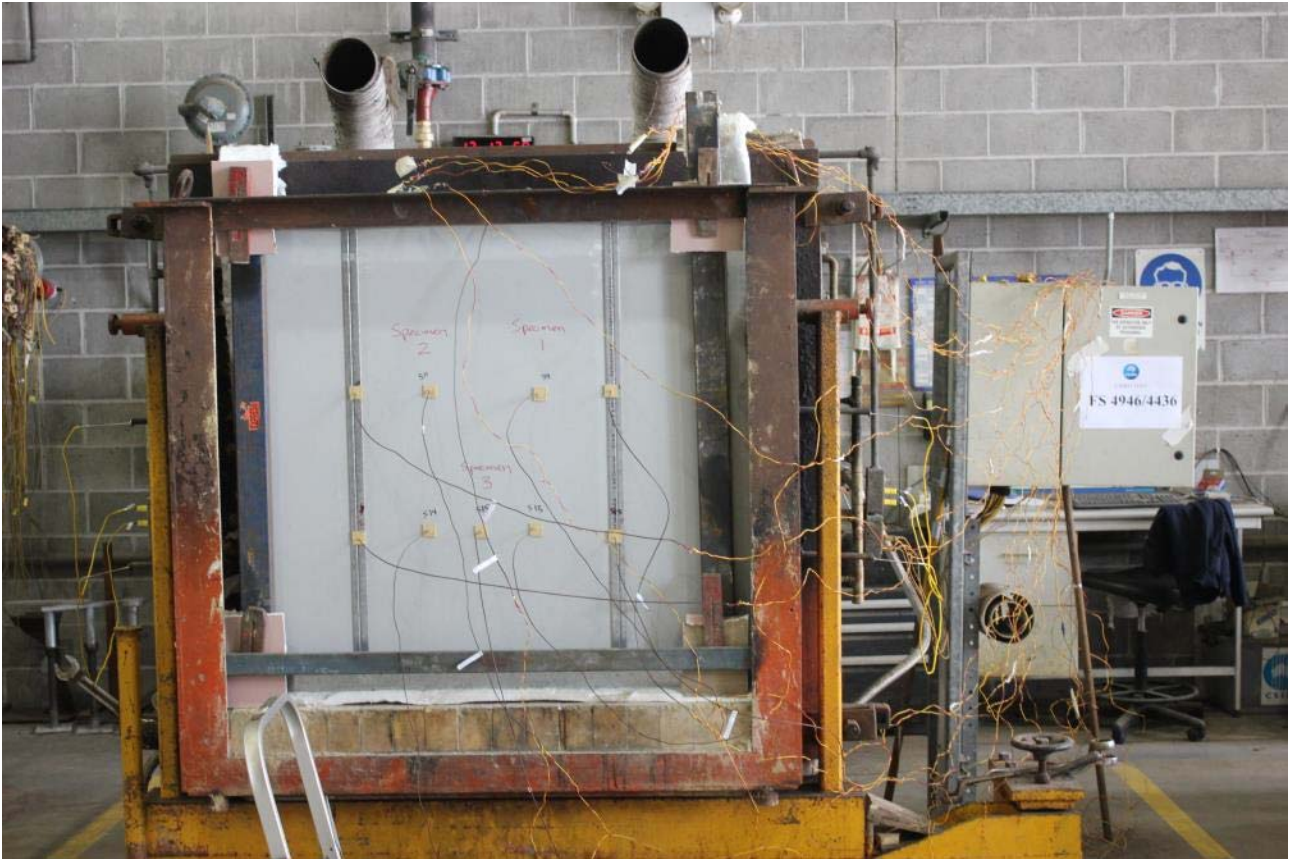
PHOTOGRAPH 3 – UNEXPOSED SIDE OF SPECIMEN PRIOR TO TESTING

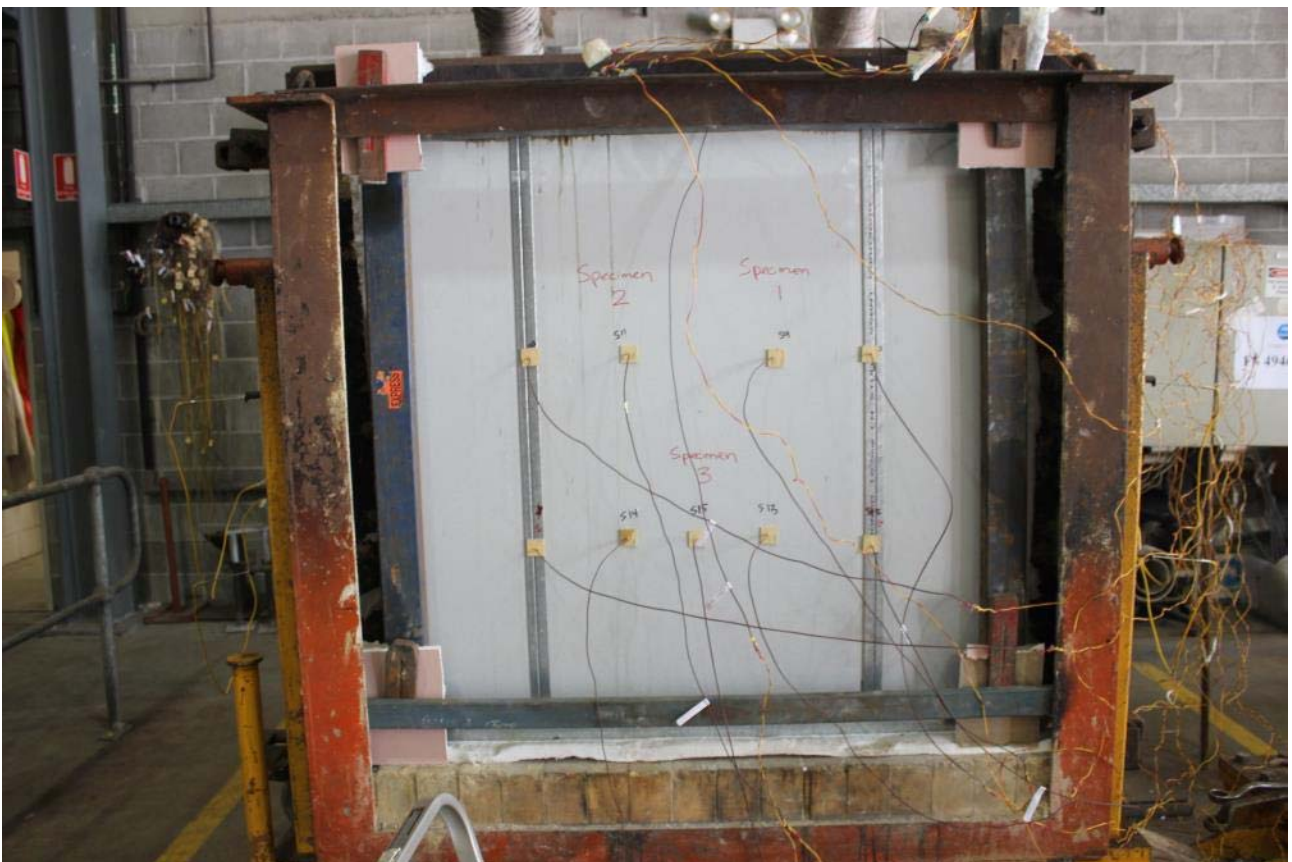
PHOTOGRAPH 4 – SPECIMEN AFTER 30 MINUTES OF TESTING

- 30 minutes - No visible change noted on any of the specimens.
- 60 minutes - No visible change noted on any of the specimens.
- 90 minutes - No visible change noted on any of the specimens.
- 120 minutes - No visible change noted on any of the specimens throughout the test.
- 121 minutes - Test terminated.

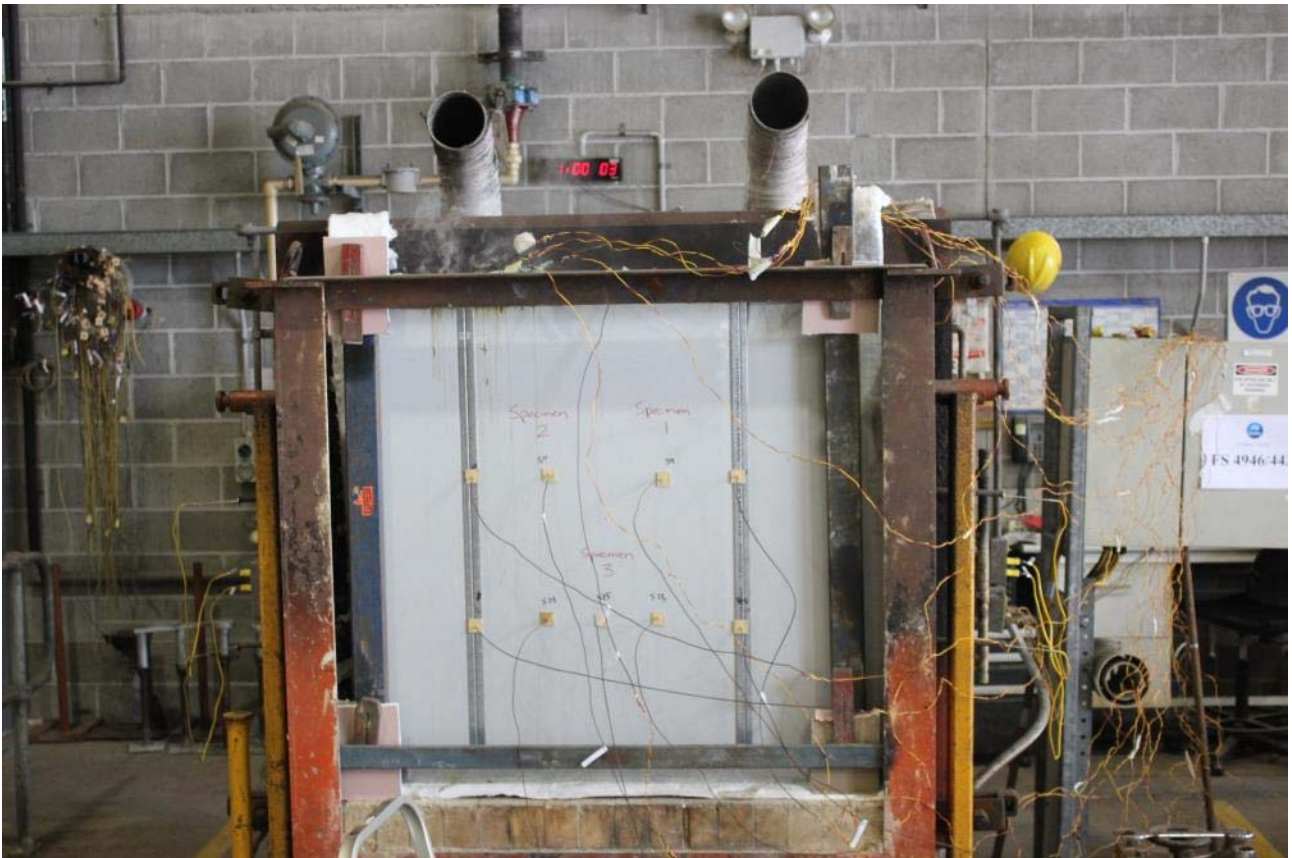
PHOTOGRAPH 5 – SPECIMEN AFTER 60 MINUTES OF TESTING

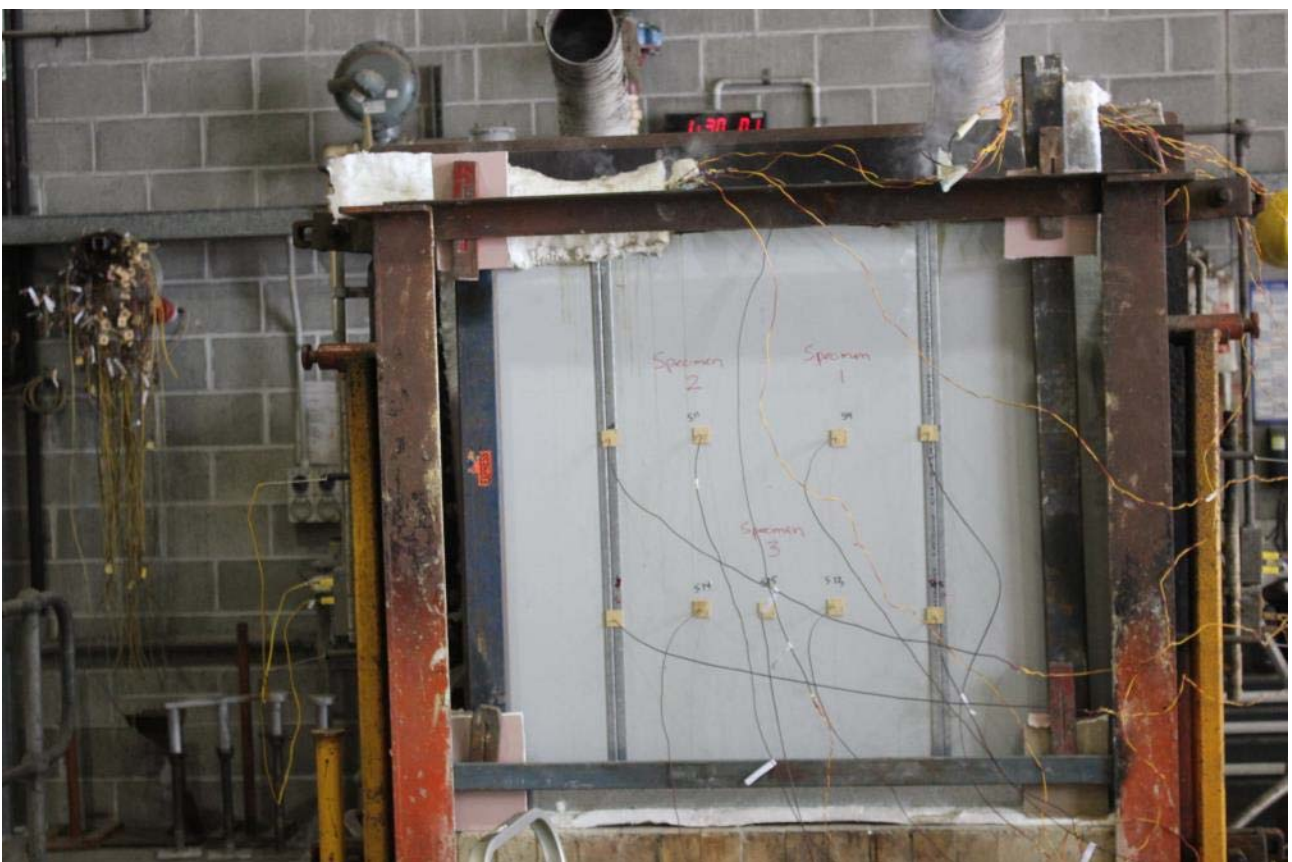
PHOTOGRAPH 6 – SPECIMEN AFTER 90 MINUTES OF TESTING

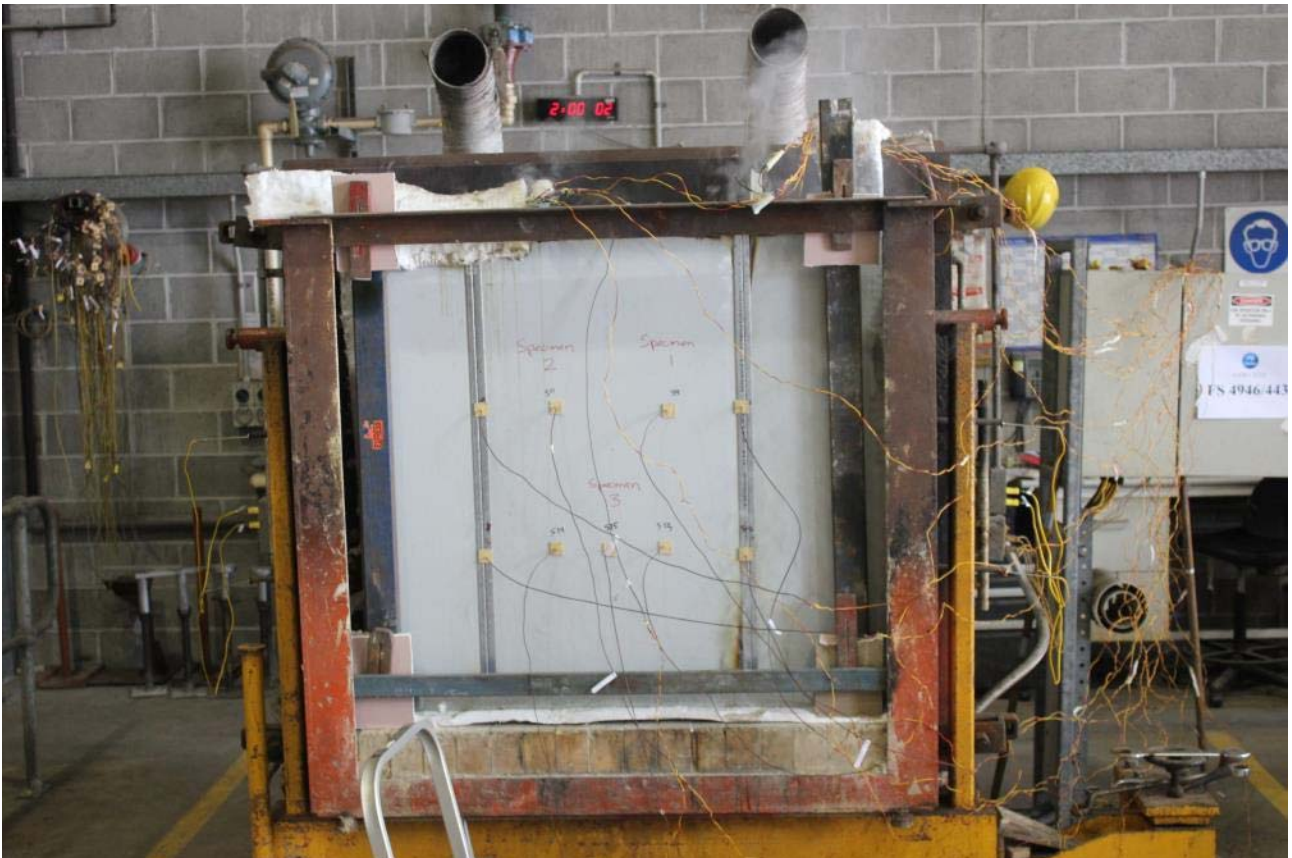
PHOTOGRAPH 7 – SPECIMEN AFTER 120 MINUTES OF TESTING

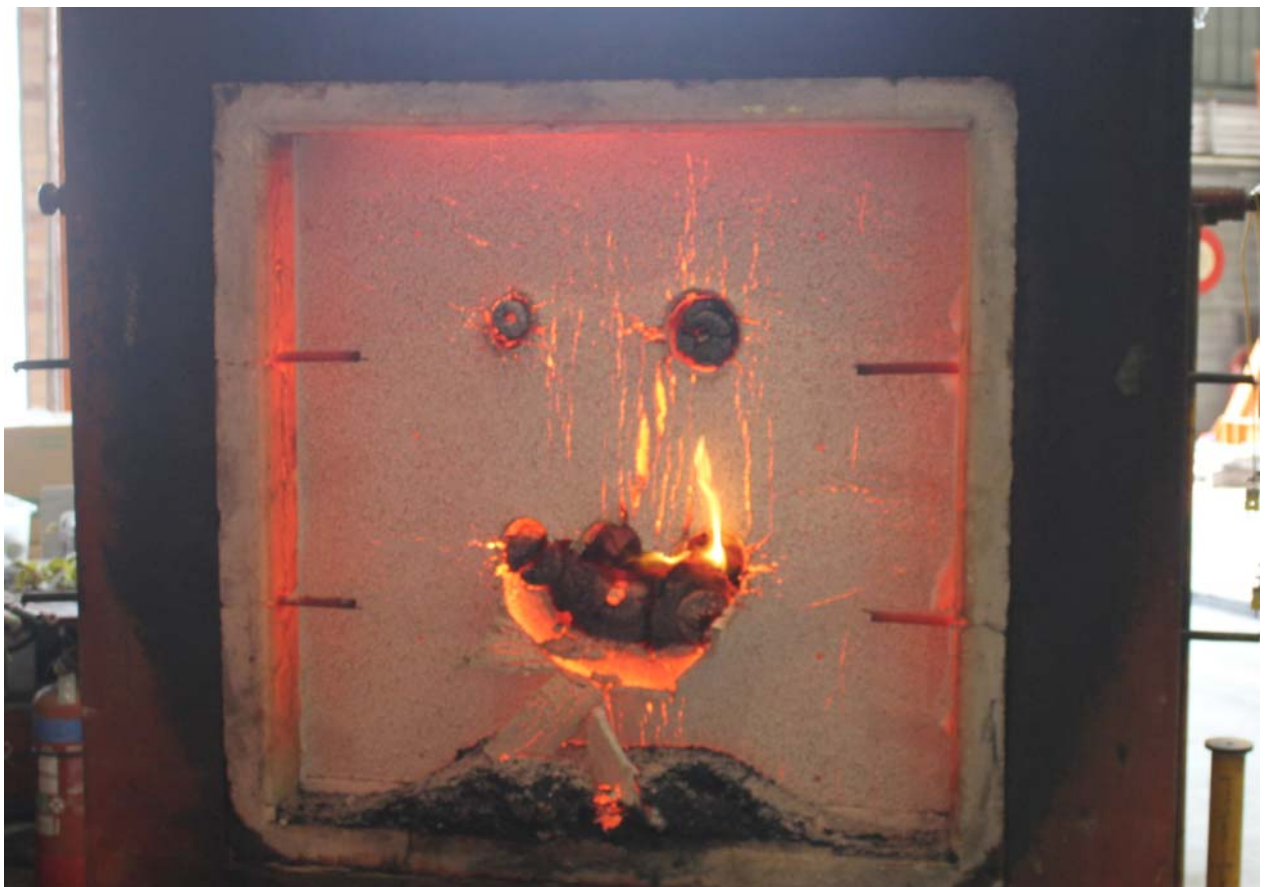
PHOTOGRAPH 8 – SPECIMENS EXPOSED FACE AFTER THE CONCLUSION OF TESTING

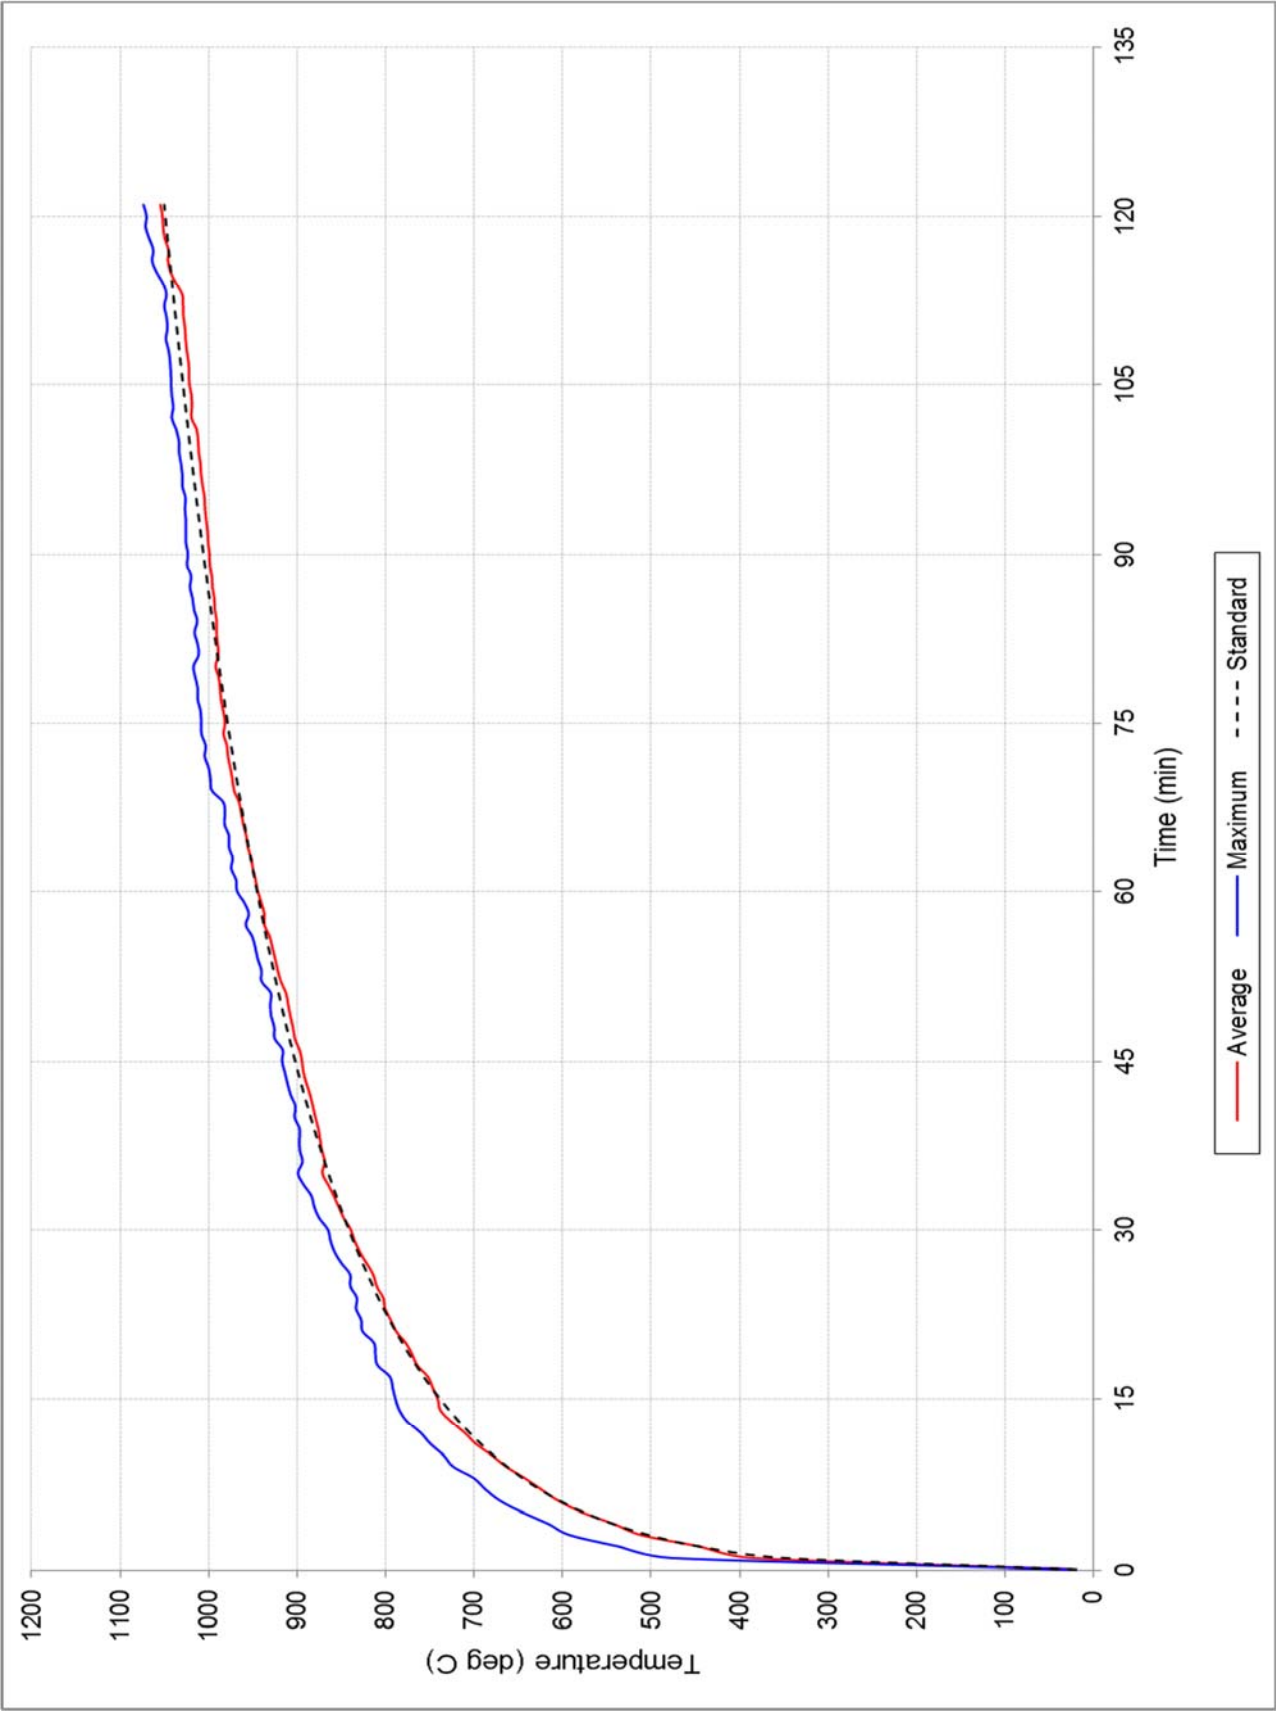
FIGURE 1 – FURNACE TEMPERATURE

Figure 1 shows the standard curves of temperature versus time for heating the furnace chamber and the actual curves of average and maximum temperature versus time recorded during the heating period.

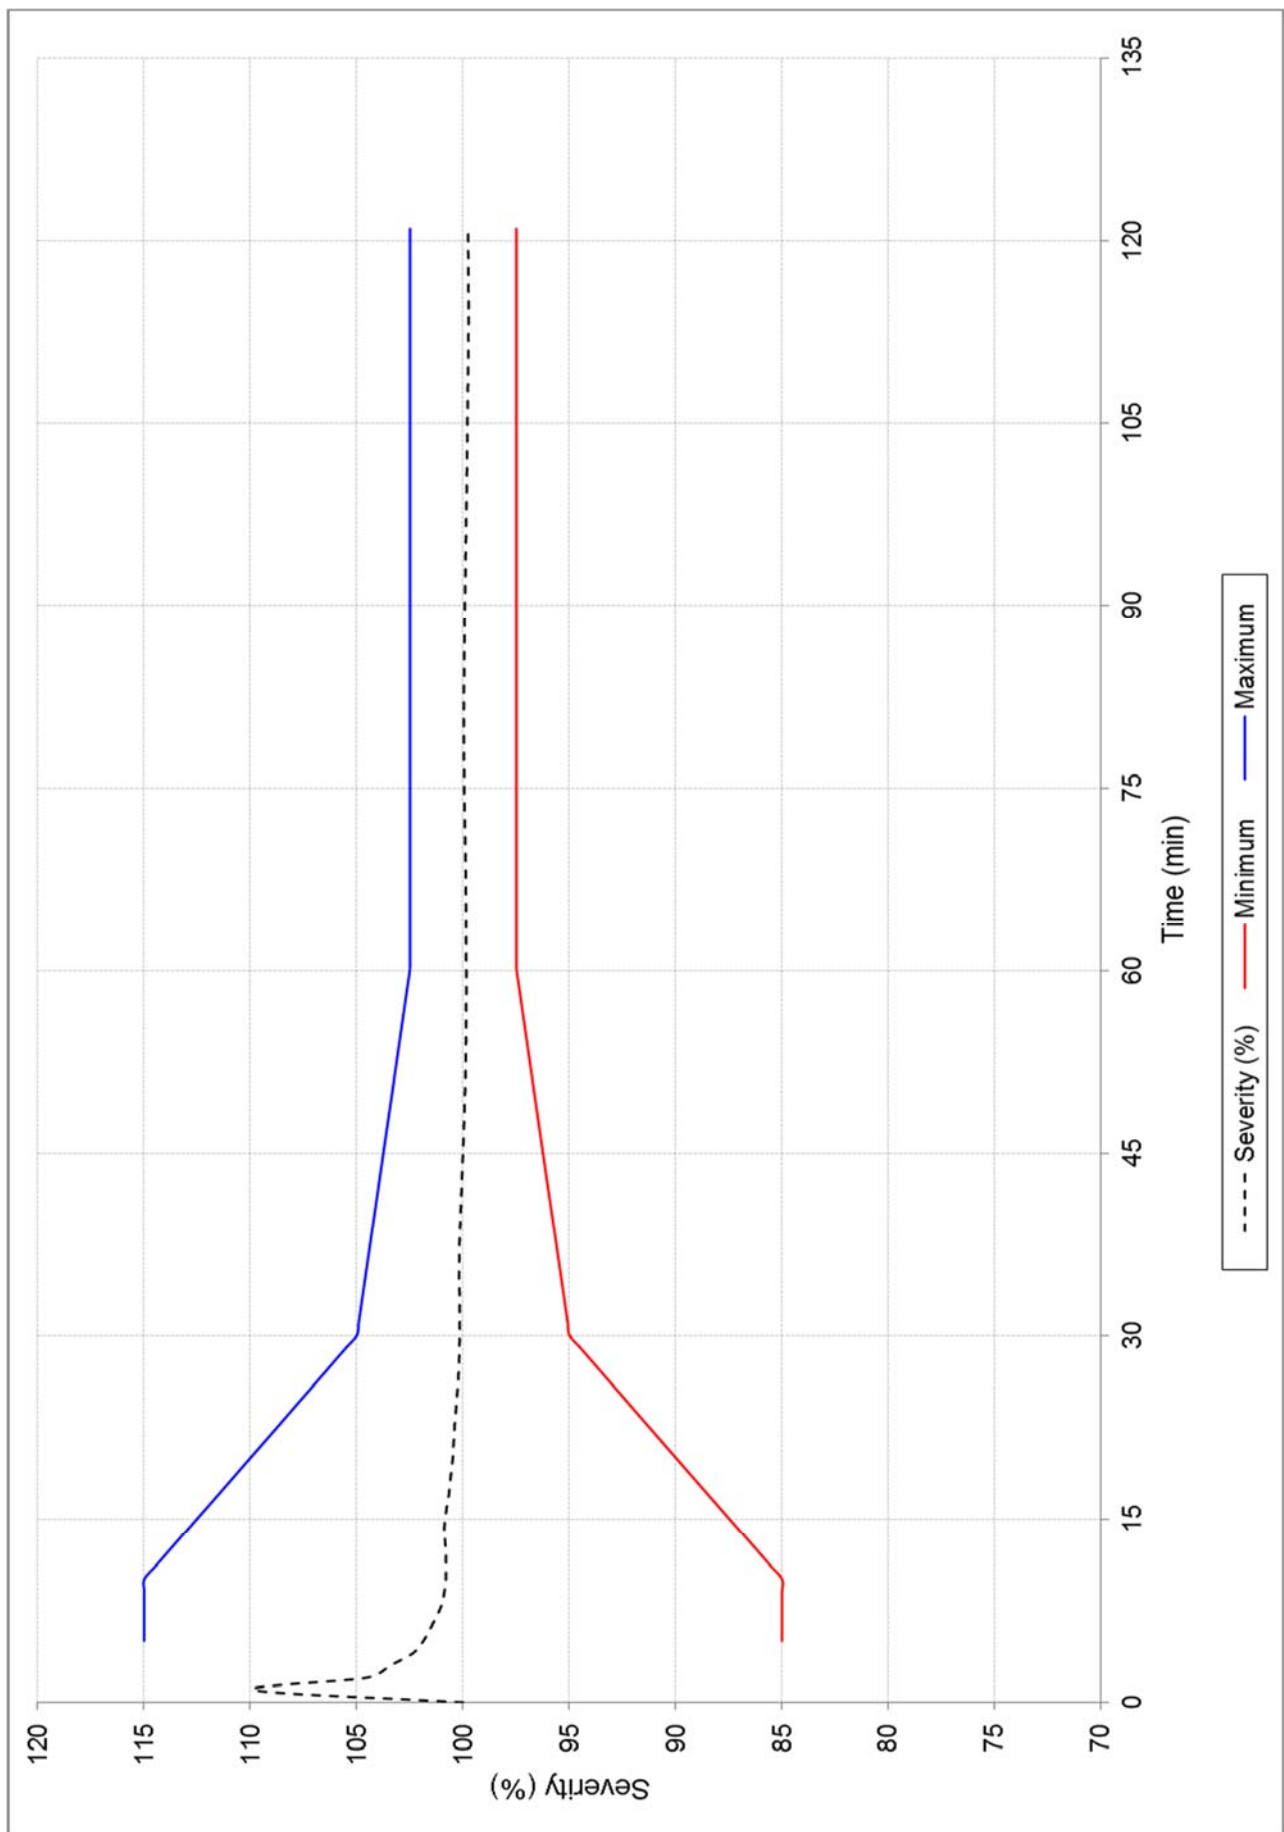
FIGURE 2 – FURNACE SEVERITY

Figure 2 shows the curve of furnace severity versus time during the heating period.

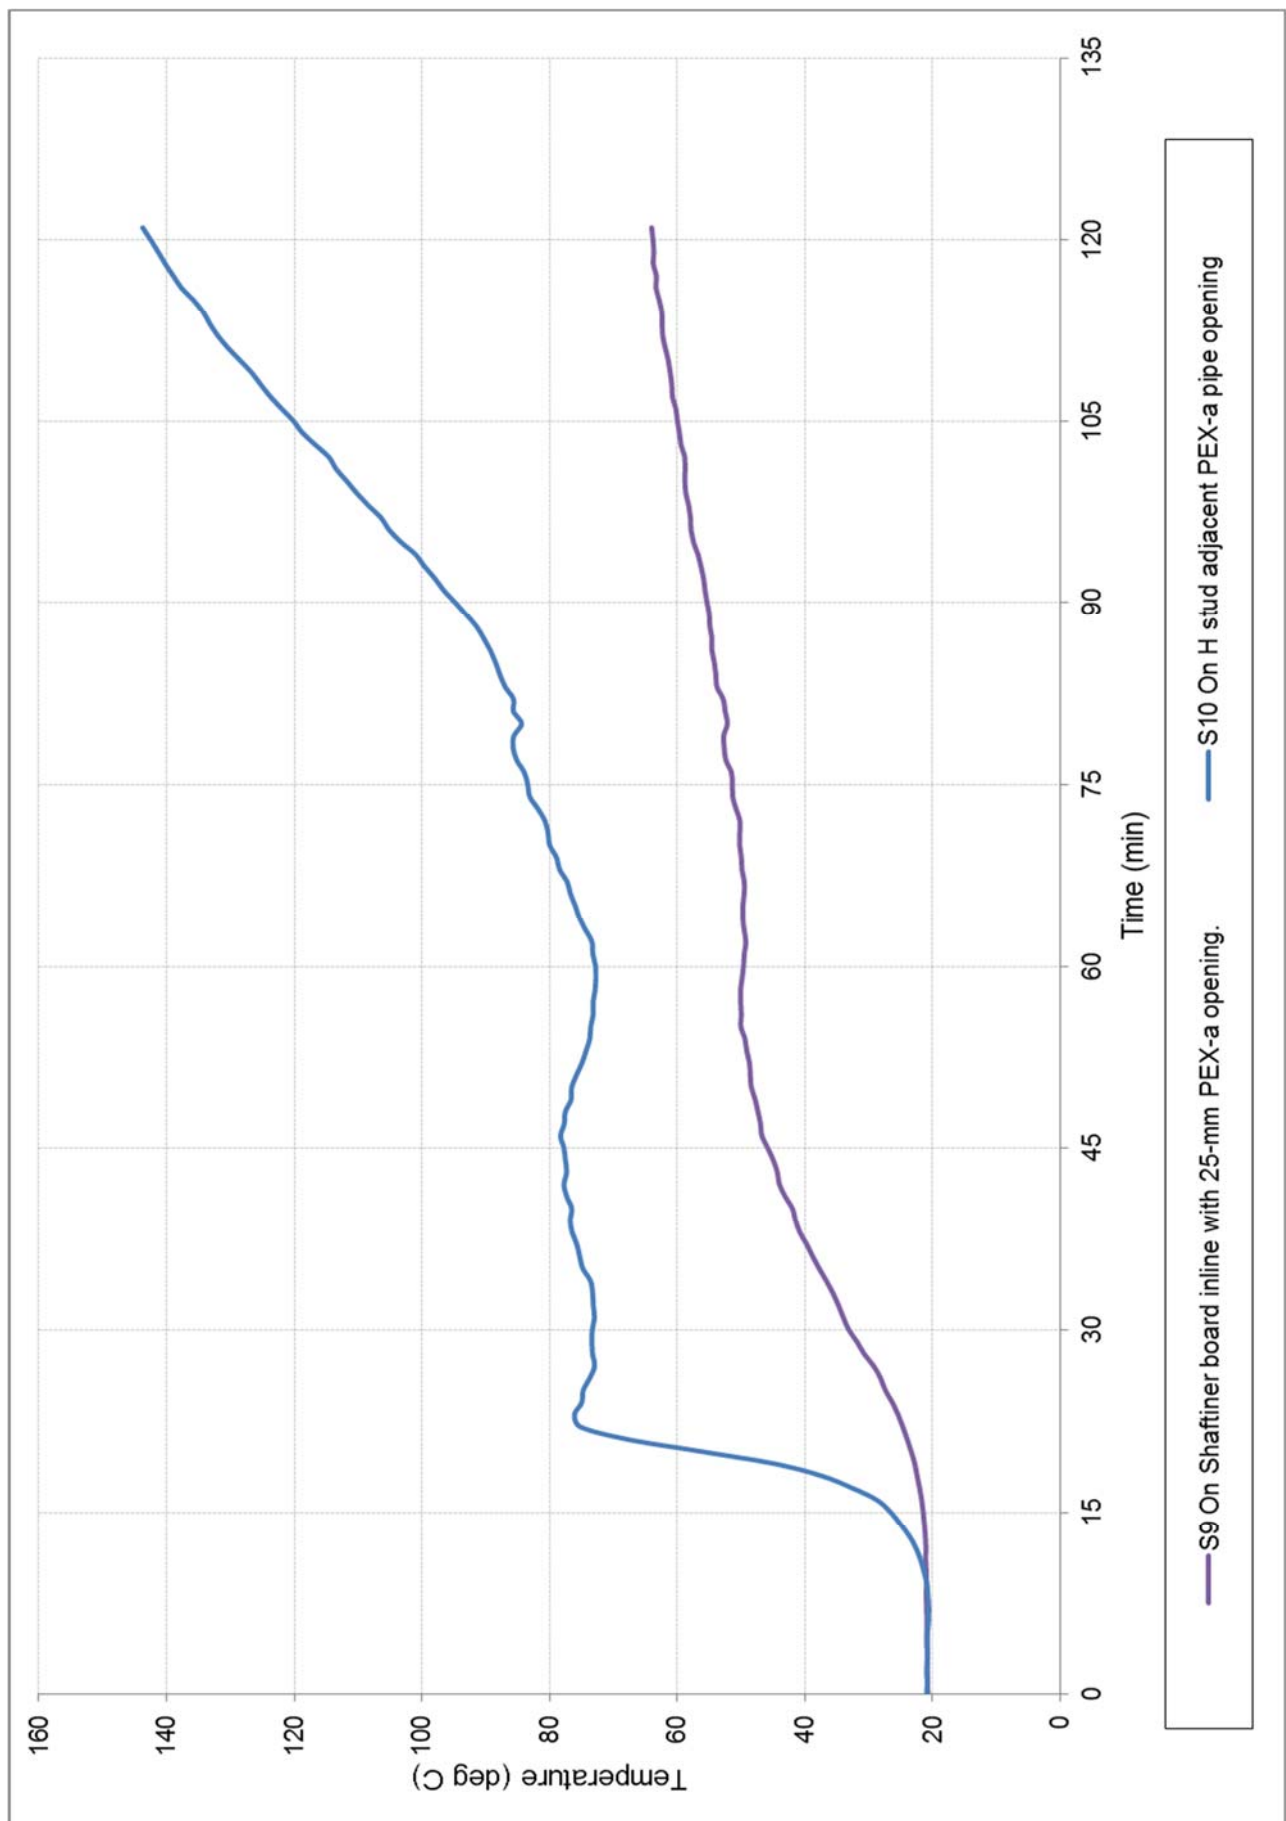
FIGURE 3 – SPECIMEN TEMPERATURE – ASSOCIATED WITH SPECIMEN 1

Figure 3 shows the curve of temperature versus time associated with Specimen 1.

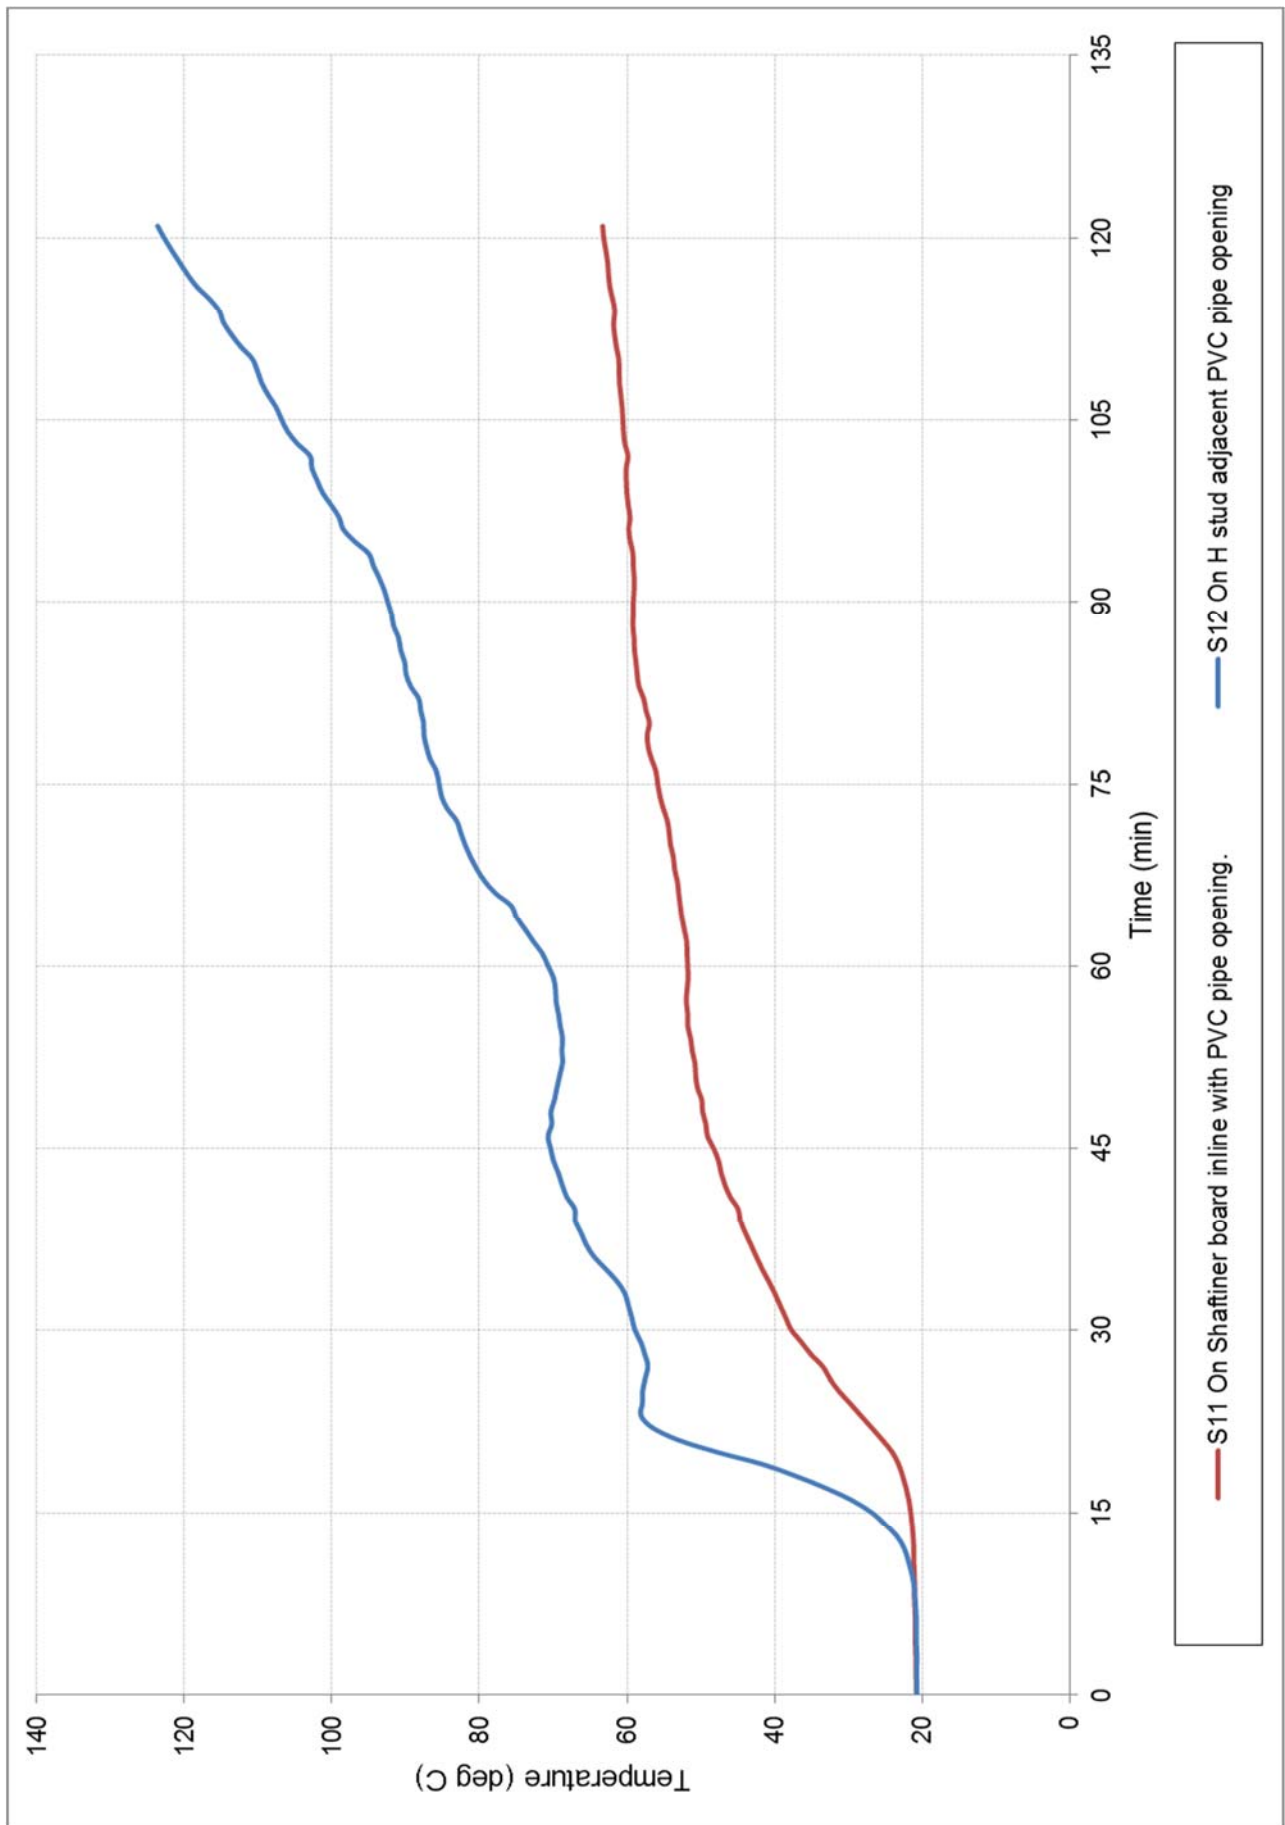
FIGURE 4 – SPECIMEN TEMPERATURE – ASSOCIATED WITH SPECIMEN 2

Figure 4 shows the curve of temperature versus time associated with Specimen 2.

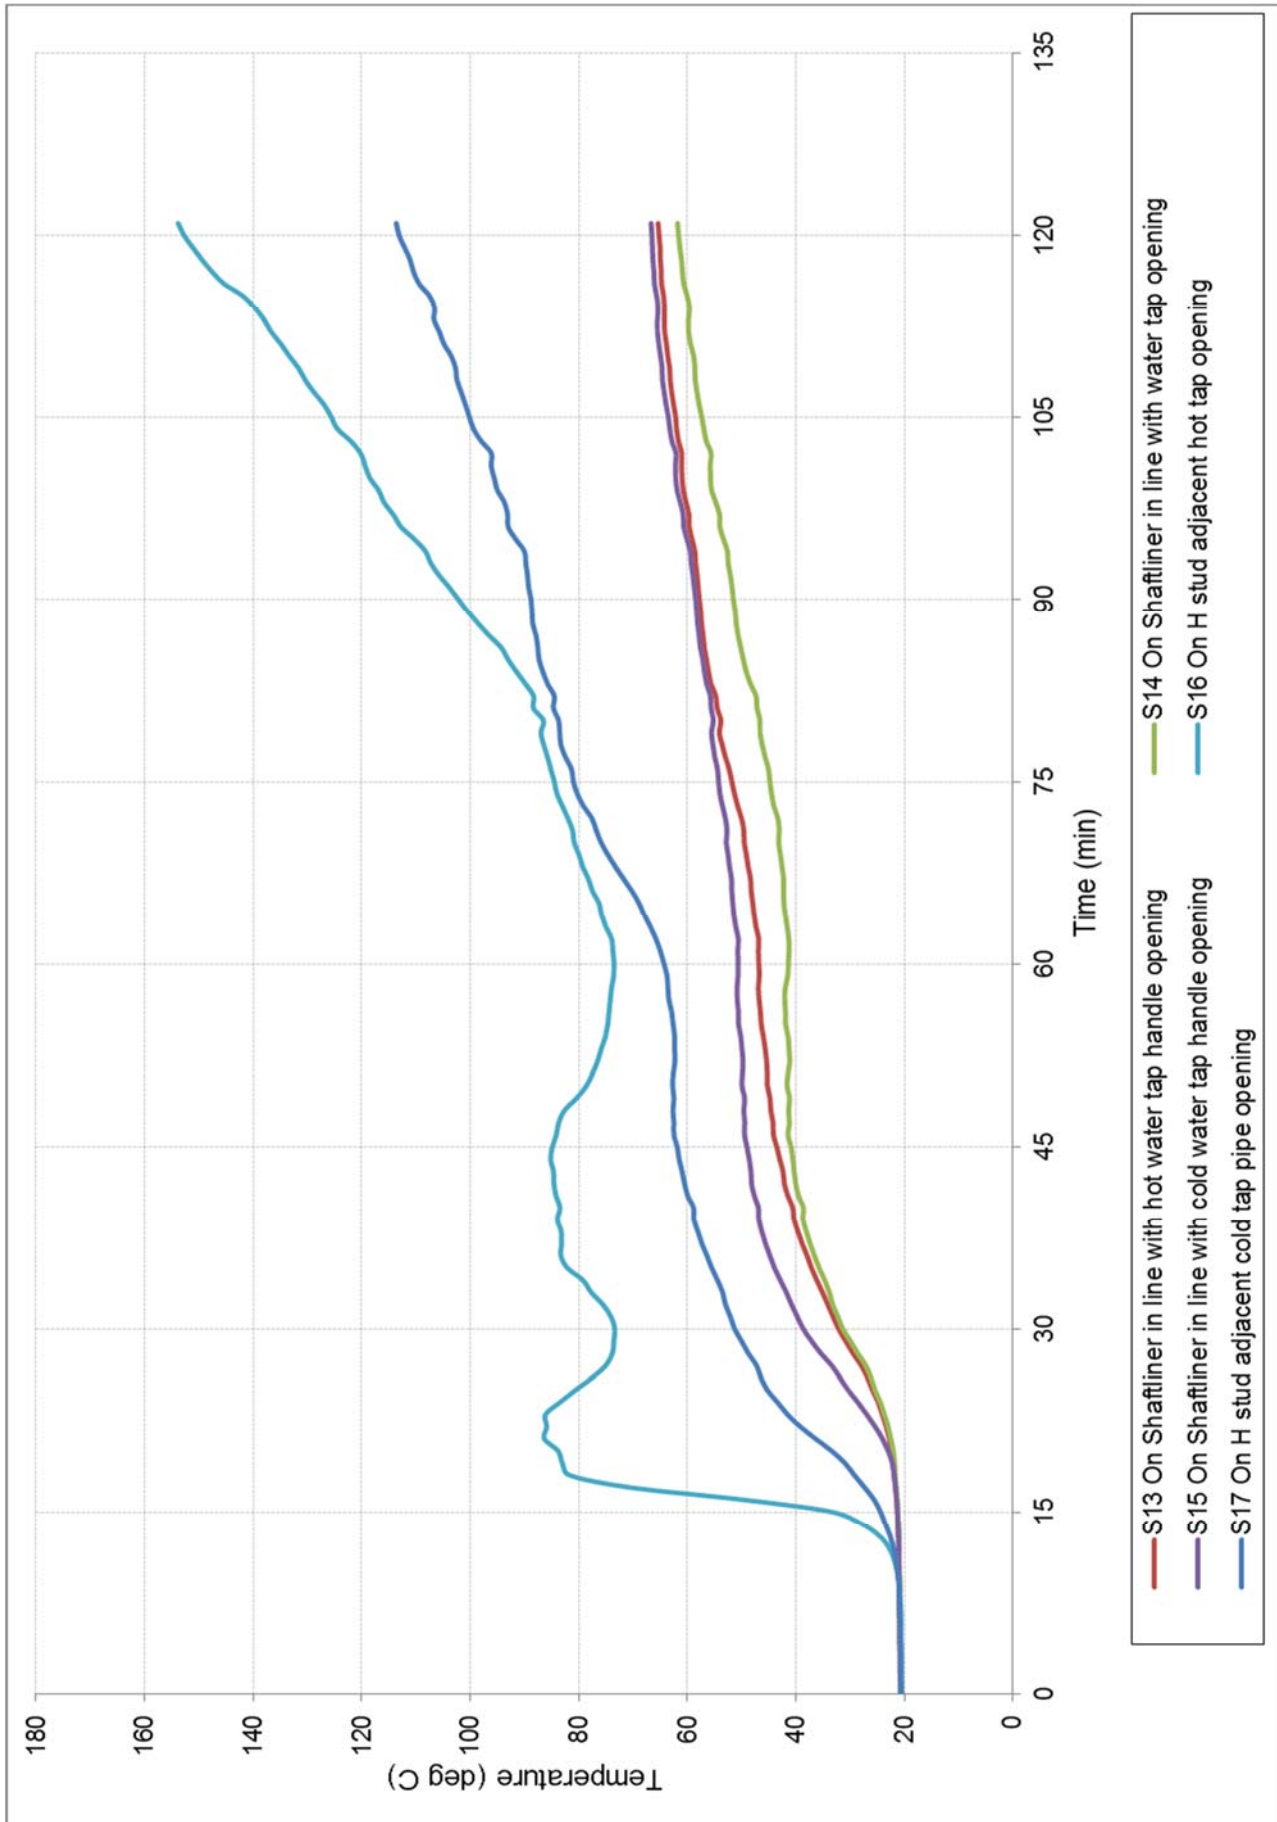
FIGURE 5 – SPECIMEN TEMPERATURE – ASSOCIATED WITH SPECIMEN 3

Figure 5 shows the curve of temperature versus time associated with Specimen 3.
