Fire-resistance test on services penetrating a Shaftliner wall system

Test Report

Author: Peter Gordon
Report number: FSP 2073
Date: 28 April 2020

Sponsored Investigation No. FSP 2073

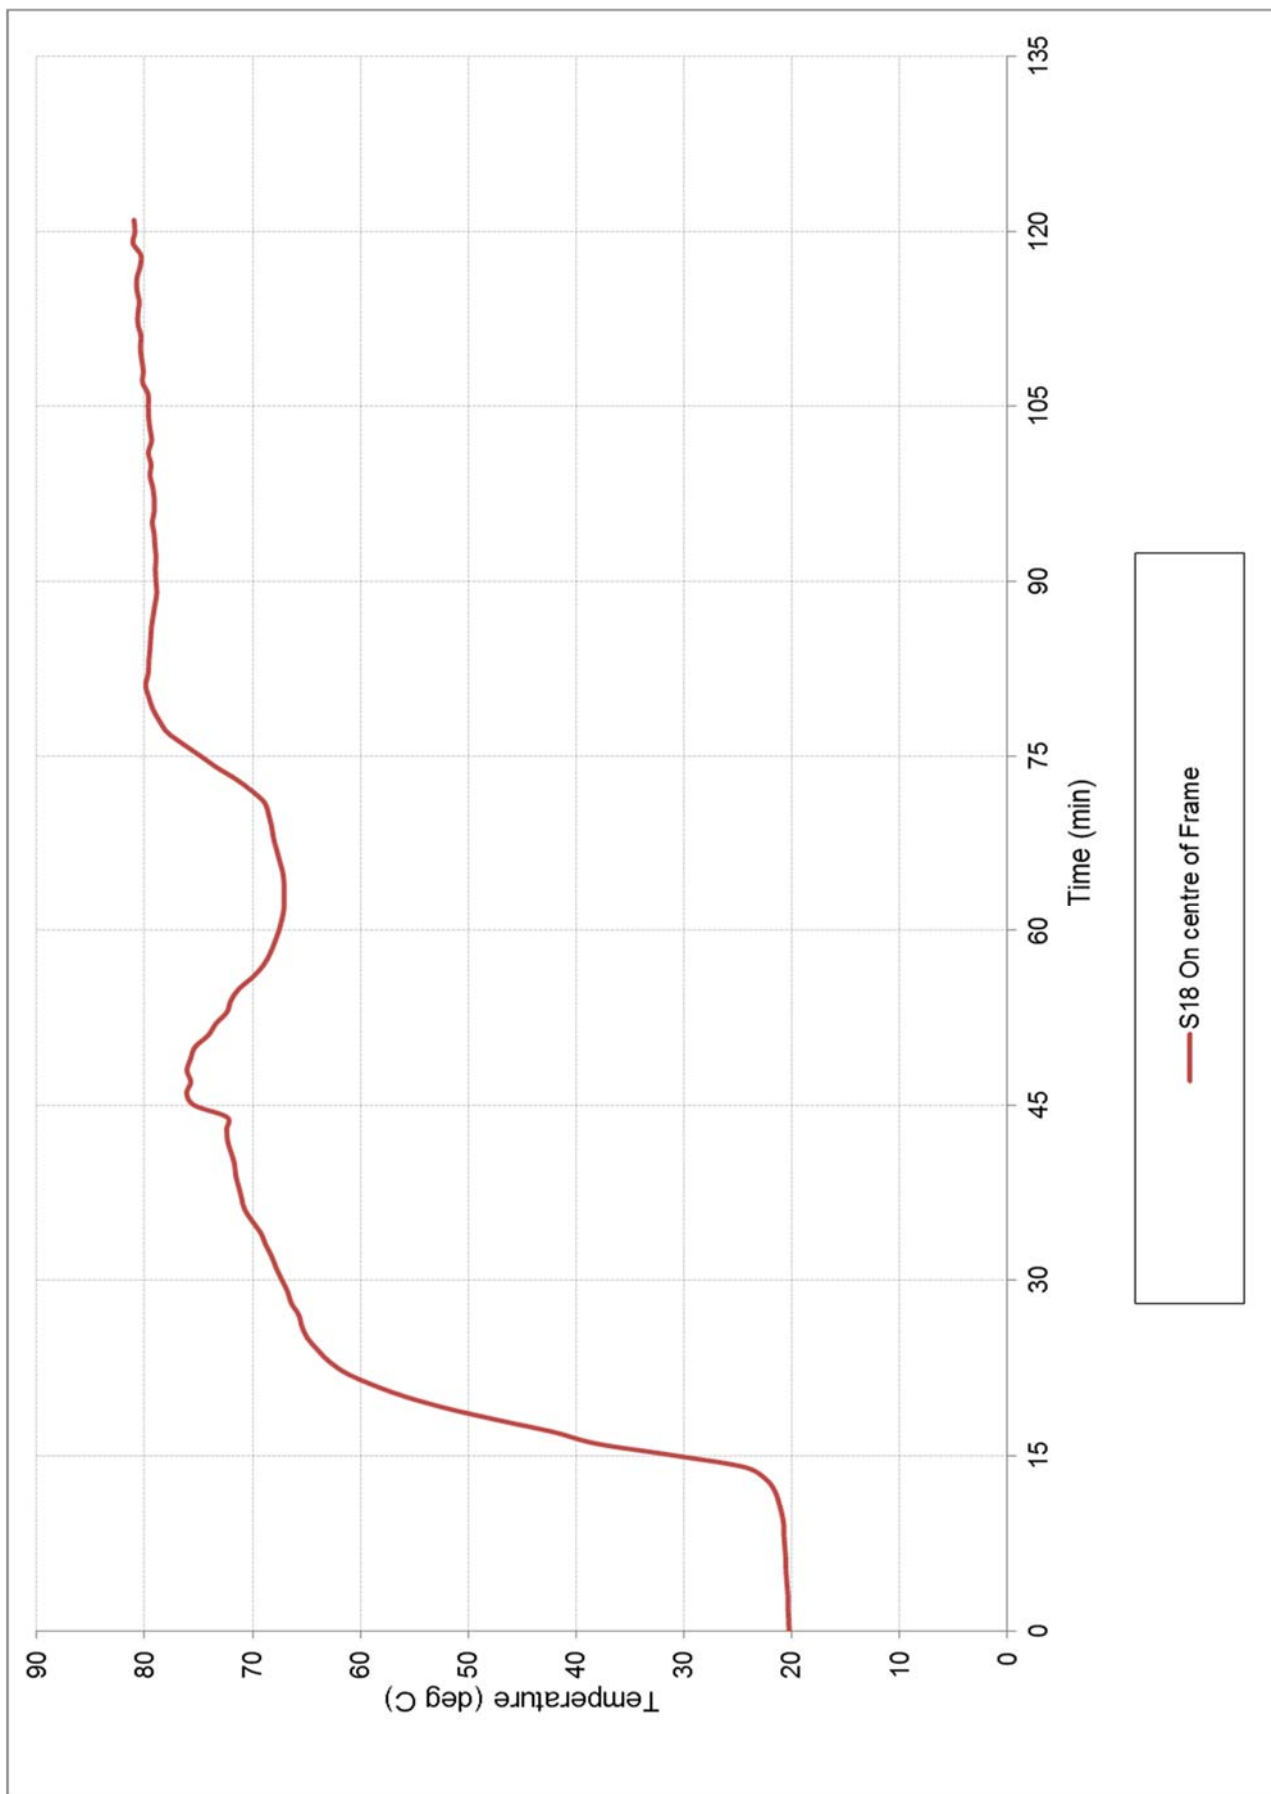
FIGURE 6 – HEAD OF SPECIMEN WALL TEMPERATURE

Figure 6 shows the curve of temperature on the frame at the head of specimen wall.

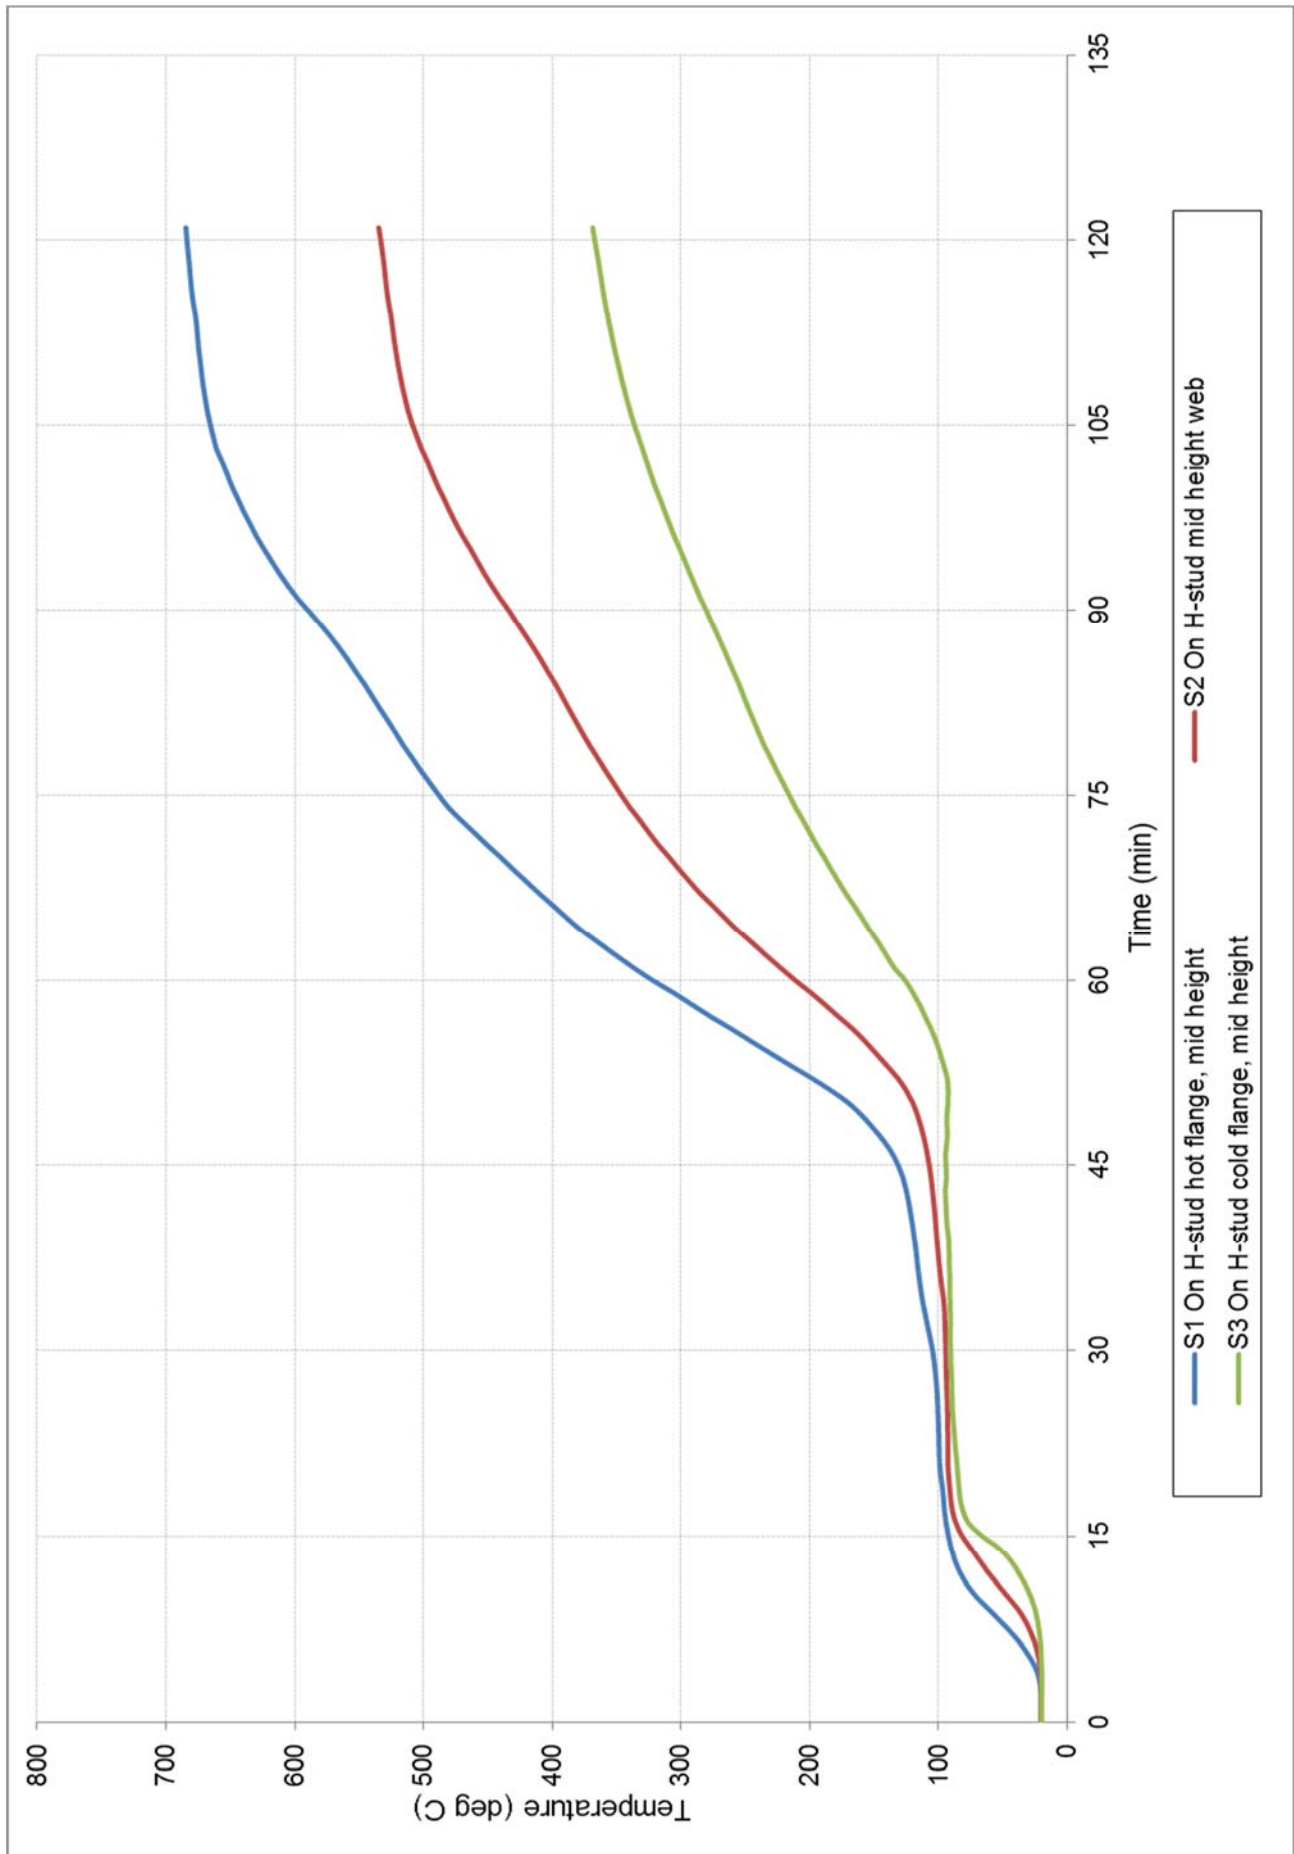
FIGURE 7 – SPECIMEN TEMPERATURE – SPECIMEN TEMPERATURE – INTERNAL C-H STEEL STUD

Figure 7 shows the curve of temperature versus time associated with the internal C-H steel stud.

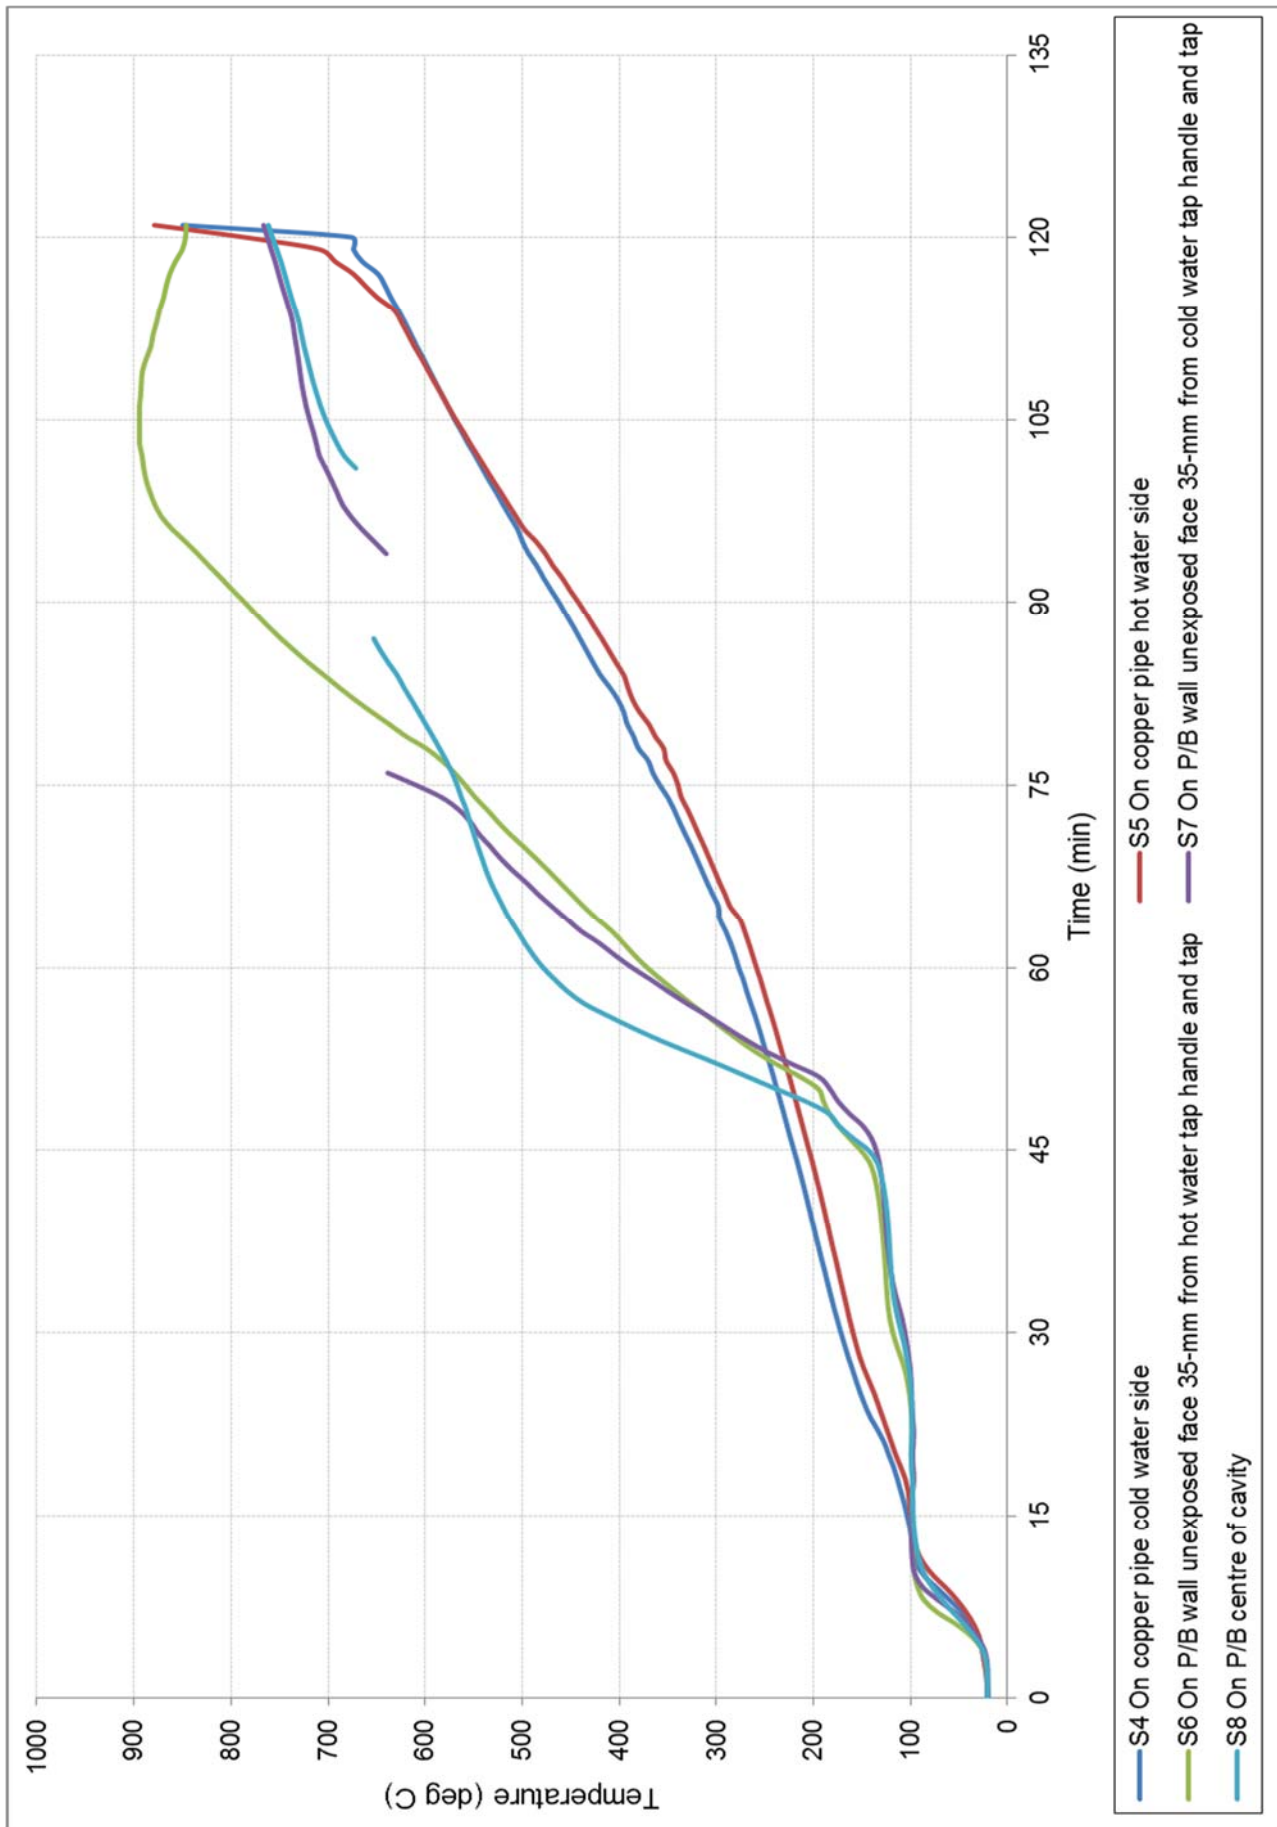
FIGURE 8 – SPECIMEN TEMPERATURE –INSIDE THE WALL CAVITY OF SPECIMEN 3

Figure 8 shows the curve of temperature versus time inside the wall cavity of Specimen 3.

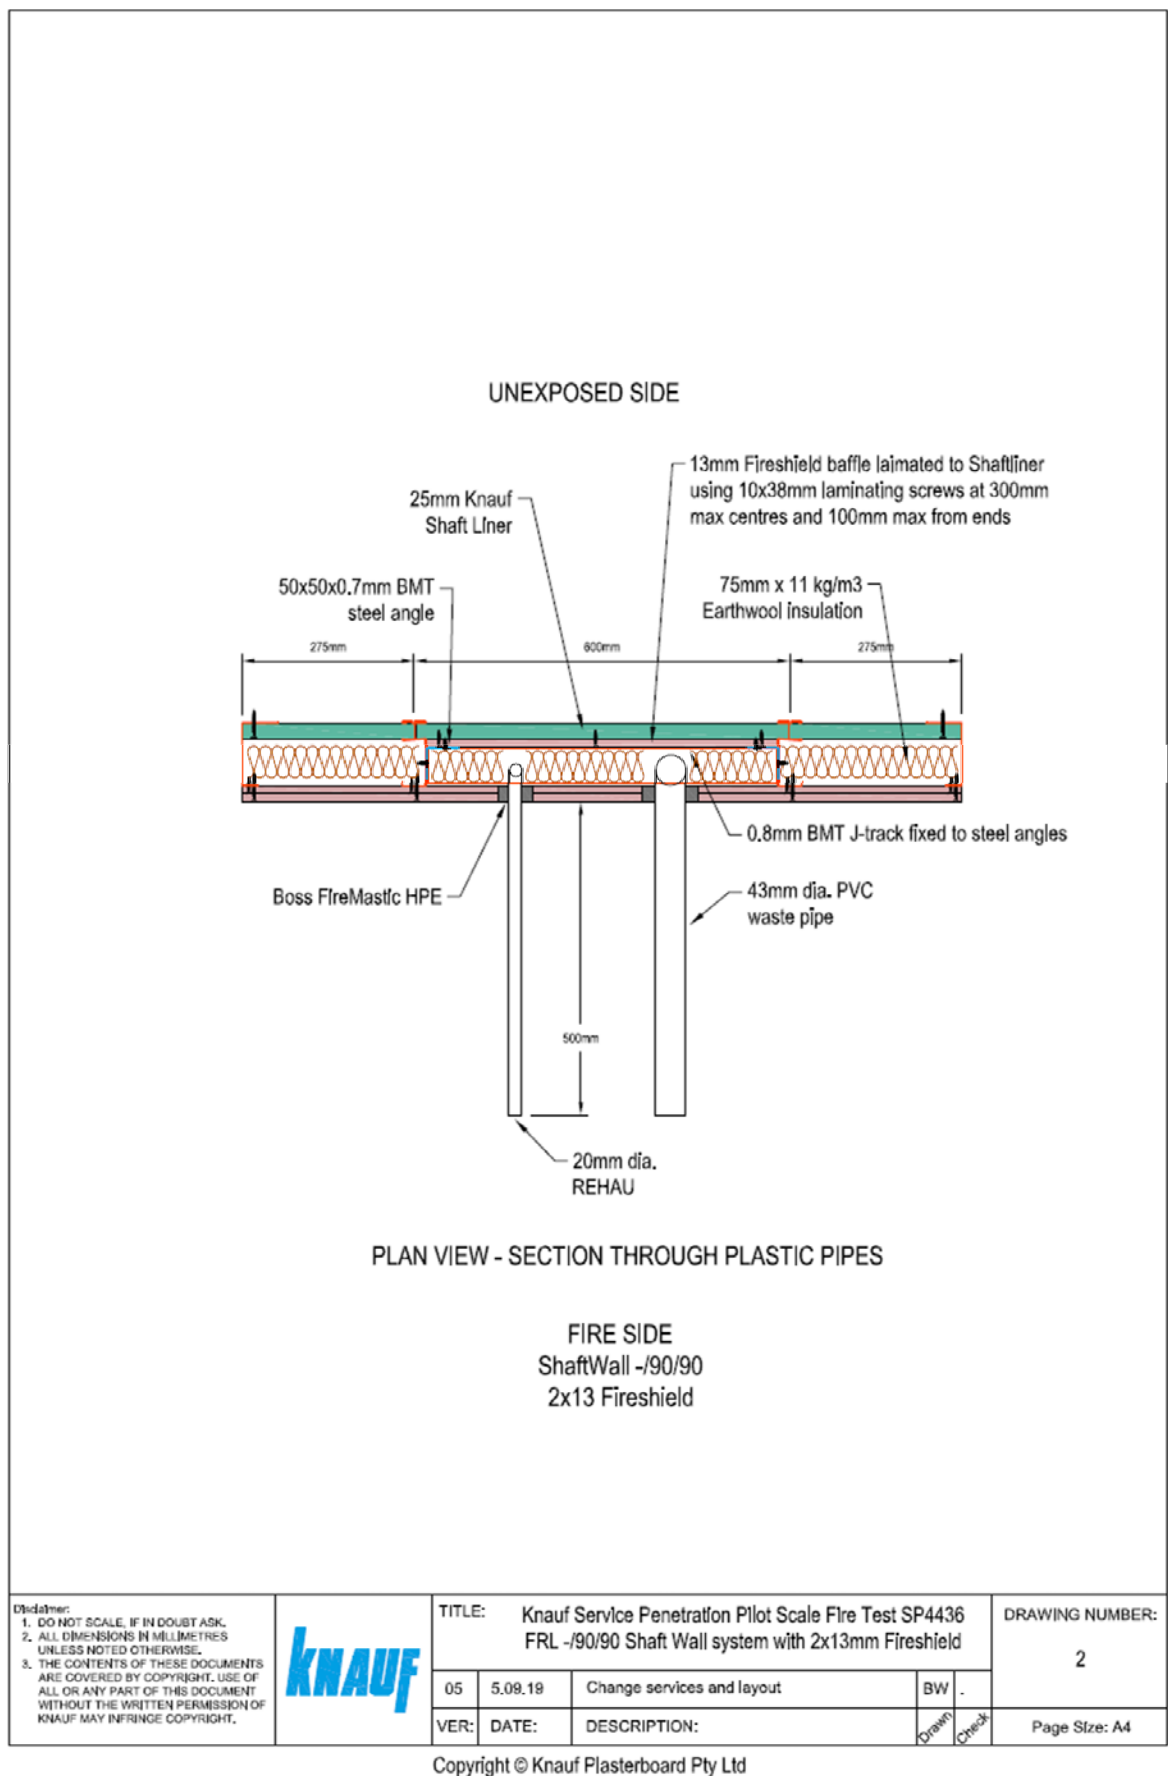
DRAWING NUMBER 2, TITLED “KNAUF SERVICE PENETRATIONS PILOT SCALE FIRE TEST SP4436 FRL-/90/90 SHAFT WALL SYSTEM WITH 2 X13MM FIRESHIELD”, DATED 5 SEPTEMBER 2019 BY KNAUF

- Drawings 1, 2 and 4 titled “Knauf Service Penetration Pilot Fire Test SP4436 FRL -/90/90 Shaft Wall system with 2 x 13mm FireShield”, dated 5 September 2019 by Knauf Plasterboard Pty Ltd.
- Drawing 3 titled “Knauf Service Penetration Pilot Fire Test SP4436 FRL -/90/90 Shaft Wall system with 2 x 13mm FireShield”, dated 23 October 2019 by Knauf Plasterboard Pty Ltd.
- Technical Data sheet titled “ FireMastic-HPE” dated 2017 by BOSS Fire & Safety Pty Ltd
- Document labelled “Hydraulic wall fixtures apartments”, dated 19 June 2019 provide by Knauf.

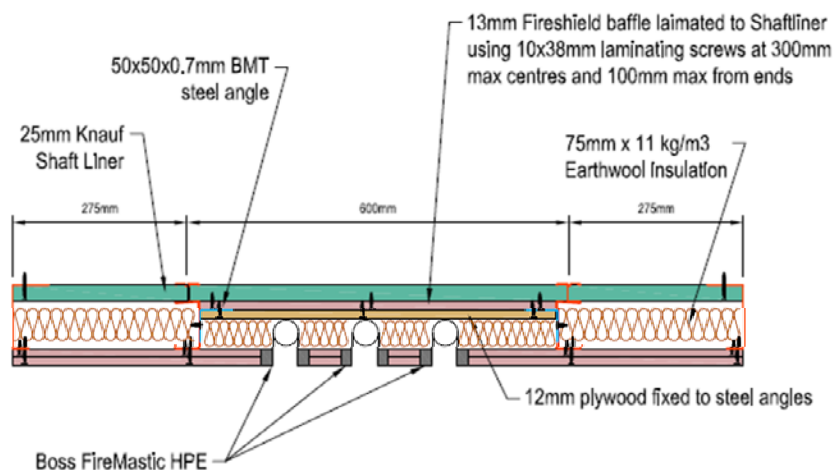
PLAN VIEW - SECTION THROUGH TAP-SET

FIRE SIDE
ShaftWall -/90/90
2x13 Fireshield

DRAWING NUMBER 3, TITLED "KNAUF SERVICE PENETRATIONS PILOT SCALE FIRE TEST SP4436 FRL-/90/90 SHAFT WALL SYSTEM WITH 2 X13MM FIRESHIELD", DATED 23 OCTOBER 2019 BY KNAUF

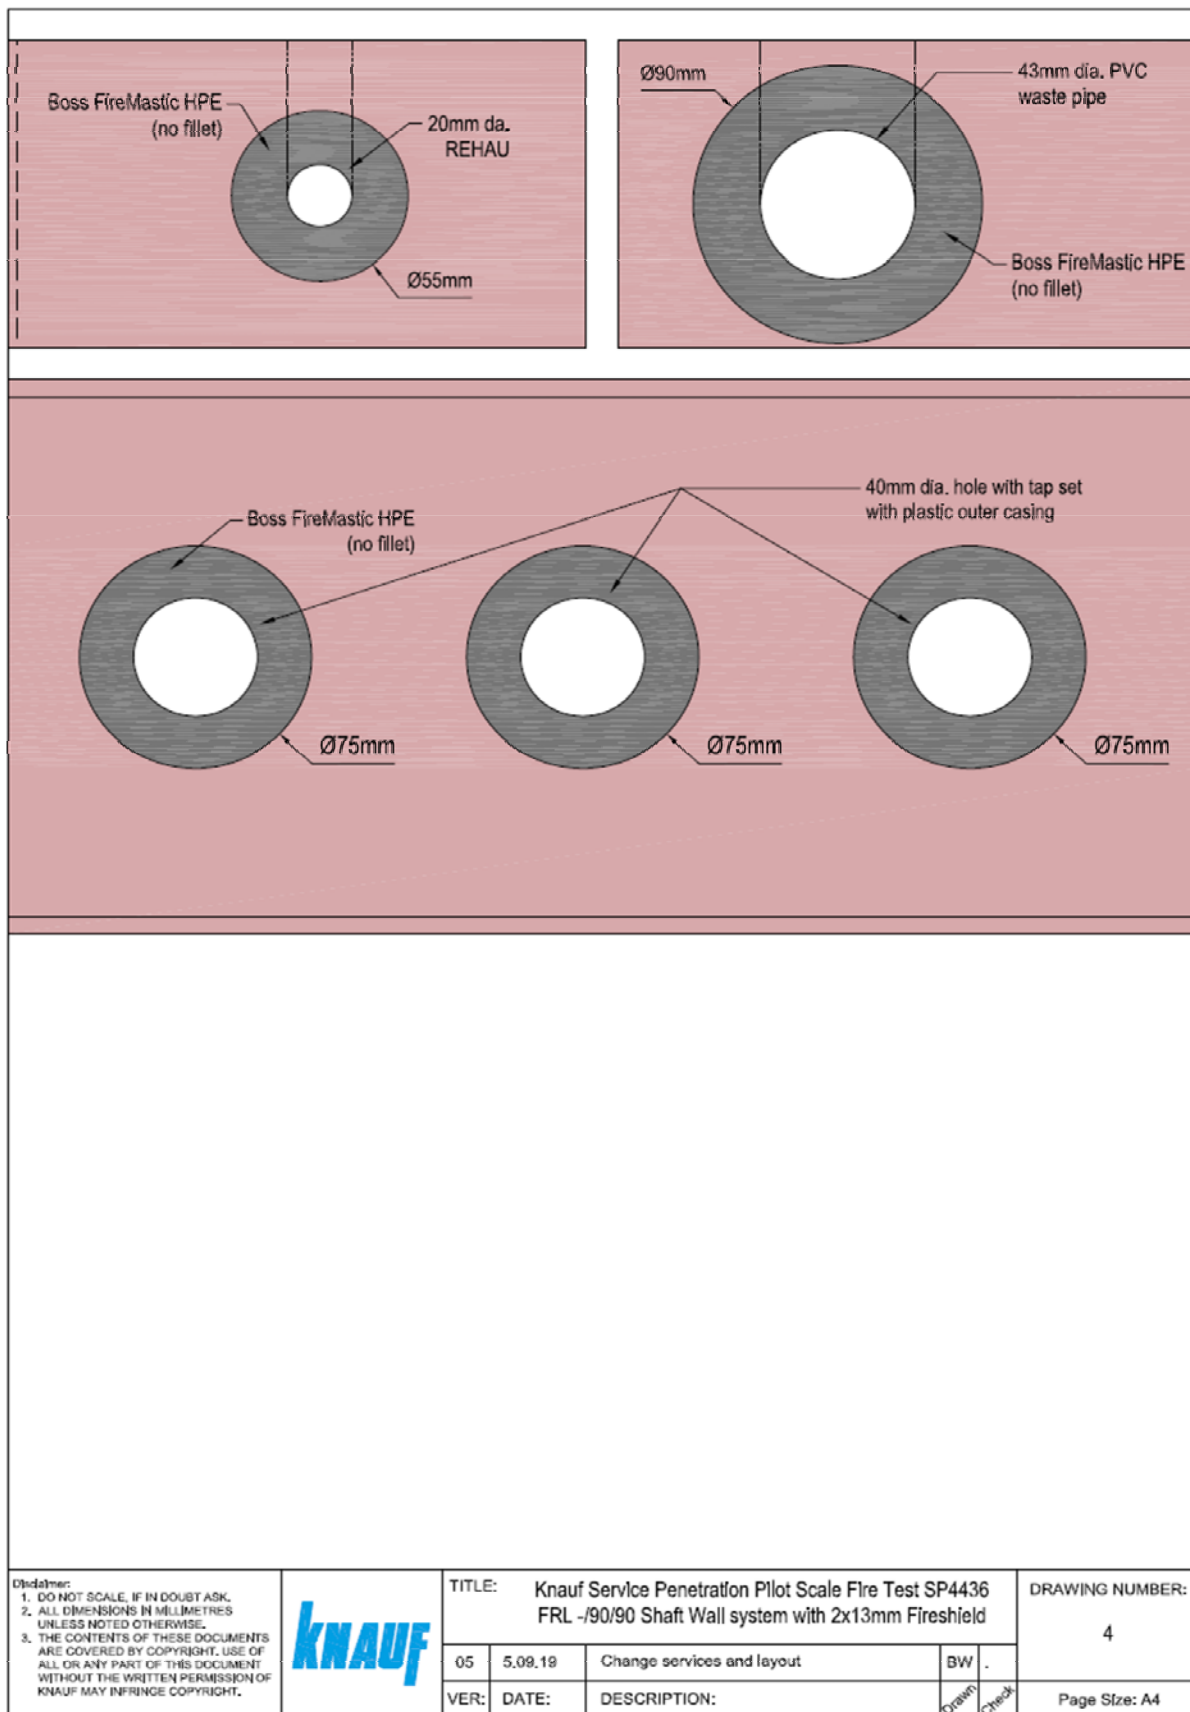
DRAWING NUMBER 4, TITLED “KNAUF SERVICE PENETRATIONS PILOT SCALE FIRE TEST SP4436 FRL-/90/90 SHAFT WALL SYSTEM WITH 2 X13MM FIRESHIELD”, DATED 5 SEPTEMBER 2019 BY KNAUF
