Fire-resistance test on services penetrating a plasterboard wall

Test Report

Author: Peter Gordon
Report number: FSP 2084
Date: 6 May 2020

Sponsored Investigation No. FSP 2084

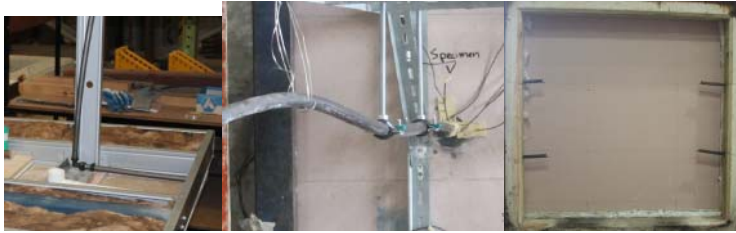
Photographs

Specimen 1 – A 20-mm diameter PE-Xa Rehau Rautitan pipe incorporating an elbow joint in the wall cavity penetrating a 55-mm aperture on the unexposed face protected with Fire Mastic HPE sealant.

Trade names	FireMastic-HPE
Manufacturers	BOSS Fire & Safety Pty Ltd
Description	FireMastic-HPE is a graphite-based, thixotropic, one-part acrylic emulsion
Application	Inside the wall cavity on the exposed side, a nominal 190-mm high x 405-mm wide piece of 13-mm FireShield plasterboard was fixed with two 190-mm wide 50-mm x 50-mm x 0.7-mm BMT steel angles that were fixed to the C-studs using four 10g X 16-mm flat top drill point tek screws. A 405-mm long 0.55-mm BMT 92-mm wide J-track was then fixed to the two angles with 10g X 16-mm flat top drill point tek screws. The 20-mm PE-Xa pipe was then fixed at the elbow joint to the J-track using a Auspex Clip and a 25-mm metal tek screw. Inside the wall cavity on the exposed side, a nominal 200-mm high x 405-mm wide piece of 13-mm FireShield plasterboard with a 55-mm opening was fixed to the wall using 10g x 38-mm laminating screws at 200-mm centres. The annular gap between the pipe and the wall was sealed with FireMastic-HPE to a depth of approximately 26-mm and finished flush with the wall.

<div> <div>Inside the wall cavity</div> <div>Unexposed face</div> <div>Exposed face</div> </div>
Drawing	Drawings 1-4, title “Knauf Service Penetration Pilot Scale Fire test SP4438 FRL-/60/60 KSW310 13mm FireShield”, by Knauf Plasterboard Pty Ltd.

Specimen 1 – A 20-mm diameter PE-Xa Rehau Rautitan pipe incorporating an elbow joint in the wall cavity penetrating a 55-mm aperture on the unexposed face protected with Fire Mastic HPE sealant.

Structural adequacy	-	Not applicable
Integrity	-	no failure at 91 minutes
Insulation	-	no failure at 91 minutes

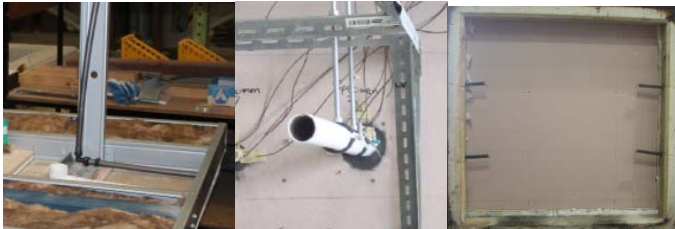
Photograph

Specimen 2 – A 43-mm diameter PVC pipe incorporating an elbow joint in the wall cavity penetrating an 88-mm aperture on the unexposed face protected with Fire Mastic HPE sealant.

Manufacturers	BOSS Fire & Safety Pty Ltd
Description	FireMastic-HPE is a graphite-based, thixotropic, one-part acrylic emulsion
Application	Inside the wall cavity on the exposed side, a nominal 190-mm high x 405-mm wide piece of 13-mm FireShield plasterboard was fixed with two 190-mm wide 50-mm x 50-mm x 0.7-mm BMT steel angles that were fixed to the C-studs using four 10g X 16-mm flat top drill point tek screws. A 405-mm long 0.55-mm BMT 92-mm wide J-track was then fixed to the two angles with 10g x 16-mm flat top drill point tek screws. The 43-mm diameter PVC pipe was then fixed at the elbow joint to the track with a nylon coated metal saddle flush clip and 10g x 16-mm flat top drill point tek screws. Inside the wall cavity on the unexposed side, a nominal 200-mm high x 405-mm wide piece of 13-mm FireShield plasterboard with a 90-mm opening was fixed to the wall using 10g x 38-mm laminating screws at 200-mm centres. The annular gap between the pipe and the wall was sealed with FireMastic-HPE to a depth of approximately 26-mm and finished flush with the wall.

<div> <div>Inside the wall cavity</div> <div>Unexposed face</div> <div>Exposed face</div> </div>
Drawing	Drawings 1-4, title “Knauf Service Penetration Pilot Scale Fire test SP4438 FRL-/60/60 KSW310 13mm FireShield”, by Knauf Plasterboard Pty Ltd.

Specimen 2 – A 43-mm diameter PVC pipe incorporating an elbow joint in the wall cavity penetrating an 88-mm aperture on the unexposed face protected with Fire Mastic HPE sealant.

Structural adequacy	-	Not applicable
Integrity	-	no failure at 91 minutes
Insulation	-	no failure at 91 minutes

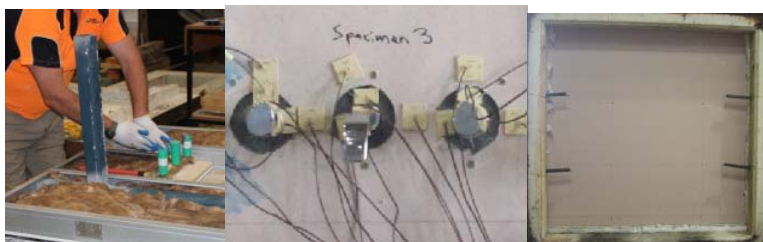
Photograph

Specimen 3 – A Hansgrohe wall mounted faucet incorporating a 3-piece hand basin tap set penetrated three 75-mm apertures on the unexposed face protected with FireMastic HPE sealant.

End conditions	The spout on the unexposed face was left open, the two tap spindle valves were in the closed position, and PE-Xa Rehau Rautitan pipes inside the wall were left open.
Supports	Internally to the exposed wall face, screwed through the wall mounted faucet.
FIRE STOPPING SYSTEM	
Trade names	FireMastic-HPE
Manufacturers	BOSS Fire & Safety Pty Ltd
Description	FireMastic-HPE is a graphite-based, thixotropic, one-part acrylic emulsion
Application	Inside the wall cavity on the exposed side, a nominal 200-mm high x 405-mm wide piece of 13-mm FireShield plasterboard was fixed to wall with two x 200-mm wide 50-mm x 50-mm x 0.7 BMT steel angles that were fixed to the C-studs using four screws. A 200-mm high x 405-mm wide sheet of 12-mm plywood was then fixed over the steel angles using three 6g x 25-mm long fine thread bugle screws over each angle. The two corners of the faucet were then fixed to the plywood with two 6g x 25-mm long fine thread bugle screws. The three annular gaps around the plastic sleeves and the FireShield plasterboard wall were sealed with FireMastic-HPE to a depth of approximately 26-mm and finished flush with the wall. The chrome escutcheons plates were not installed for this test.

<div> <div>Inside the wall cavity</div> <div>Unexposed face</div> <div>Exposed face</div> </div>
Drawing	Drawings 1-4, title "Knauf Service Penetration Pilot Scale Fire test SP4438 FRL-/60/60 KSW310 13mm FireShield", by Knauf Plasterboard Pty Ltd.

Specimen 3 – A Hansgrohe wall mounted faucet incorporating a 3-piece hand basin tap set penetrated three 75-mm apertures on the unexposed face protected with FireMastic HPE sealant.

Structural adequacy	-	Not applicable
Integrity	-	no failure at 91 minutes
Insulation	-	no failure at 91 minutes

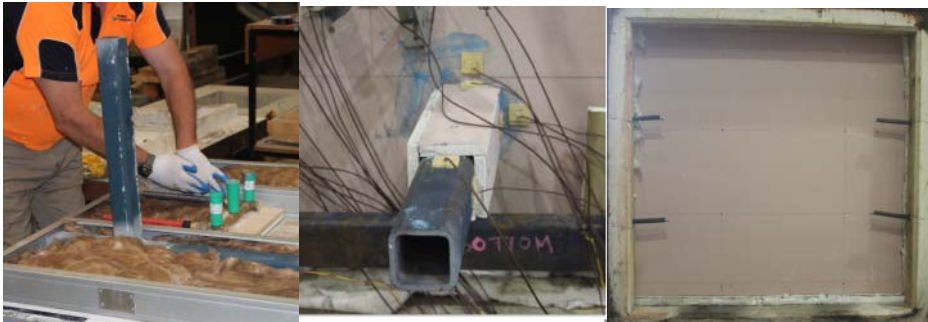
Specimen 4 – A SHS 65-mm x 65-mm x 6mm thick beam penetrating the unexposed face of the wall through a 75-mm x 75-mm square opening protected with Knauf Bindex Fire and Acoustic sealant and 13-mm thick FireShield plasterboard.

Manufacturers	Knauf Plasterboard Pty Limited
Description	Knauf Bindex Fire and Acoustic sealant is a one-part acrylic sealant. 13-mm thick FireShield Plasterboard.
Application	The annular gap between the SHS arm and the wall was sealed with Knauf Bindex Fire and Acoustic sealant to a depth of 13-mm and finished flush with the wall. Four pieces of 13-mm thick FireShield plasterboard approximately 78-mm x 300-mm were then fixed around the base of the arm using two 12-gauge x 50-mm CSK self-tapping screws per sheet.
Photograph

<div style="display: flex; justify-content: space-around; margin-top: 5px;"> Inside the wall cavity Unexposed face Exposed face </div>

Specimen 4 – A SHS 65-mm x 65-mm x 6mm thick beam penetrating the unexposed face of the wall through a 75-mm x 75-mm square opening protected with Knauf Bindex Fire and Acoustic sealant and 13-mm thick FireShield plasterboard.

Structural adequacy	-	Not applicable
Integrity	-	no failure at 91 minutes
Insulation	-	no failure at 91 minutes

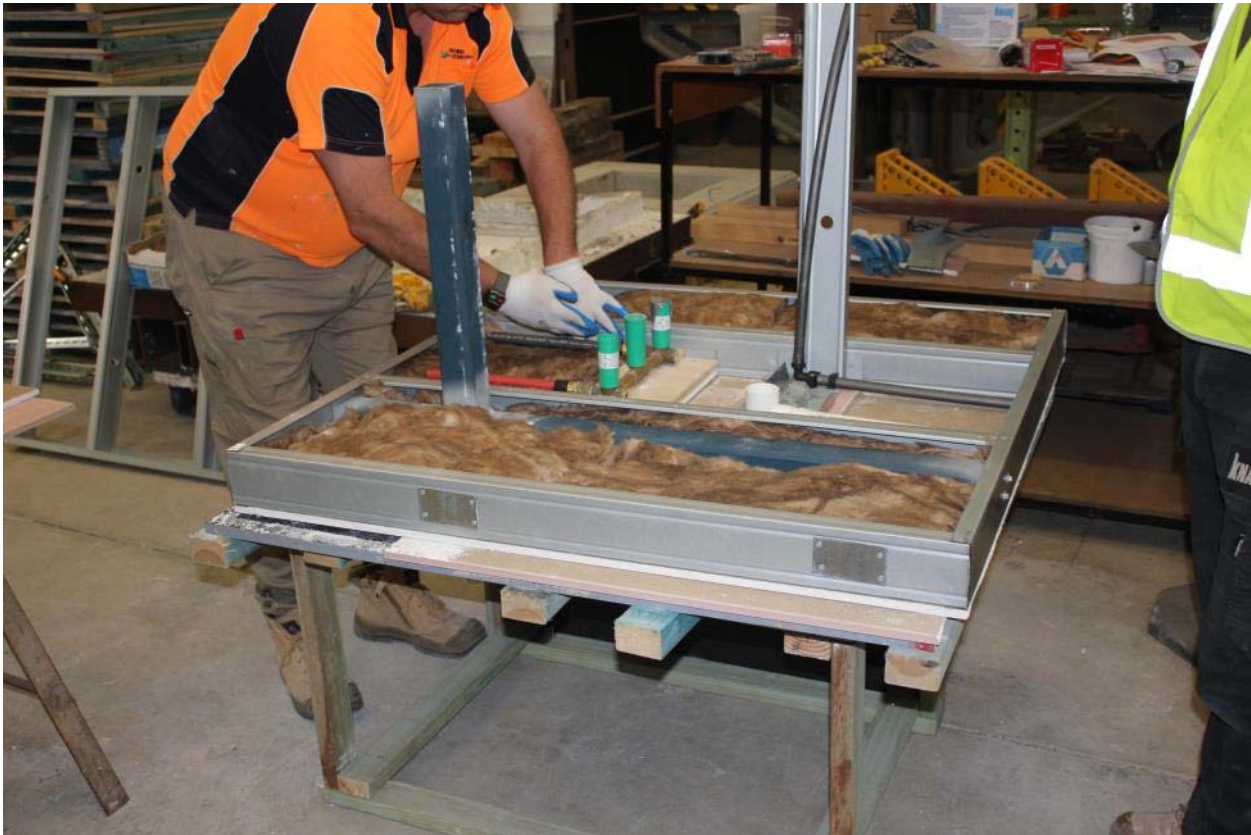
PHOTOGRAPH 1 – SPECIMENS DURING CONSTRUCTION PRIOR TO TESTING.

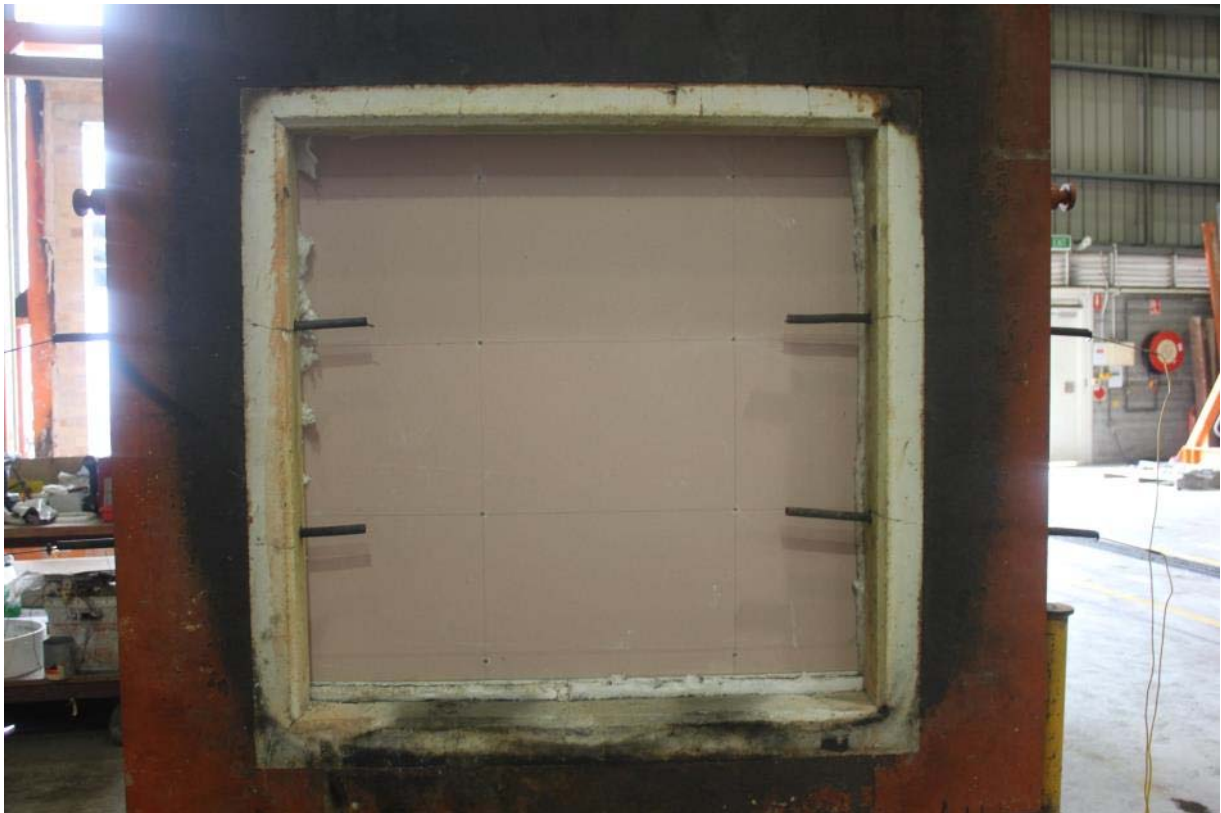
PHOTOGRAPH 2 – EXPOSED SIDE OF SPECIMENS PRIOR TO TESTING

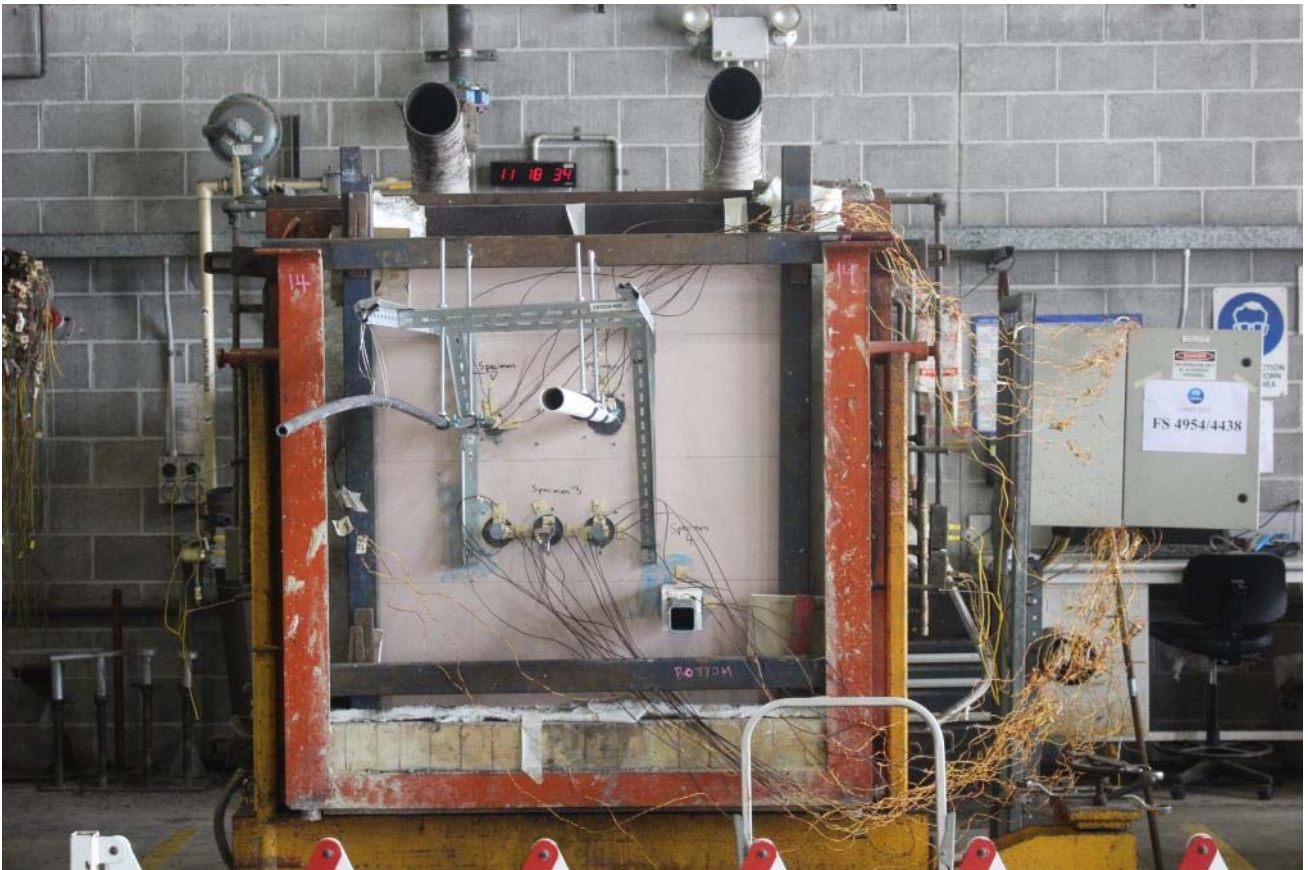
PHOTOGRAPH 3 – UNEXPOSED SIDE OF SPECIMENS PRIOR TO TESTING

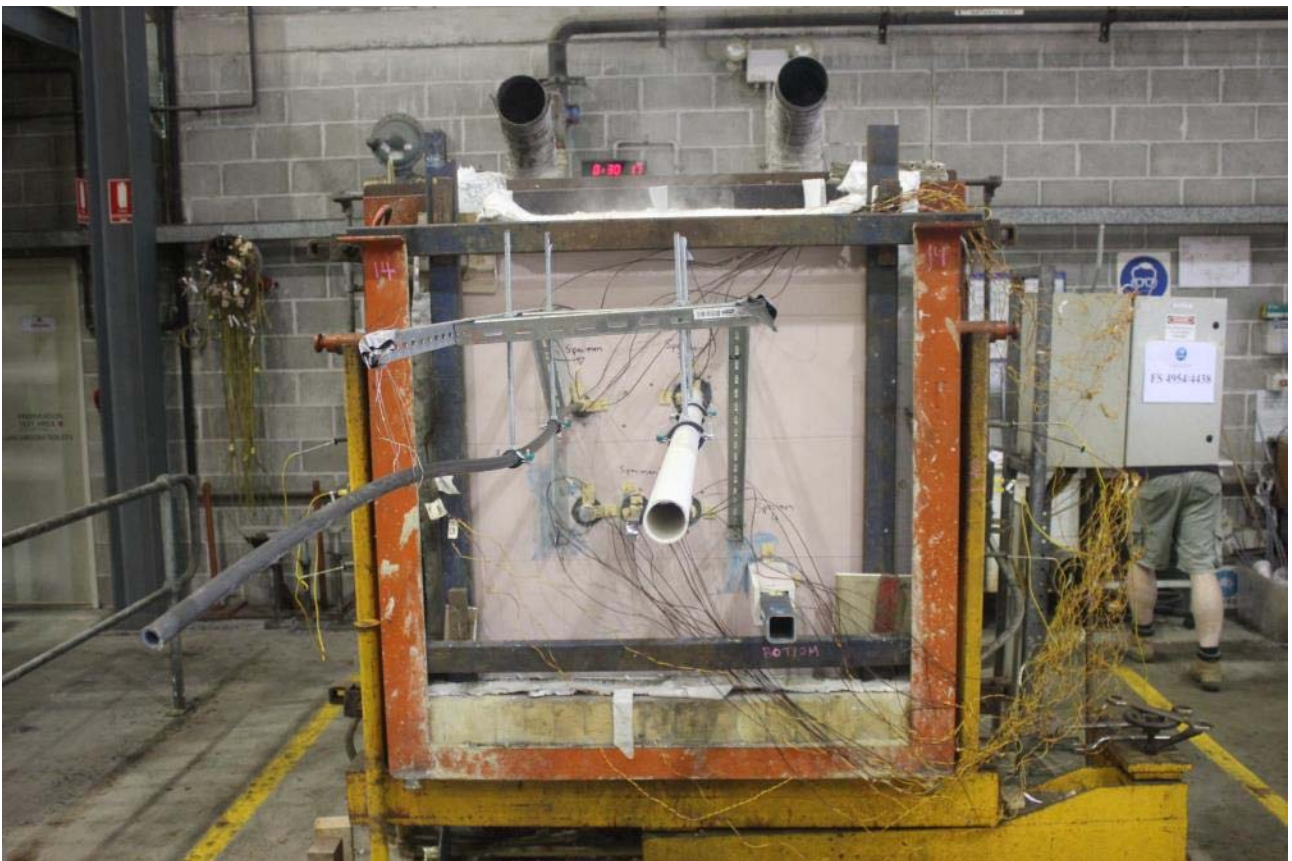
PHOTOGRAPH 4 – SPECIMENS AFTER 30 MINUTES OF TESTING

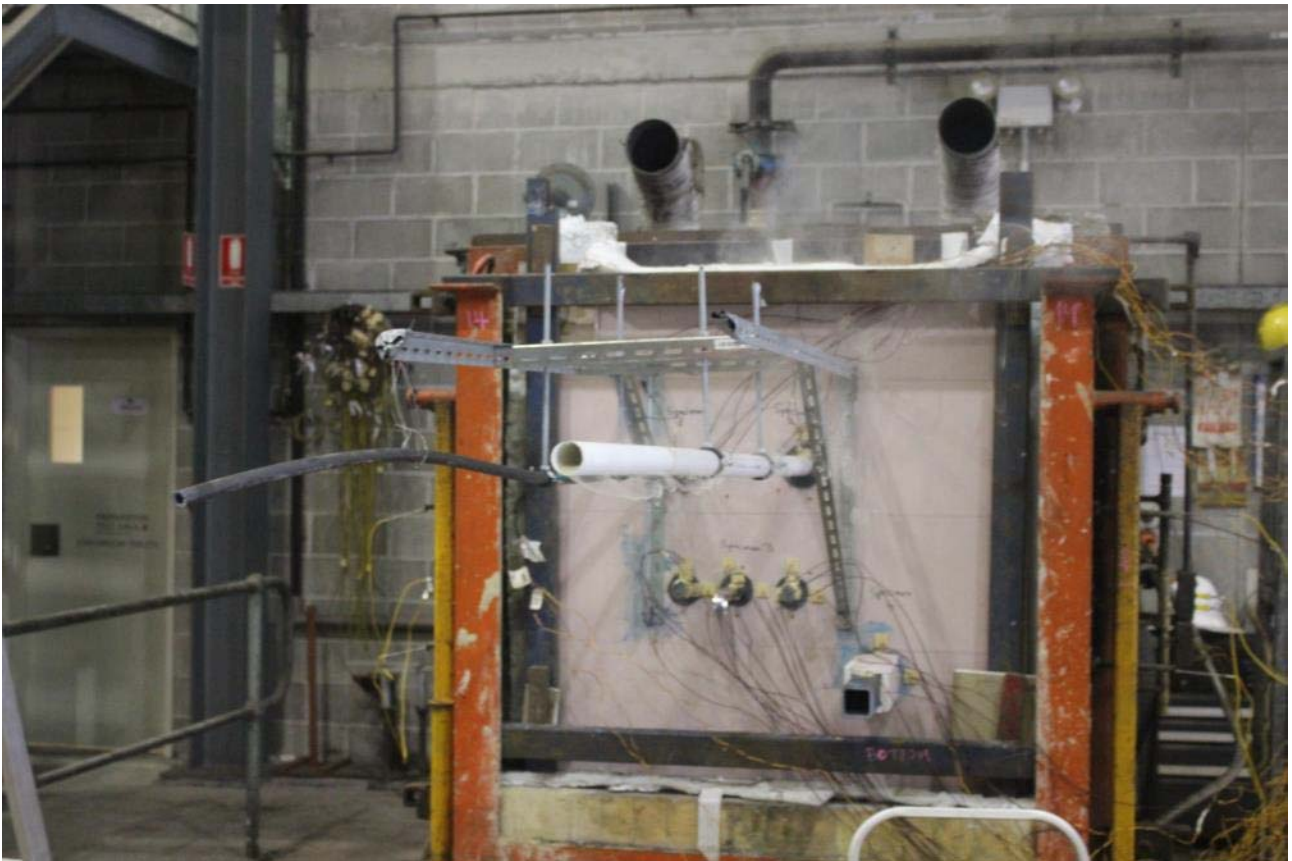
PHOTOGRAPH 5 – SPECIMENS AFTER 37 MINUTES OF TESTING

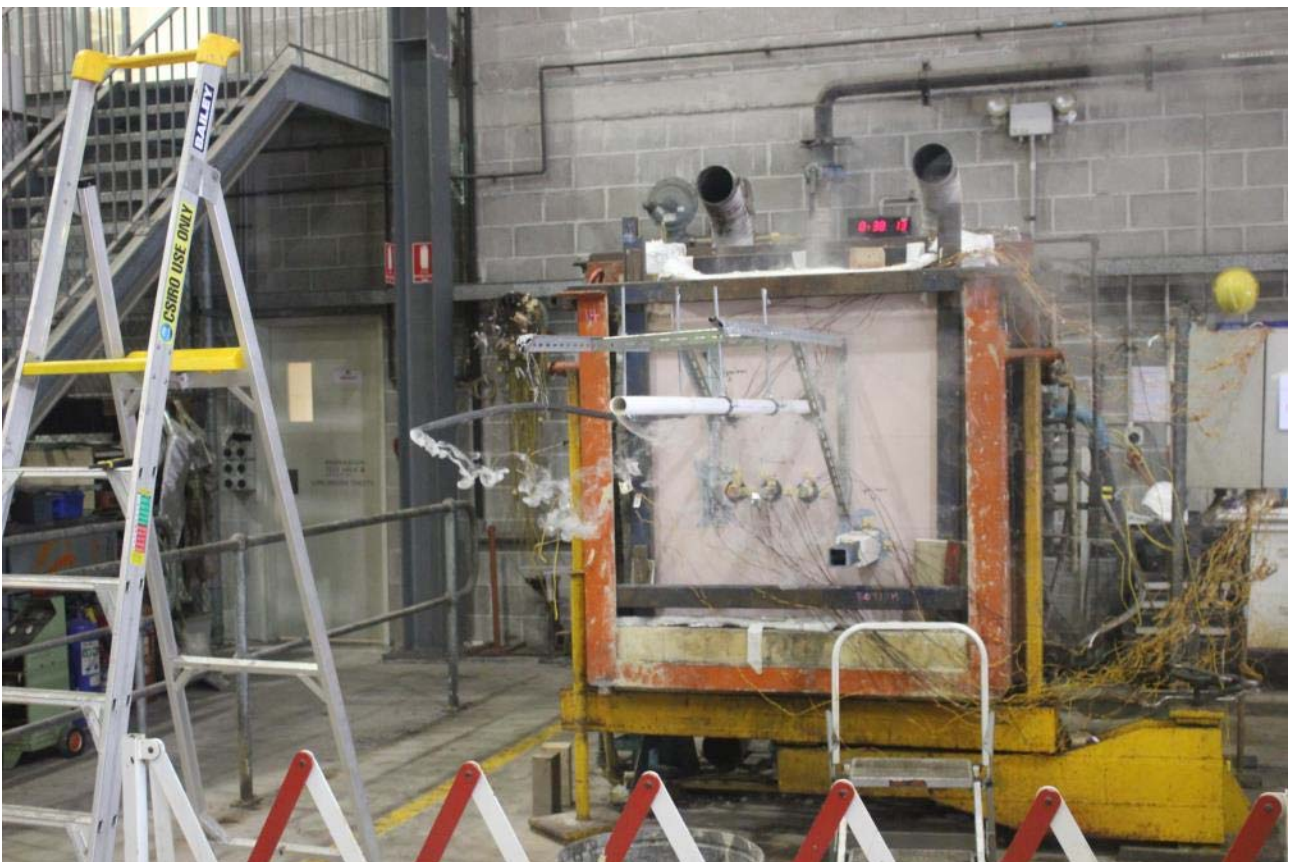
PHOTOGRAPH 6 – SPECIMENS AFTER 38 MINUTES OF TESTING

- 21 minutes - Smoke / steam has started venting from the mastic of Specimens 1, 2 and 3.
- 36 minutes - Smoke has started fluing from the end of the pipe of Specimen 2.
- 38 minutes - Smoke has started fluing from the end of the pipe of Specimen 1.
- 40 minutes - A small crack has developed between the mastic and the plasterboard wall around Specimens 2 and 3.
- 42 minutes - The smoke fluing from the end of the pipe of Specimen 2 has increased, whilst the smoke fluing from Specimen 1 has now ceased.

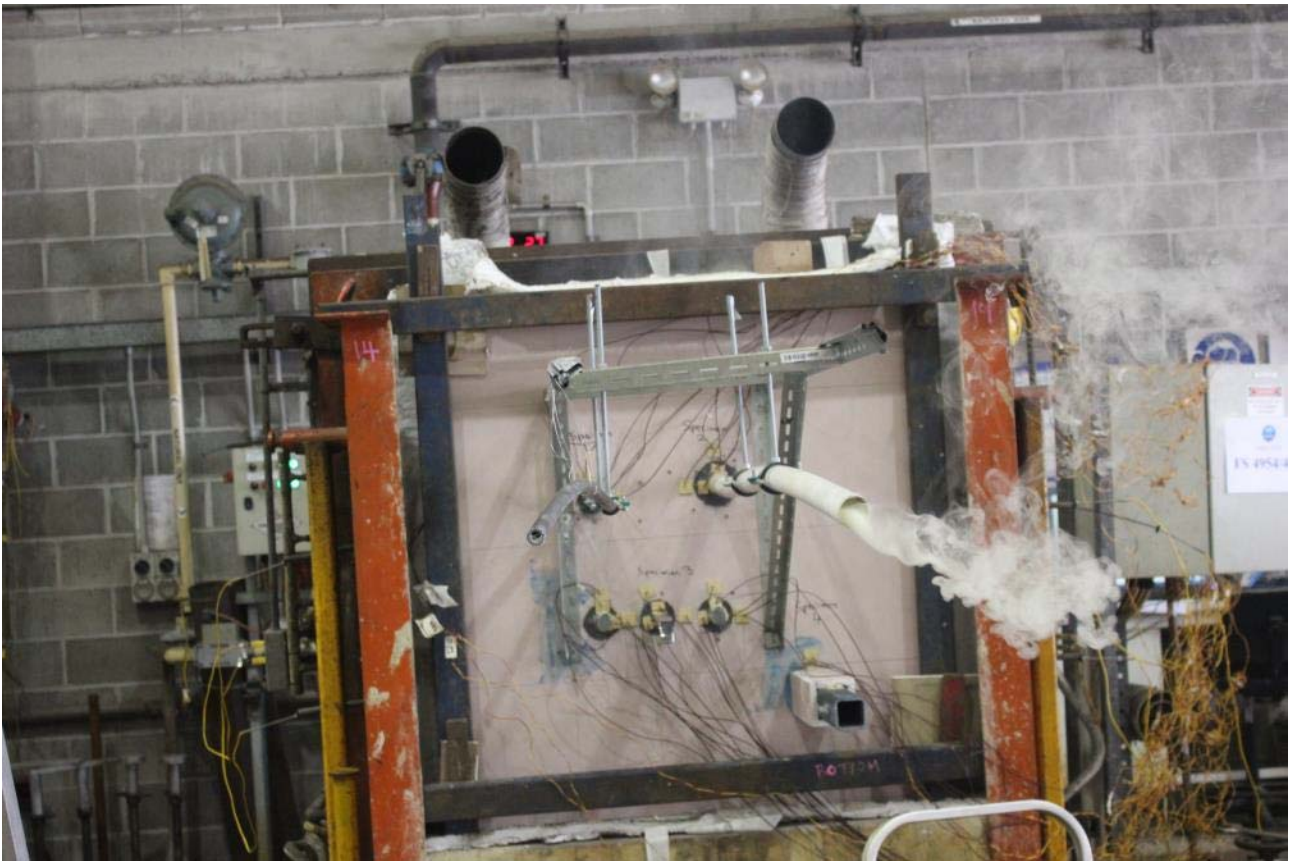
PHOTOGRAPH 7 – SPECIMENS AFTER 42 MINUTES OF TESTING

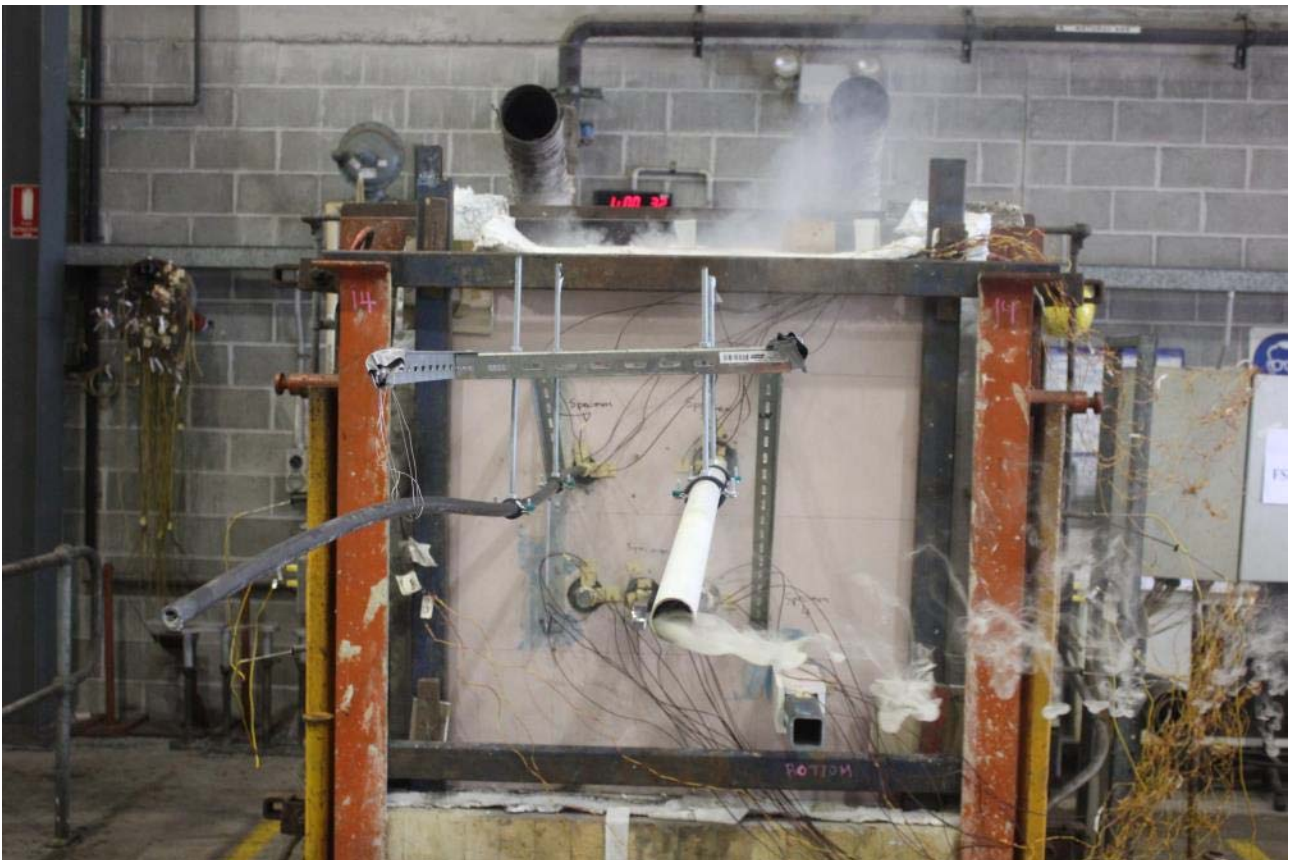
PHOTOGRAPH 8 – SPECIMENS AFTER 60 MINUTES OF TESTING

- 59 minutes - The level of smoke fluing from the pipe of Specimen 1 has decreased.
- 60 minutes - The plasterboard at the base of the wall has started to discolour.

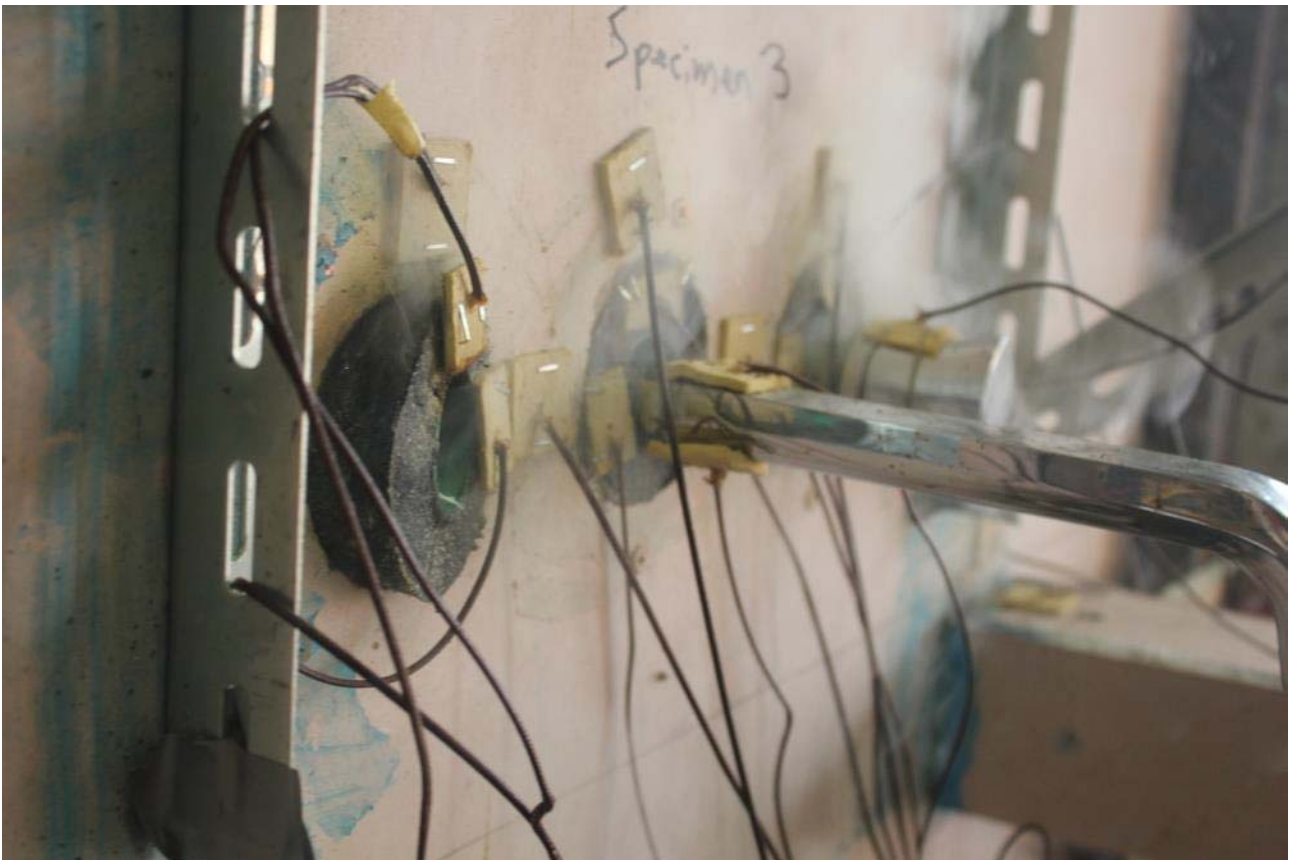
PHOTOGRAPH 10 – SPECIMEN 3 AFTER 75 MINUTES OF TESTING

- 71 minutes - Smoke has started venting from the end of the SHS tube of Specimen 4.
- 75 minutes - The left tap handle has dropped off.
- 80 minutes - The right tap handle has dropped off.

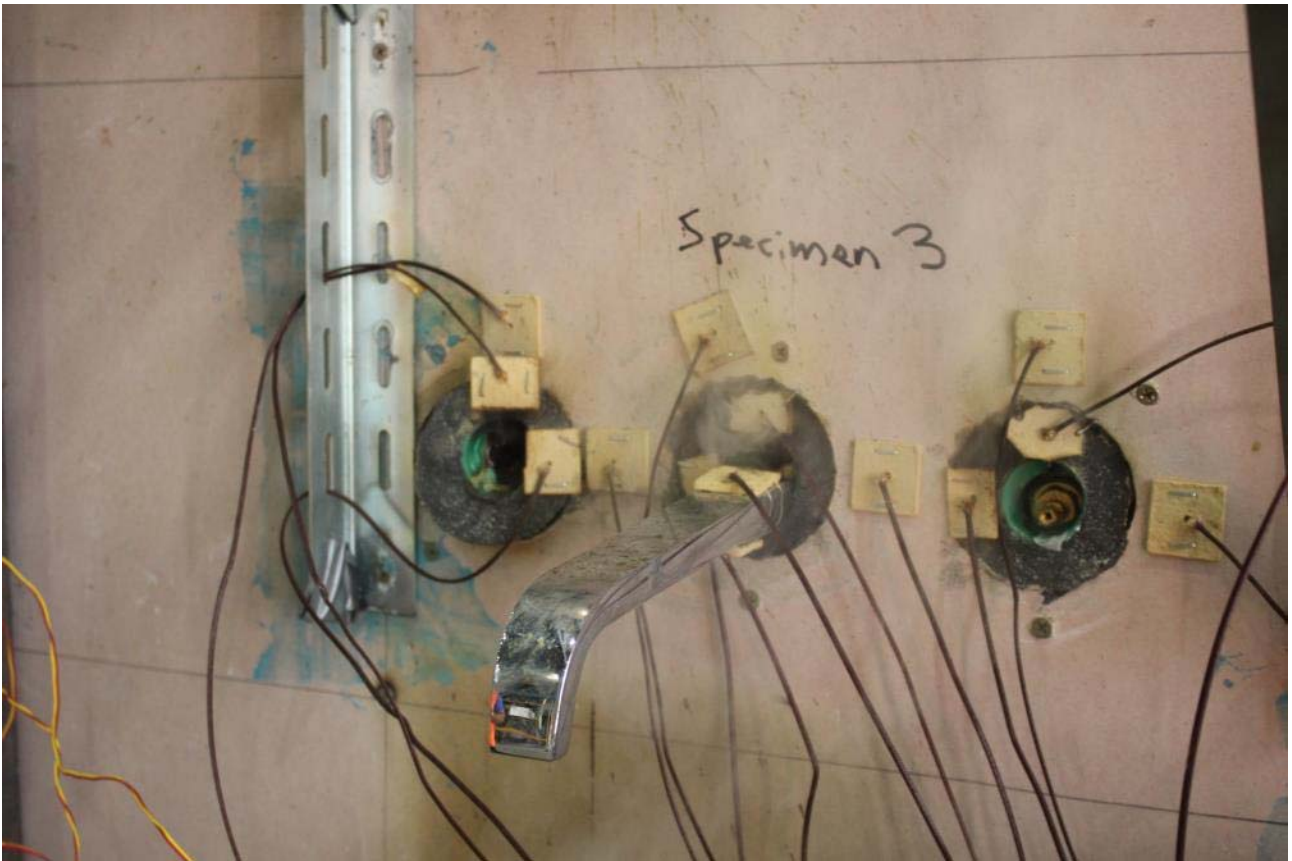
PHOTOGRAPH 11 – SPECIMEN 3 AFTER 83 MINUTES OF TESTING

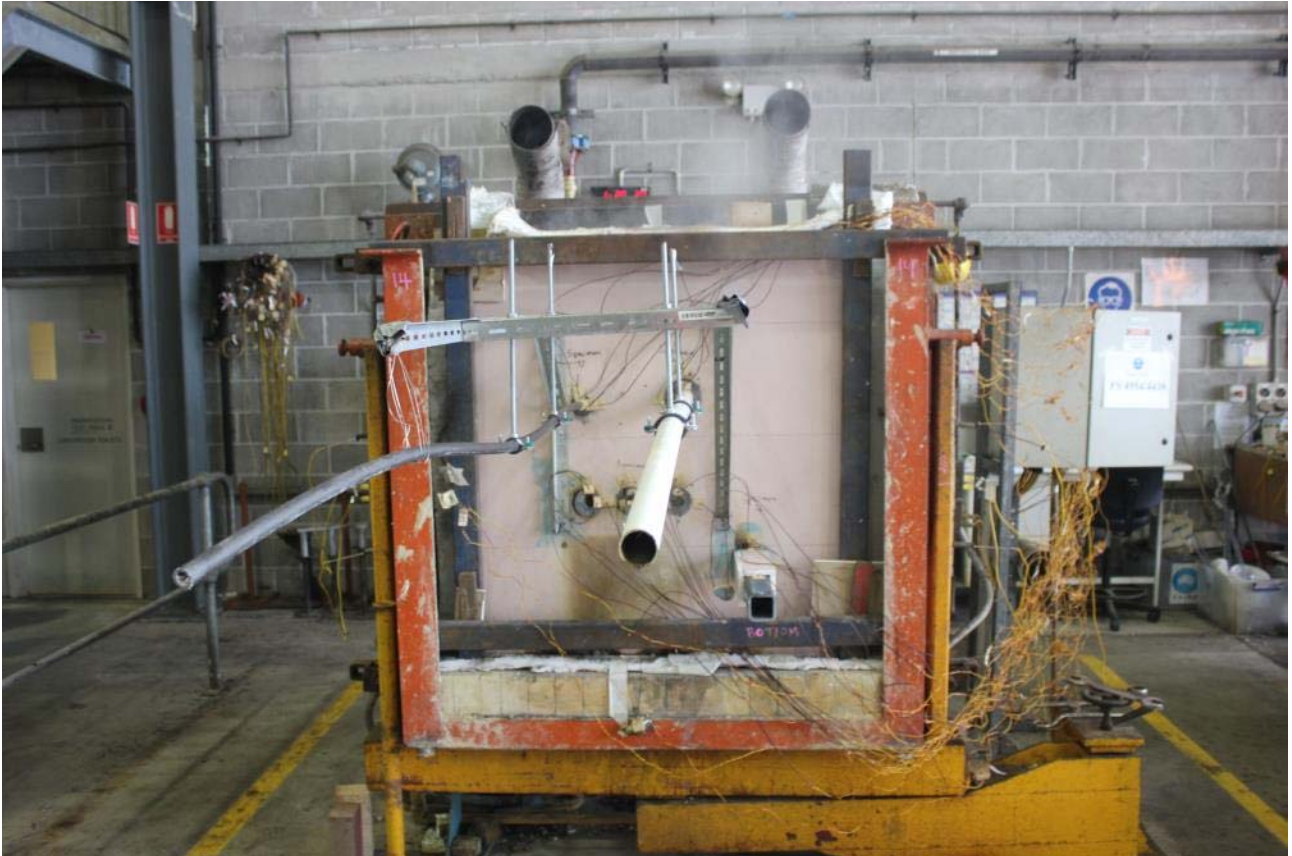
PHOTOGRAPH 12 – SPECIMENS AFTER 90 MINUTES OF TESTING

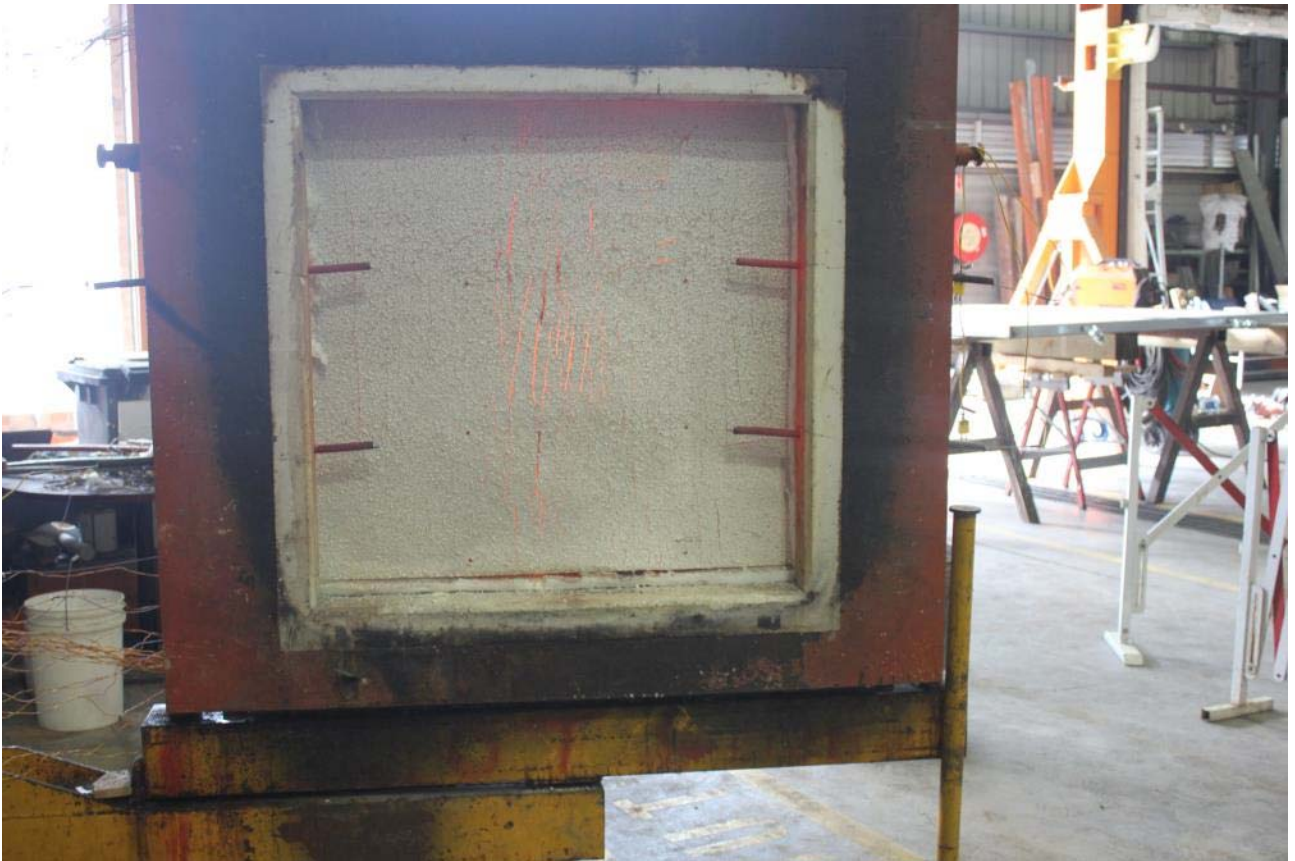
PHOTOGRAPH 13 –EXPOSED FACE OF SPECIMENS AFTER THE CONCLUSION OF TESTING

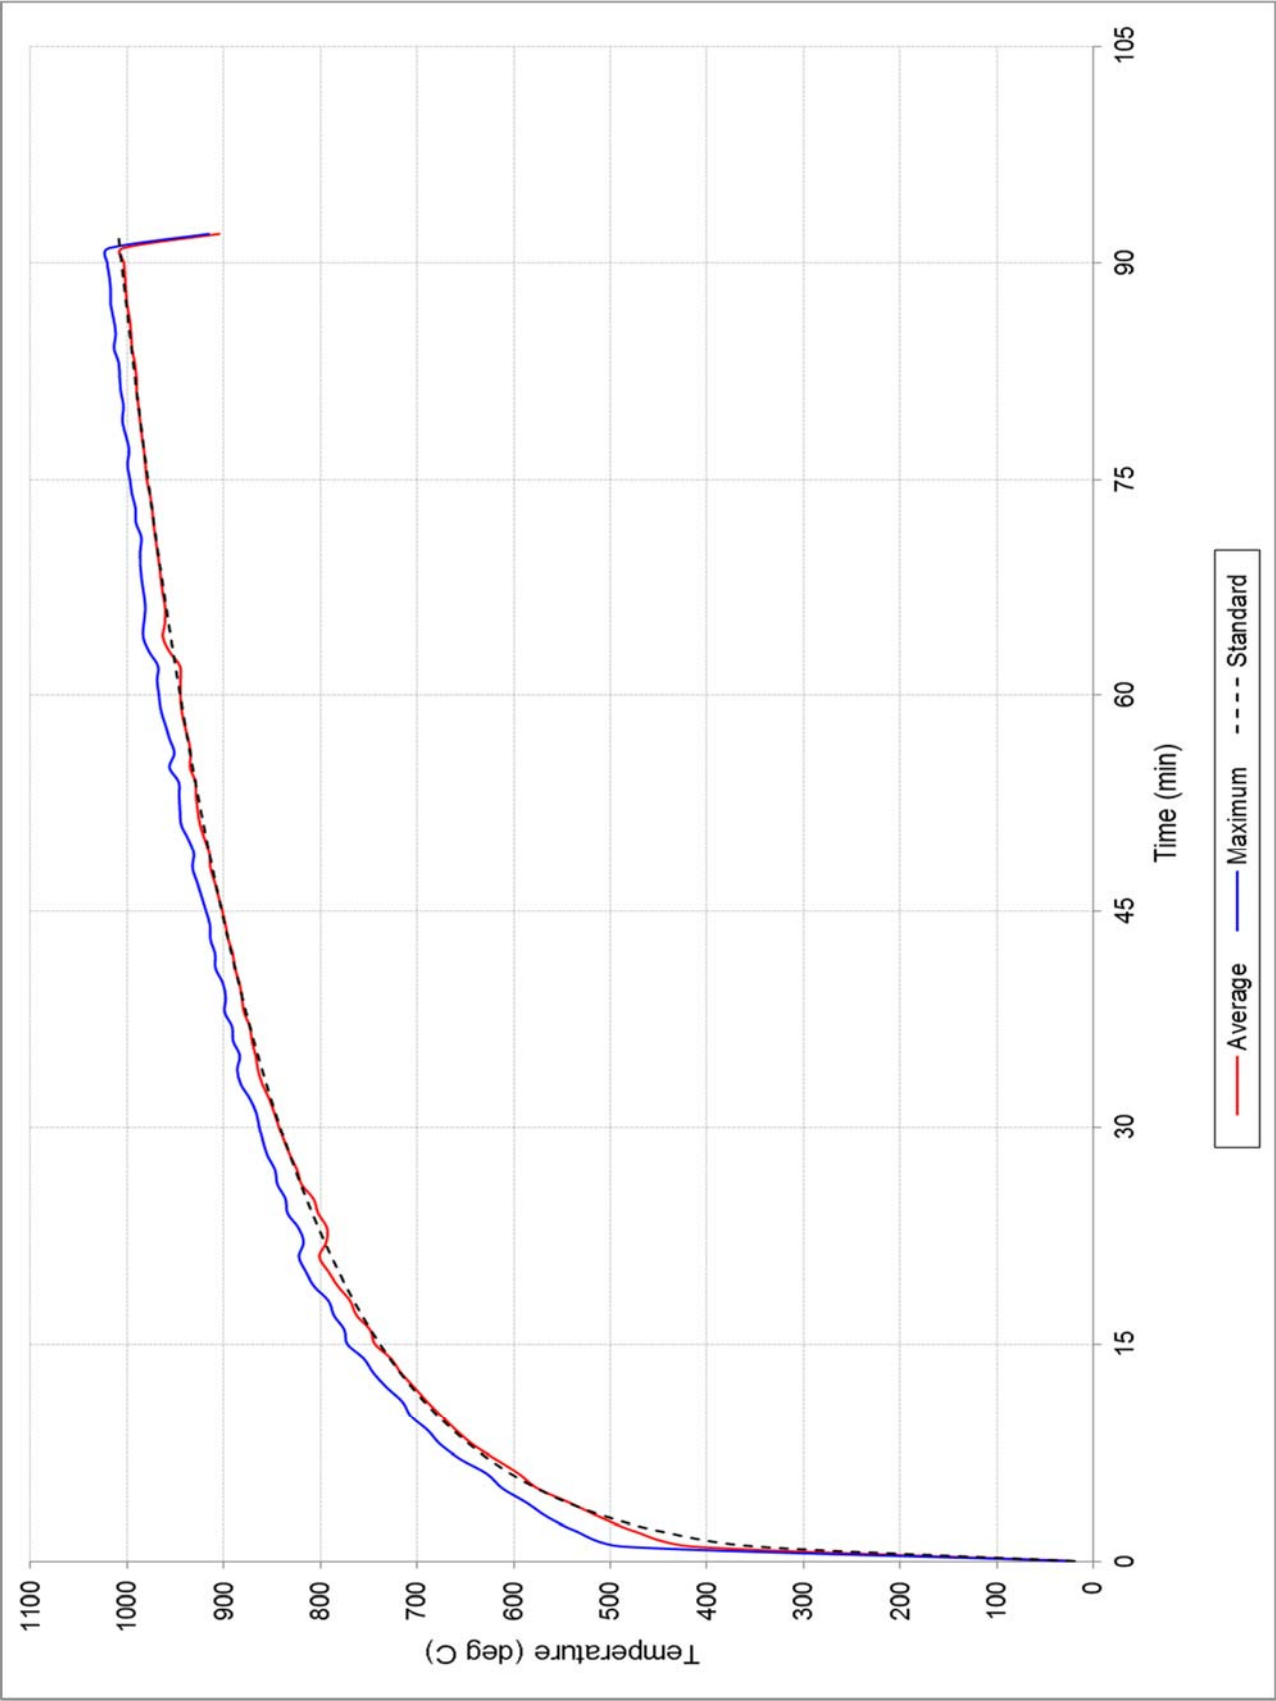
FIGURE 1 – FURNACE TEMPERATURE

Figure 1 shows the standard curves of temperature versus time for heating the furnace chamber and the actual curves of average and maximum temperature versus time recorded during the heating period.

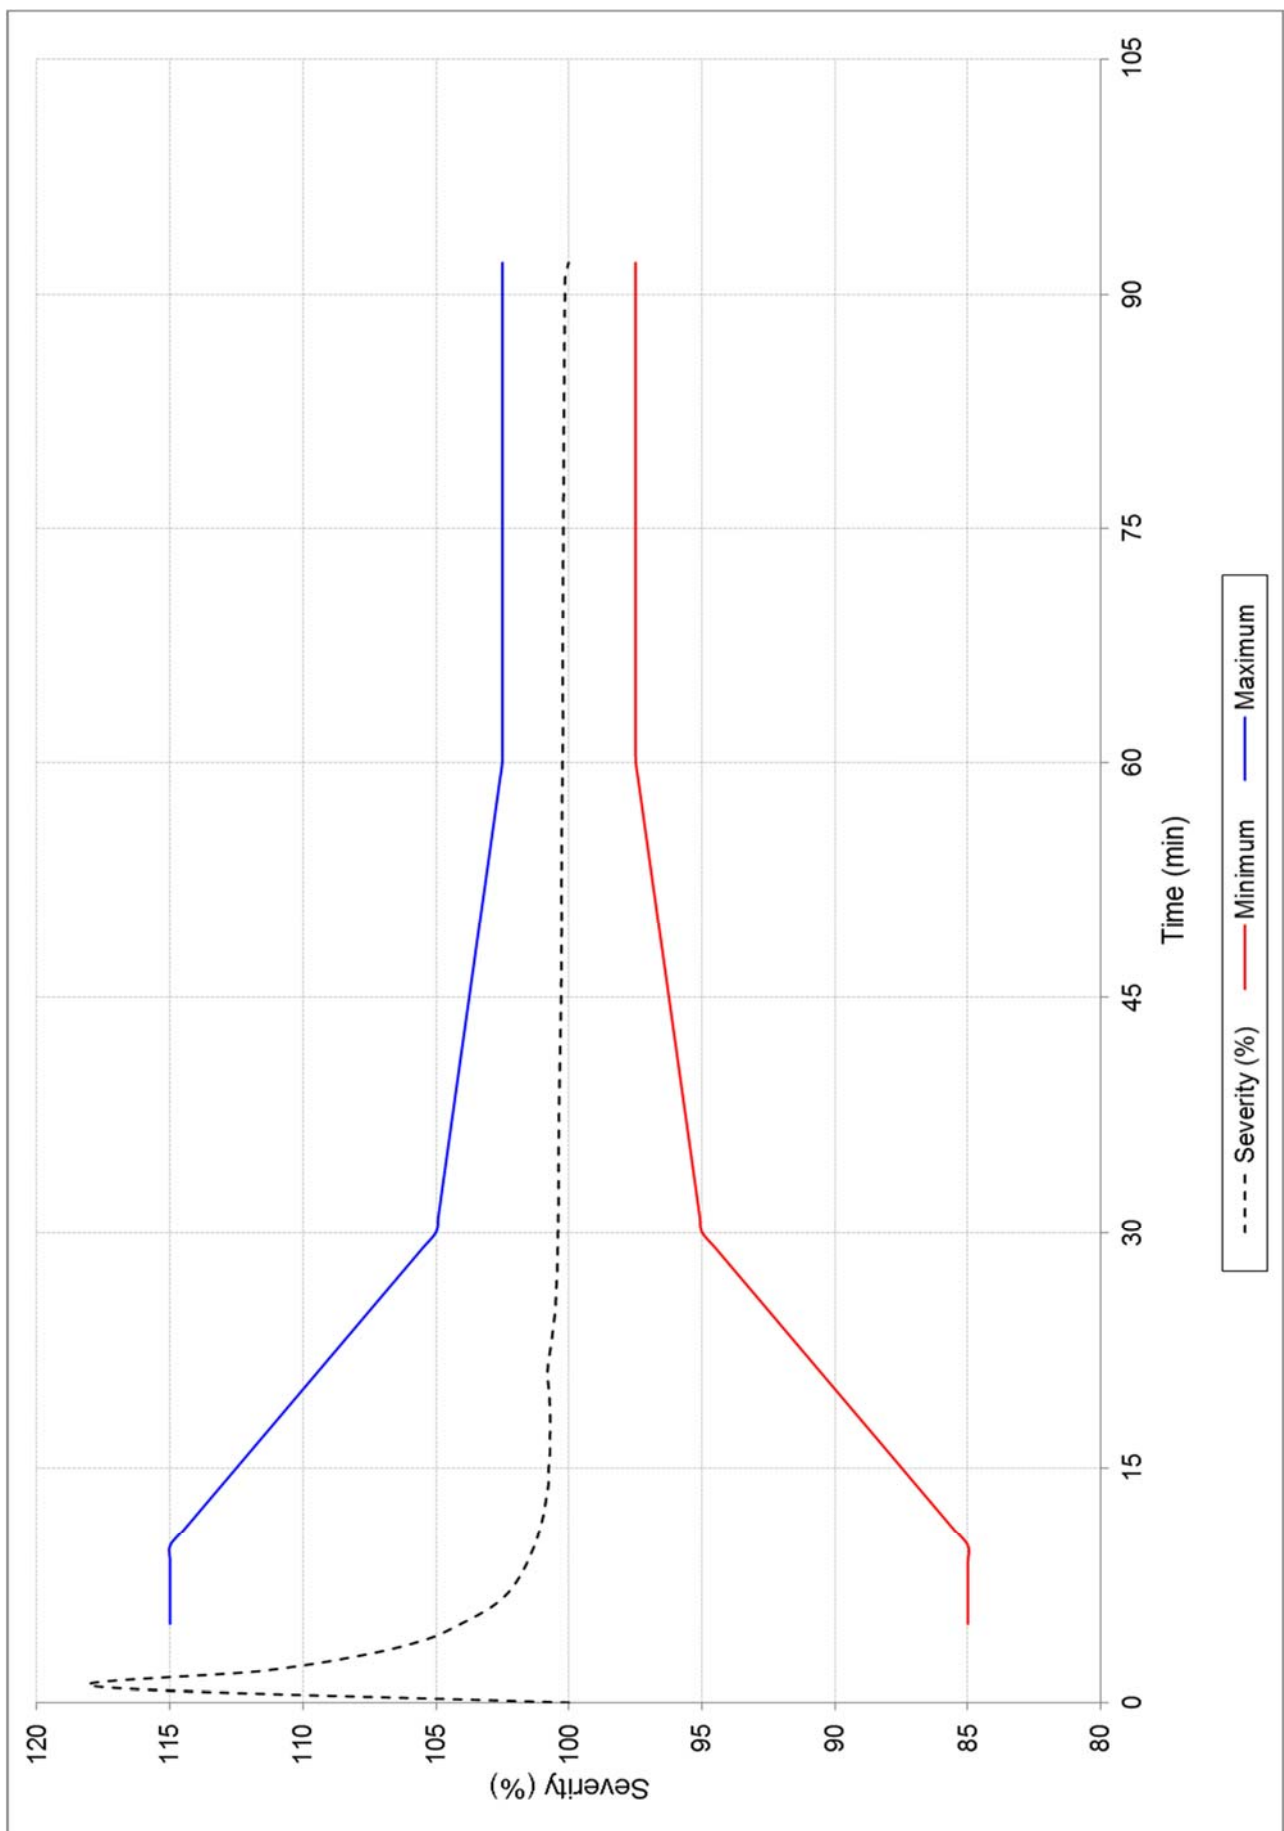
FIGURE 2 – FURNACE SEVERITY

Figure 2 shows the curve of furnace severity versus time during the heating period.
