Fire-resistance test on services penetrating a plasterboard wall

Test Report

Author: Peter Gordon
Report number: FSP 2084
Date: 6 May 2020

Sponsored Investigation No. FSP 2084

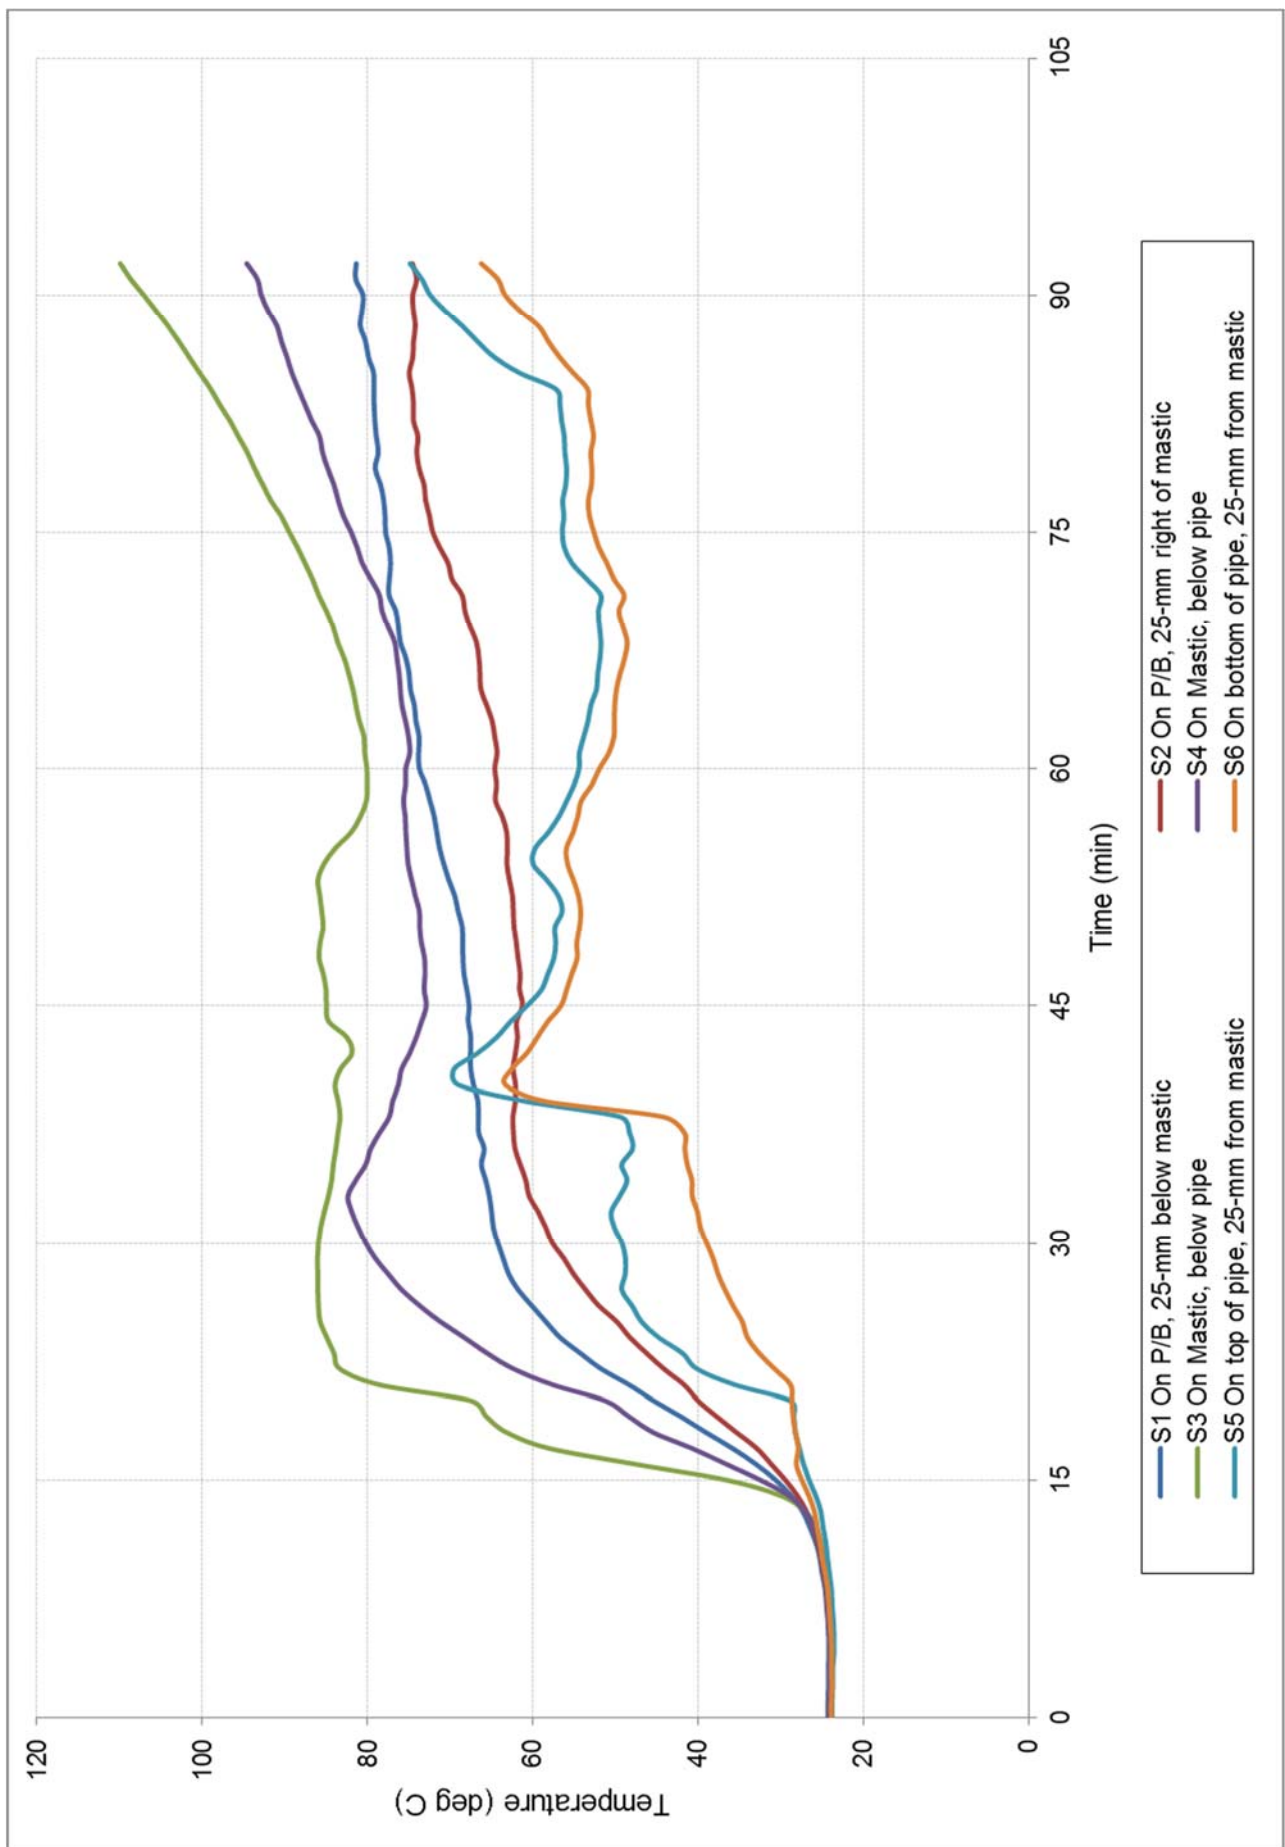
FIGURE 3 – SPECIMEN TEMPERATURE – ASSOCIATED WITH SPECIMEN 1

Figure 3 shows the curve of temperature versus time associated with Specimen 1.

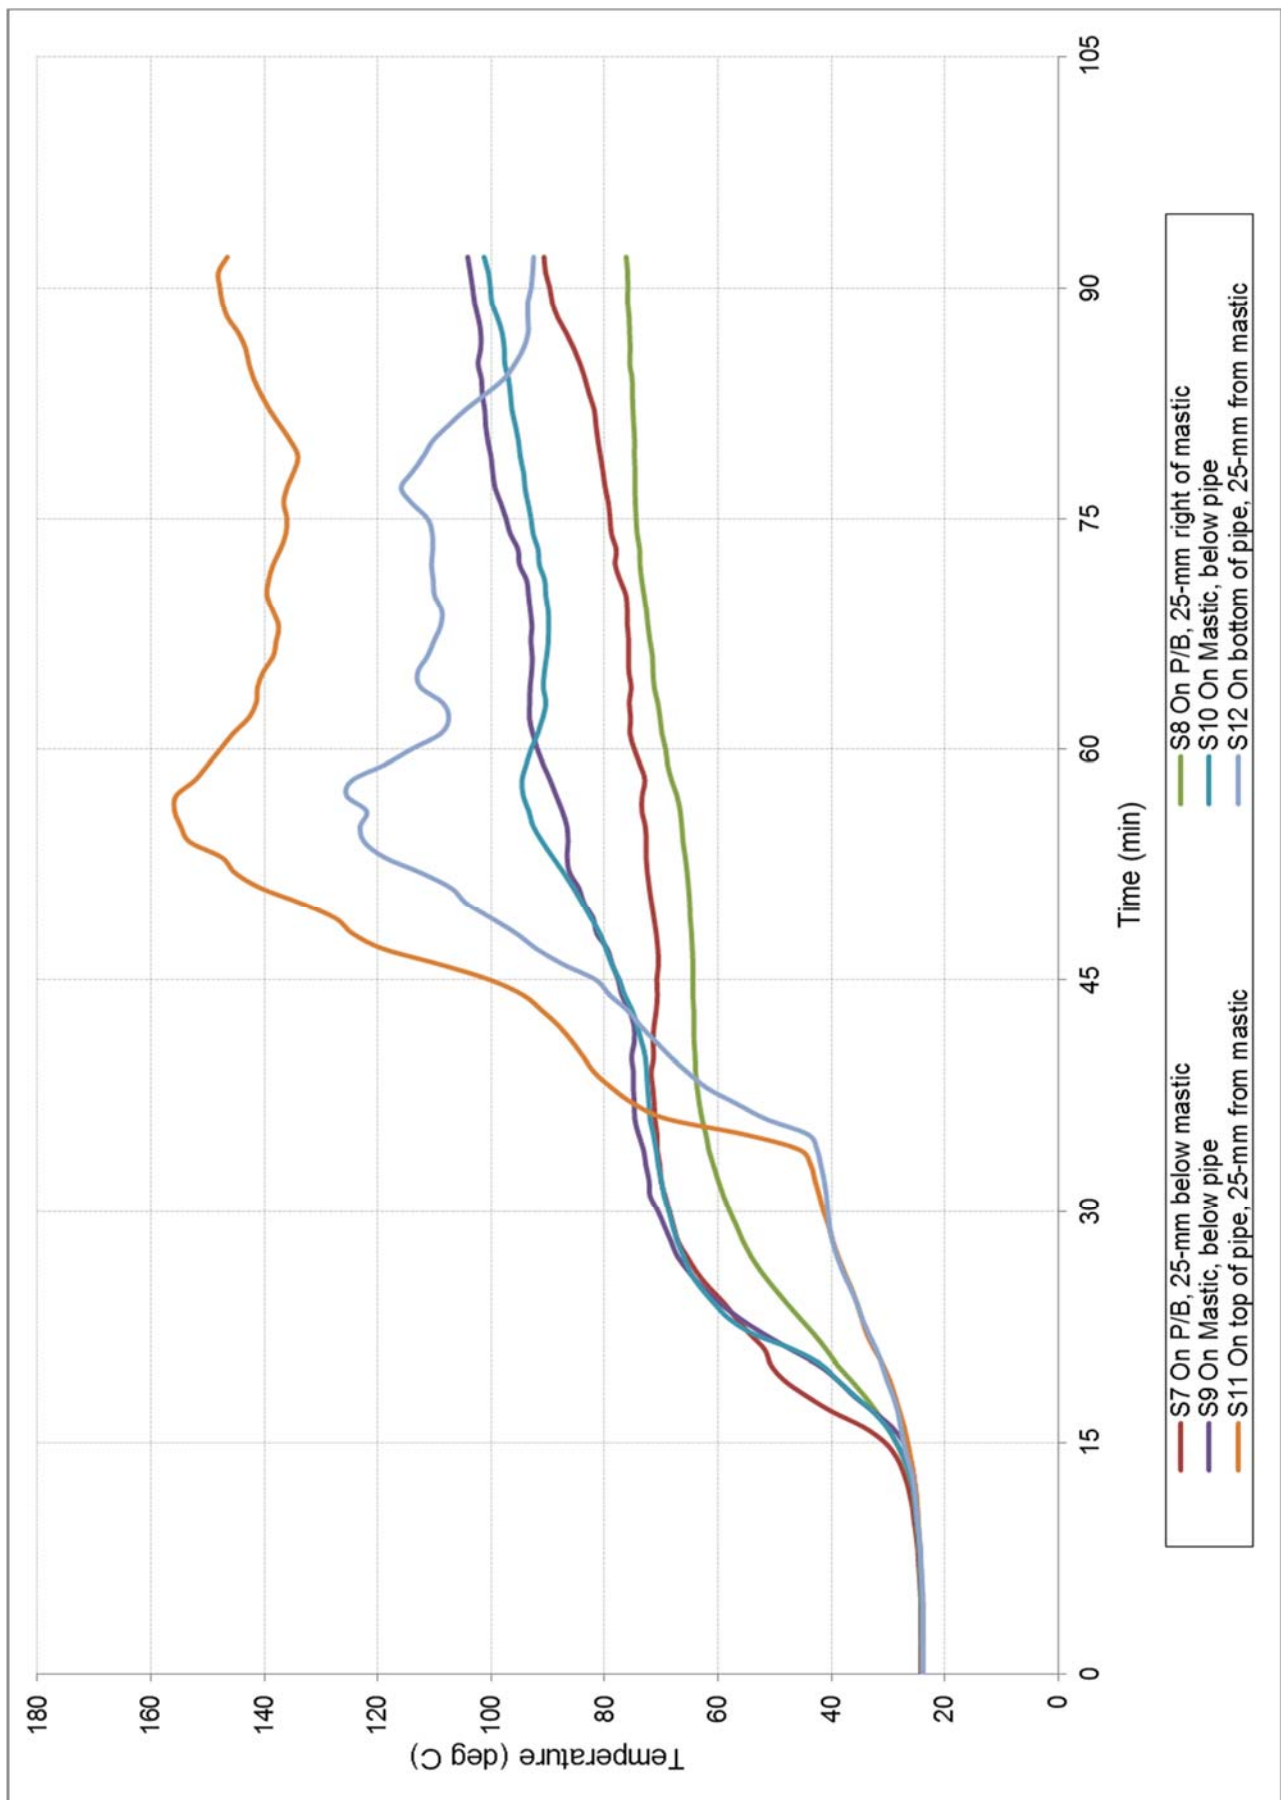
FIGURE 4 – SPECIMEN TEMPERATURE – ASSOCIATED WITH SPECIMEN 2

Figure 4 shows the curve of temperature versus time associated with Specimen 2.

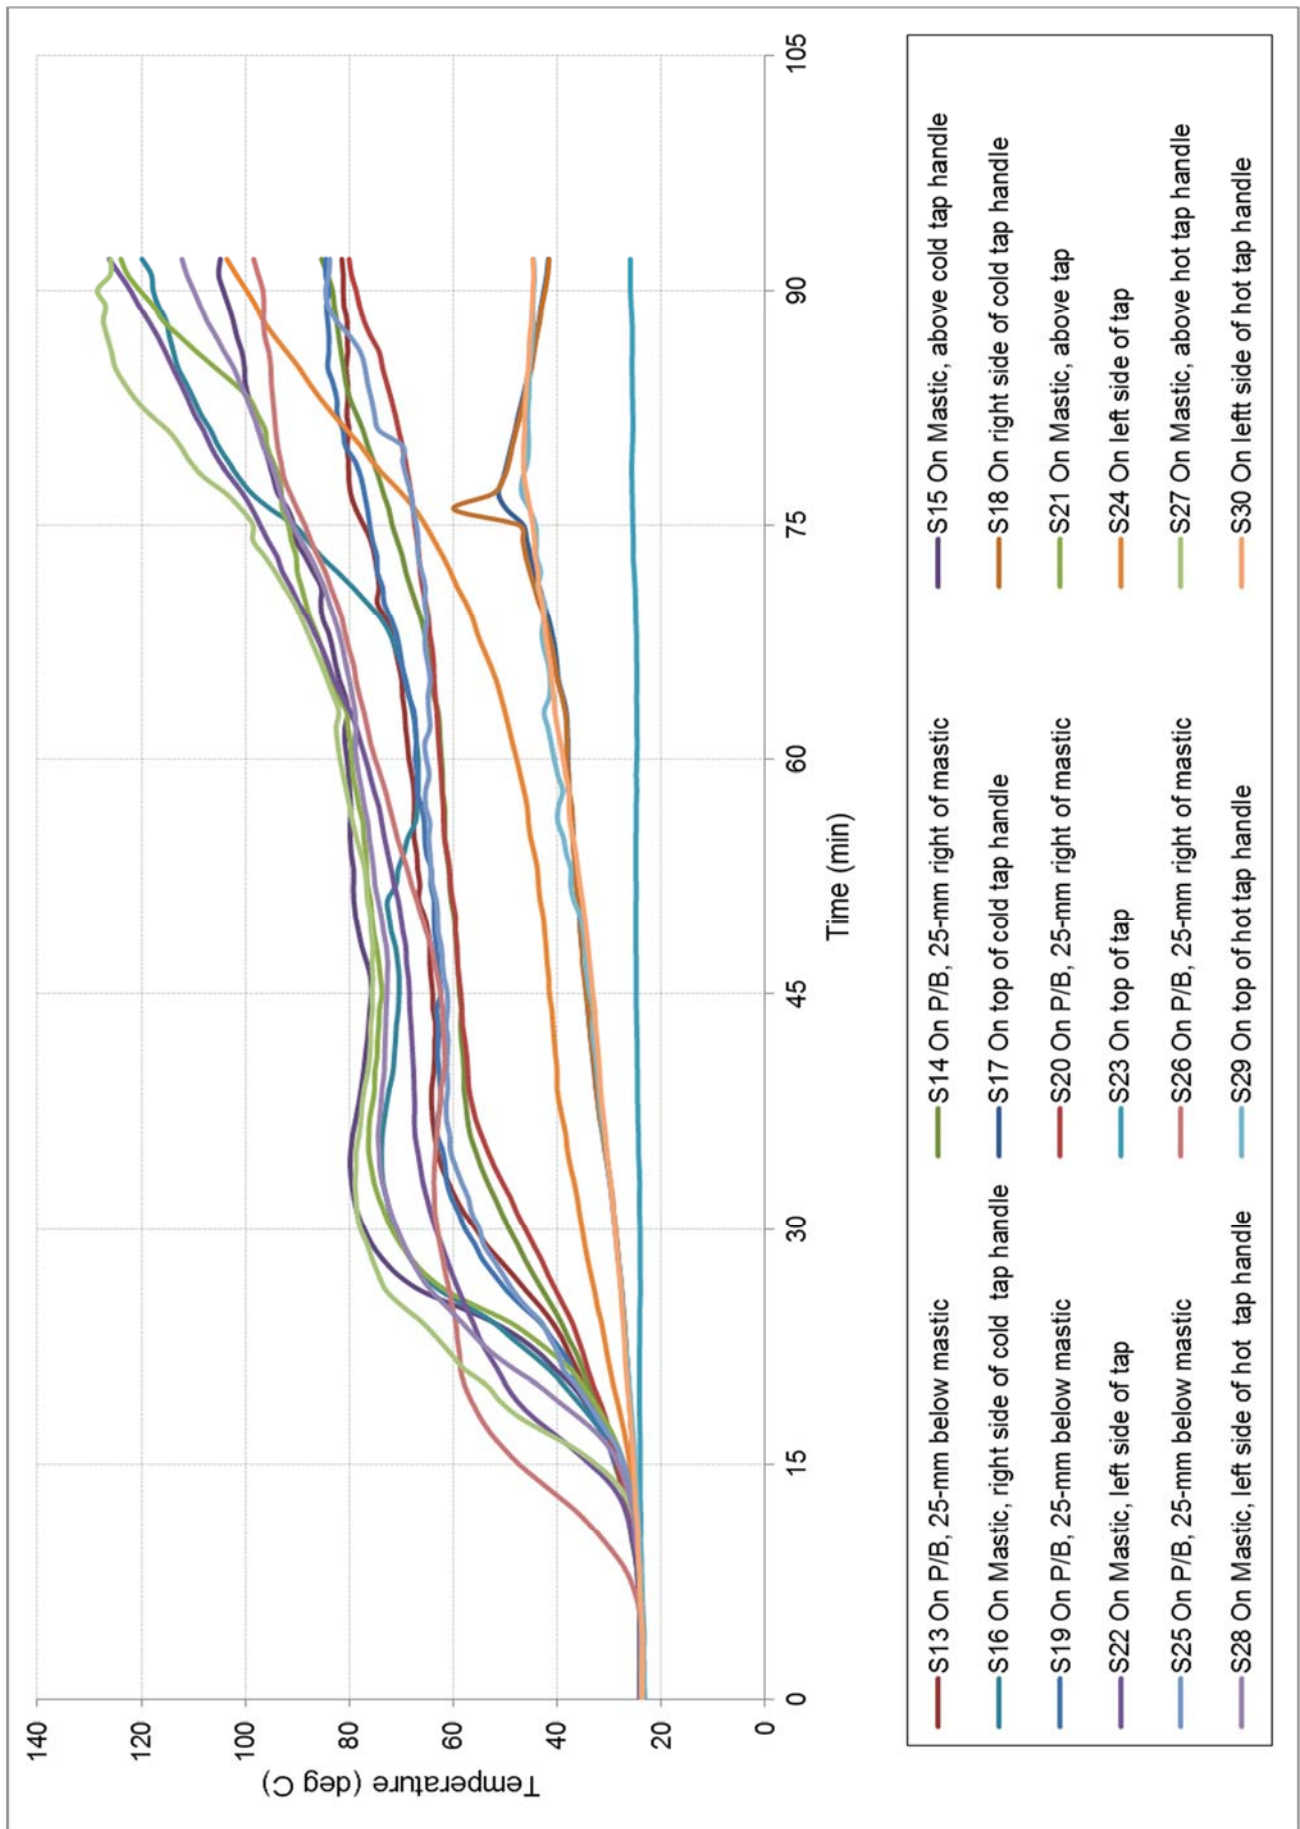
FIGURE 5 – SPECIMEN TEMPERATURE – ASSOCIATED WITH SPECIMEN 3

Figure 5 shows the curve of temperature versus time associated with Specimen 3.

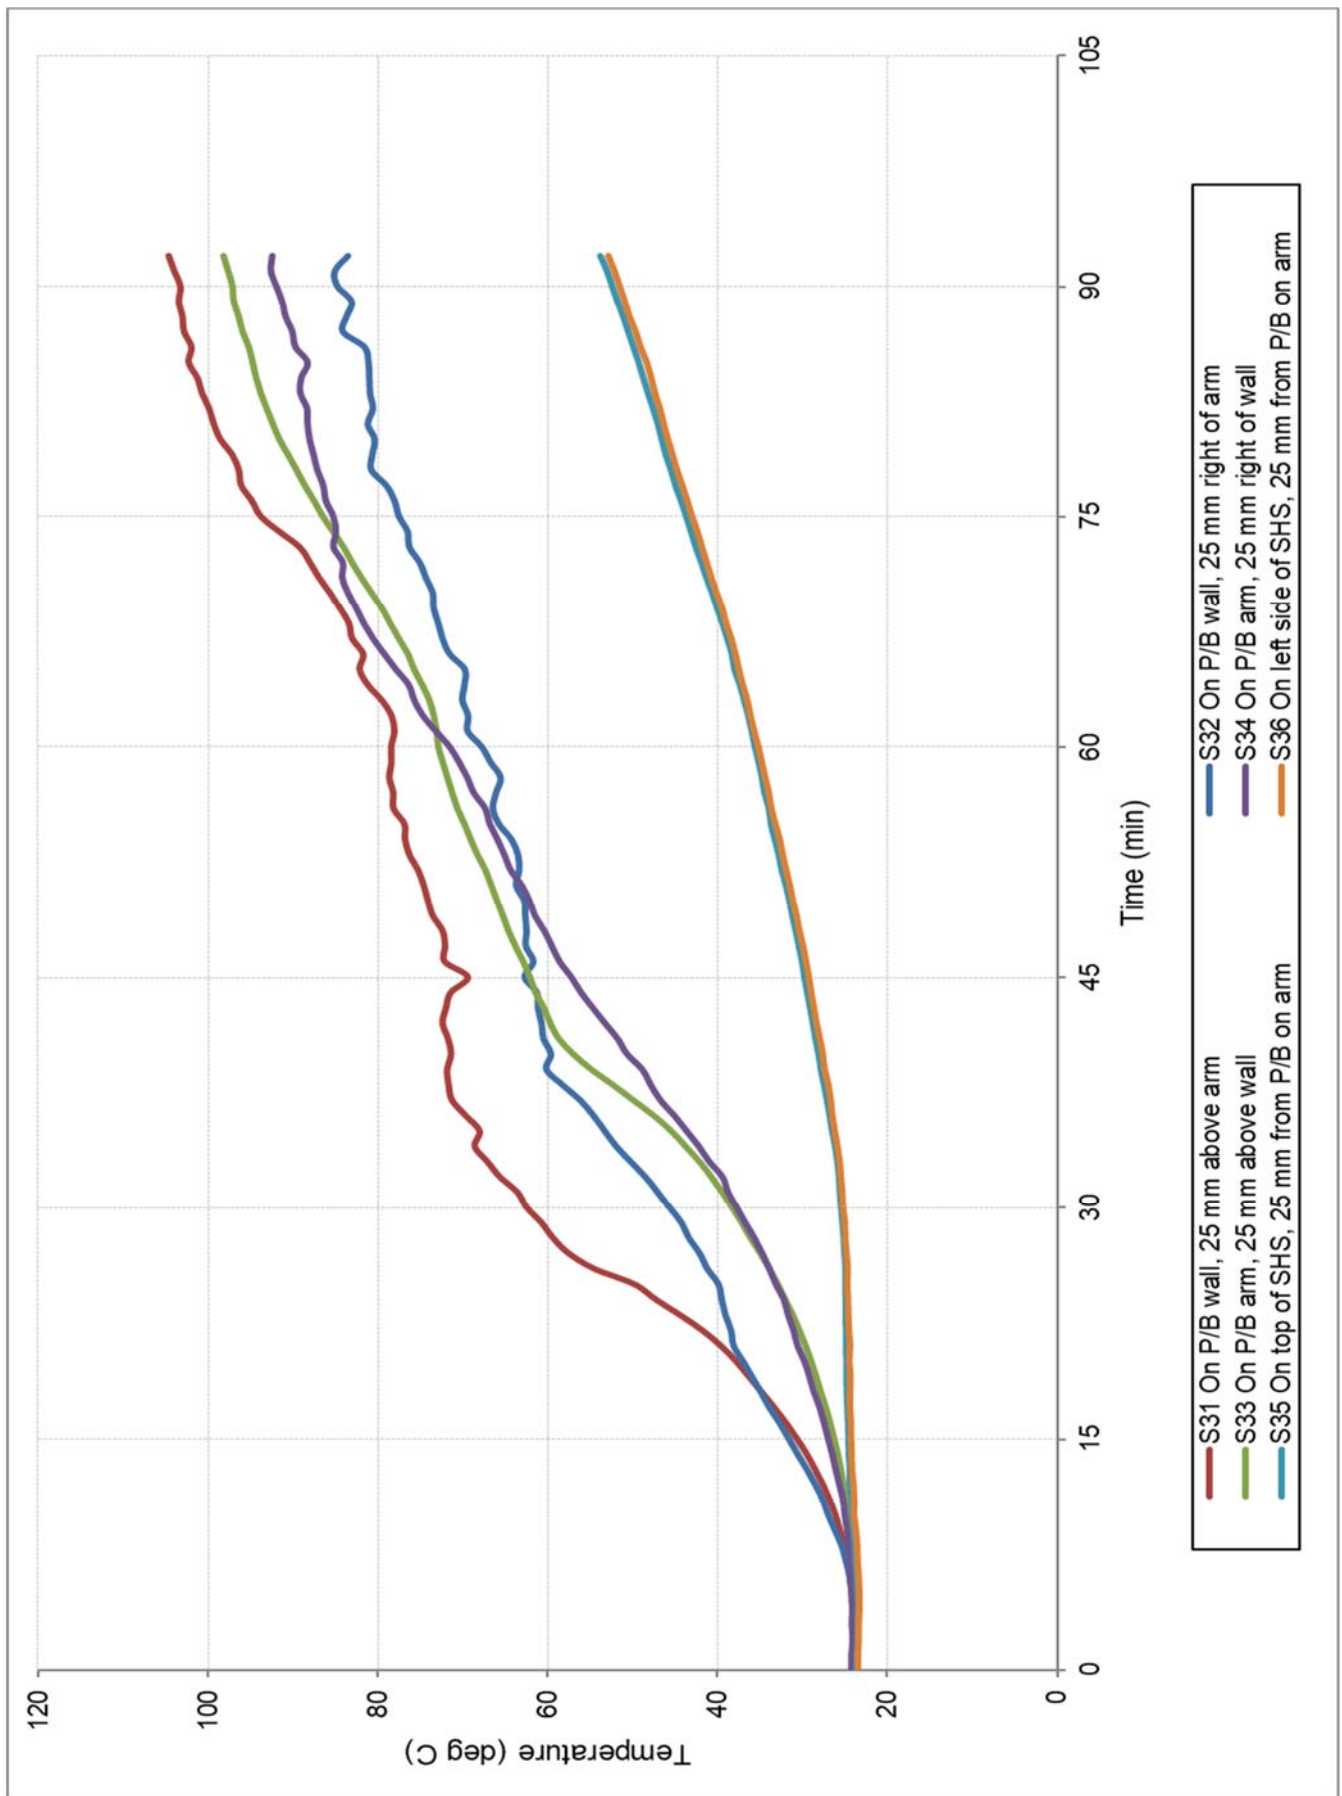
FIGURE 6 – SPECIMEN TEMPERATURE – ASSOCIATED WITH SPECIMEN 4

Figure 6 shows the curve of temperature versus time associated with Specimen 4.

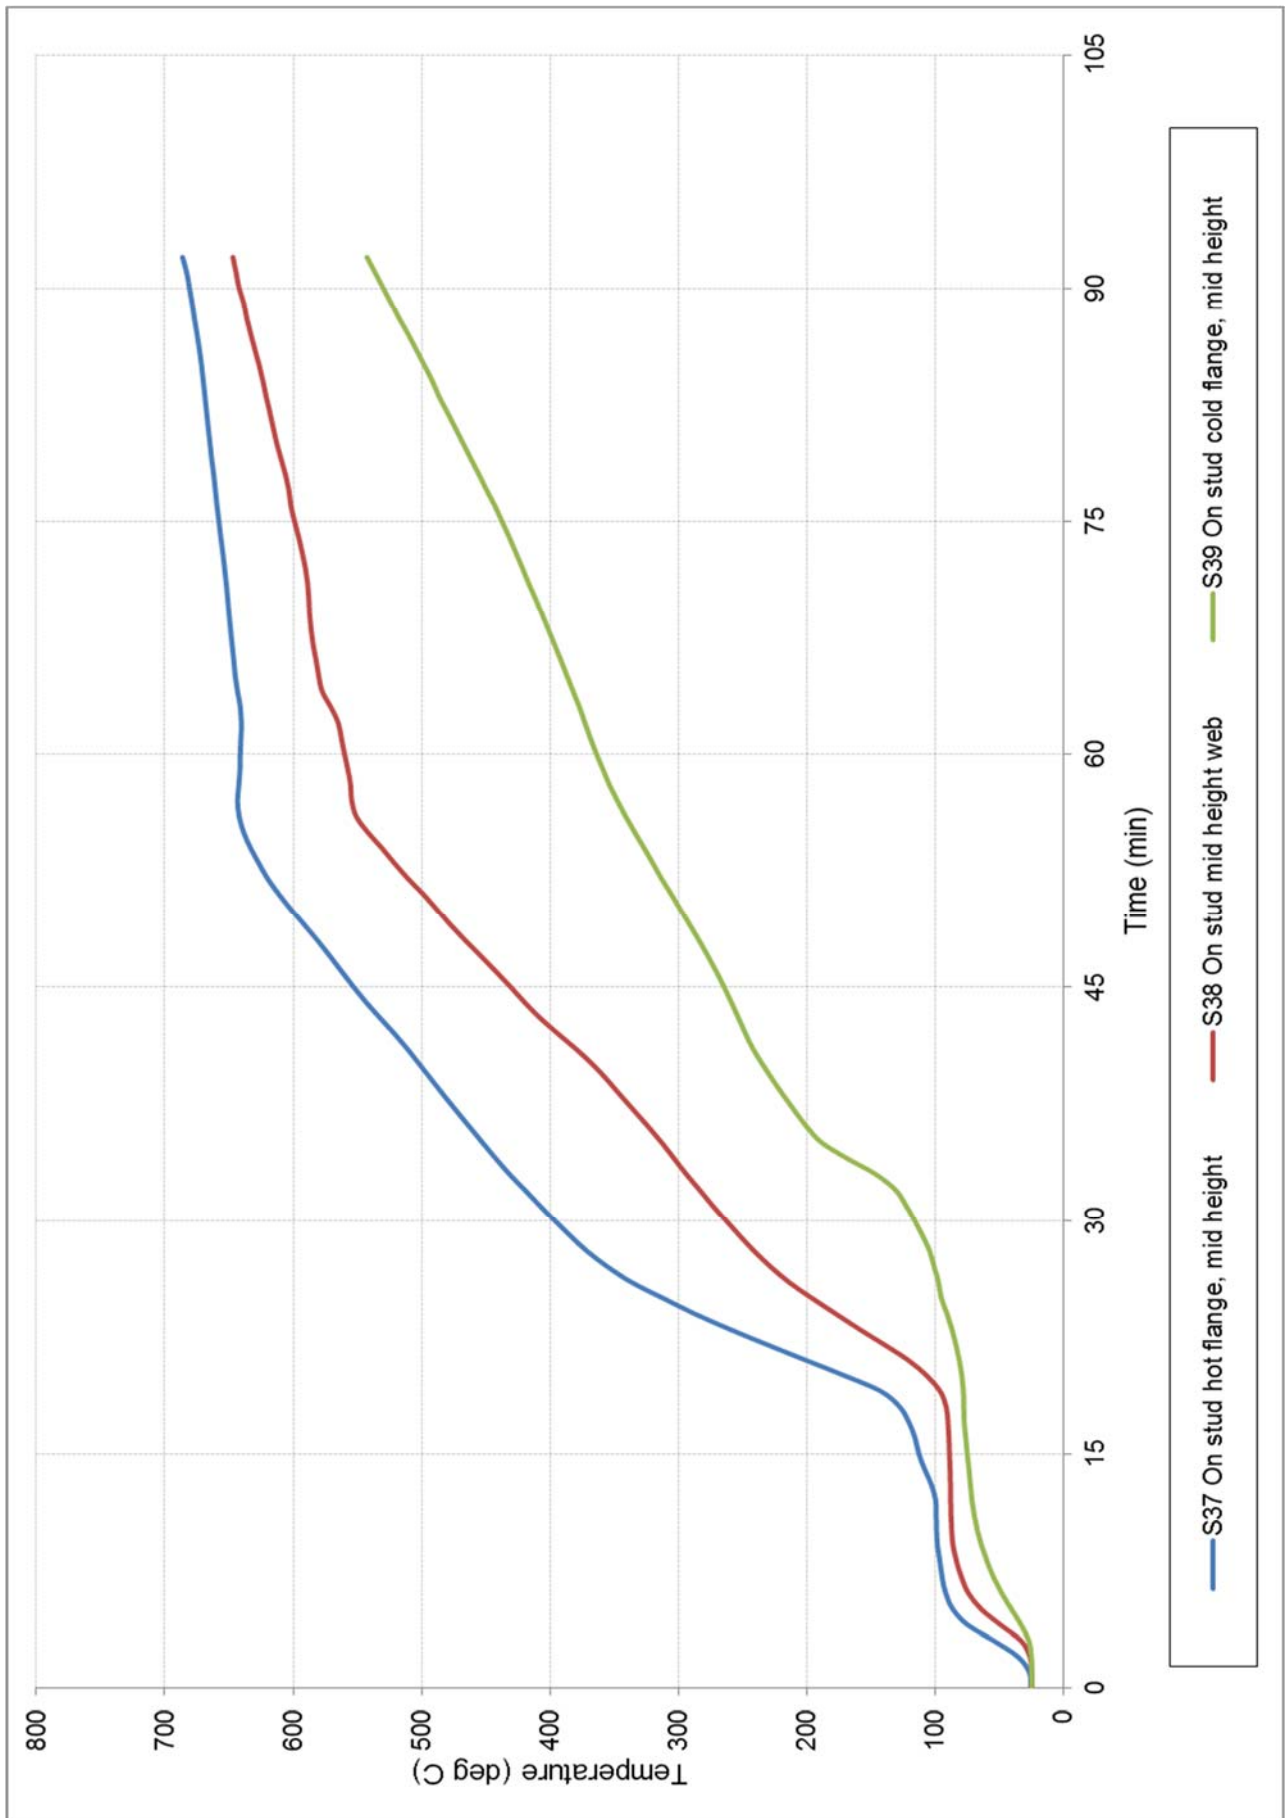
FIGURE 7 – SPECIMEN TEMPERATURE – STUD INSIDE WALL CAVITY

Figure 7 shows the curve of temperature versus time associated with the stud inside wall cavity.

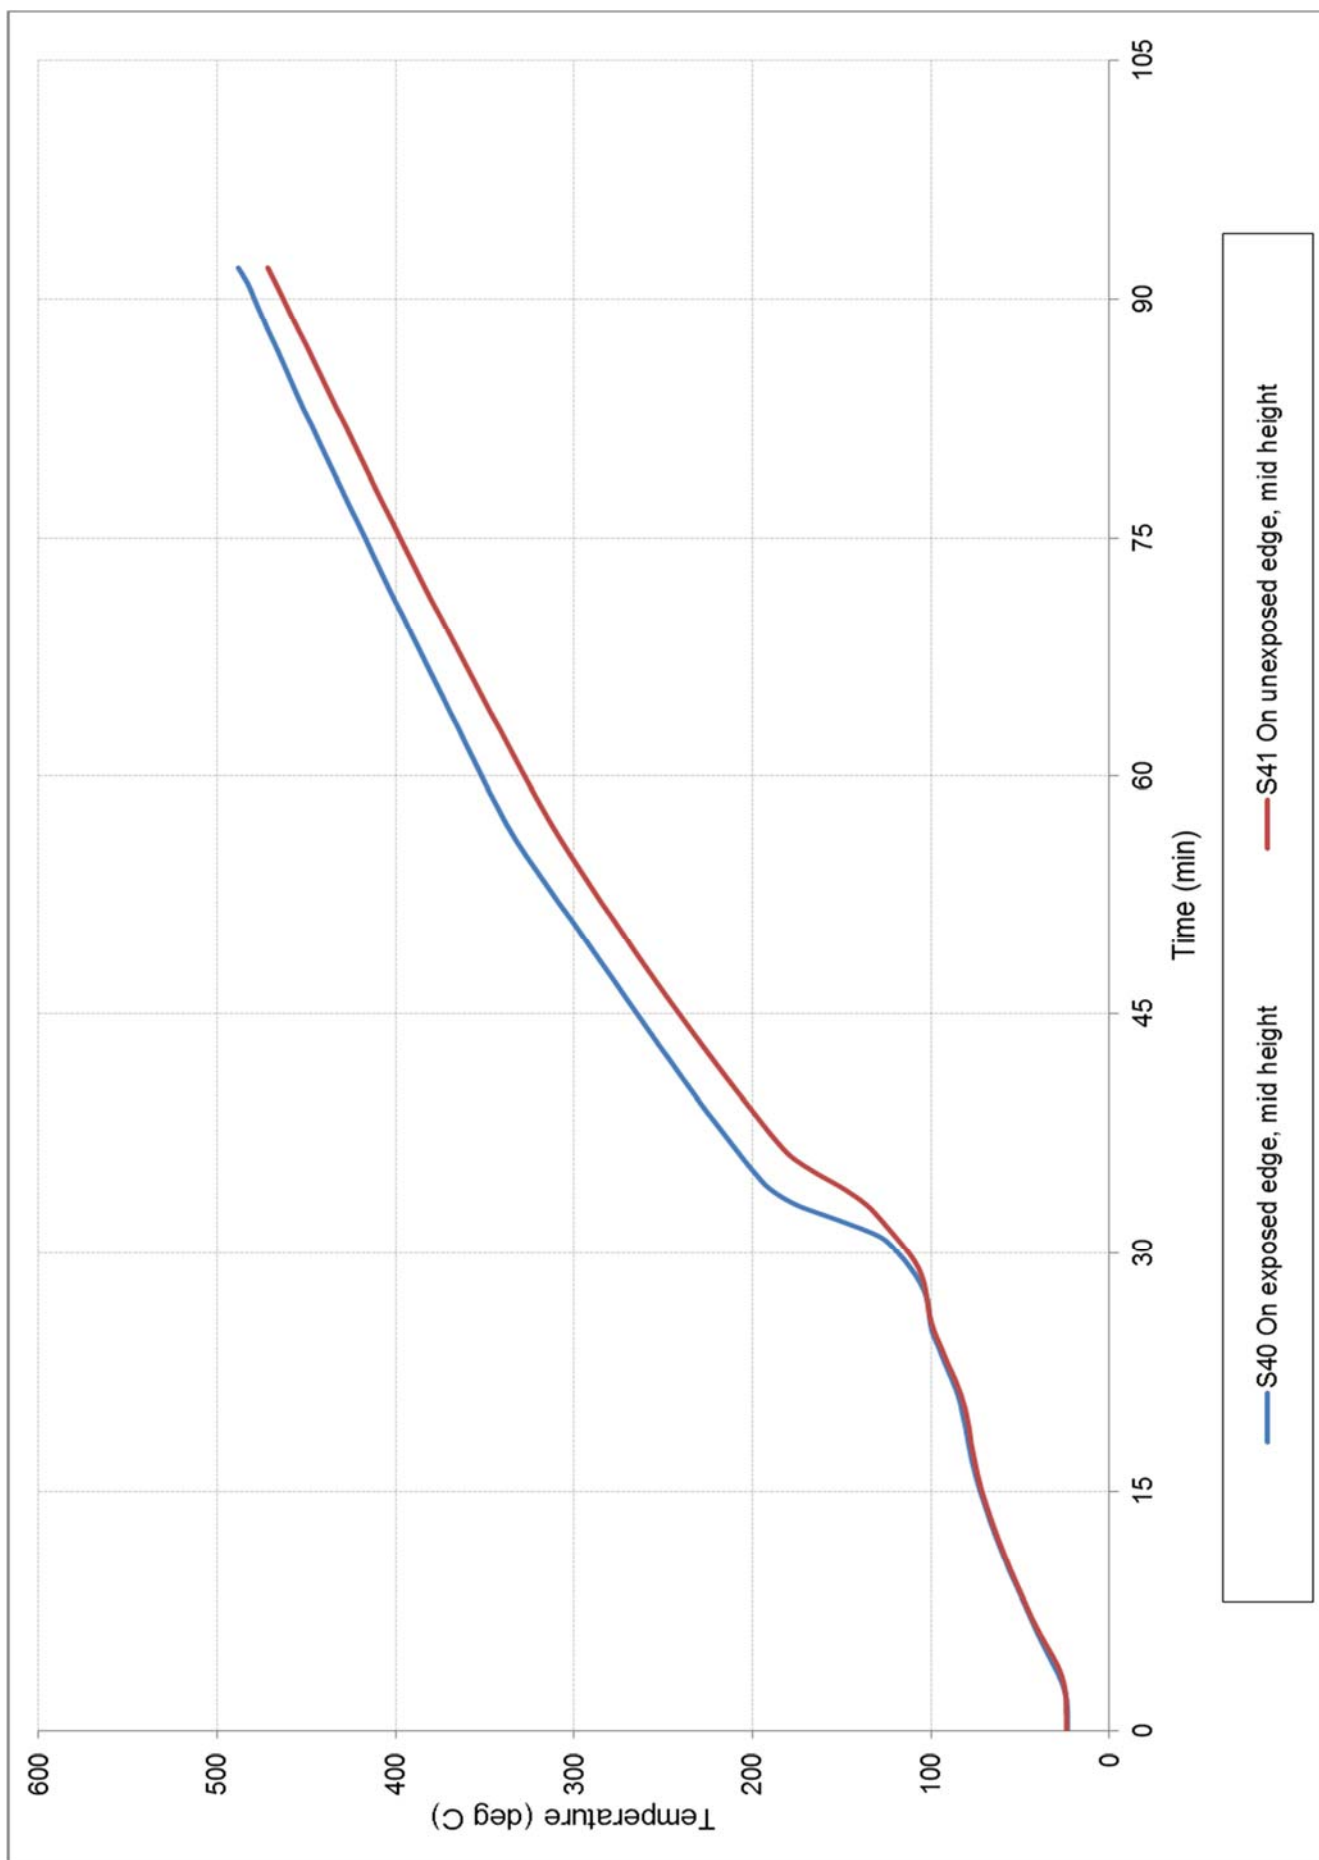
FIGURE 4 – SPECIMEN TEMPERATURE – SHS TUBE INSIDE CAVITY

Figure 8 shows the curve of temperature versus time associated with the SHS inside wall cavity.

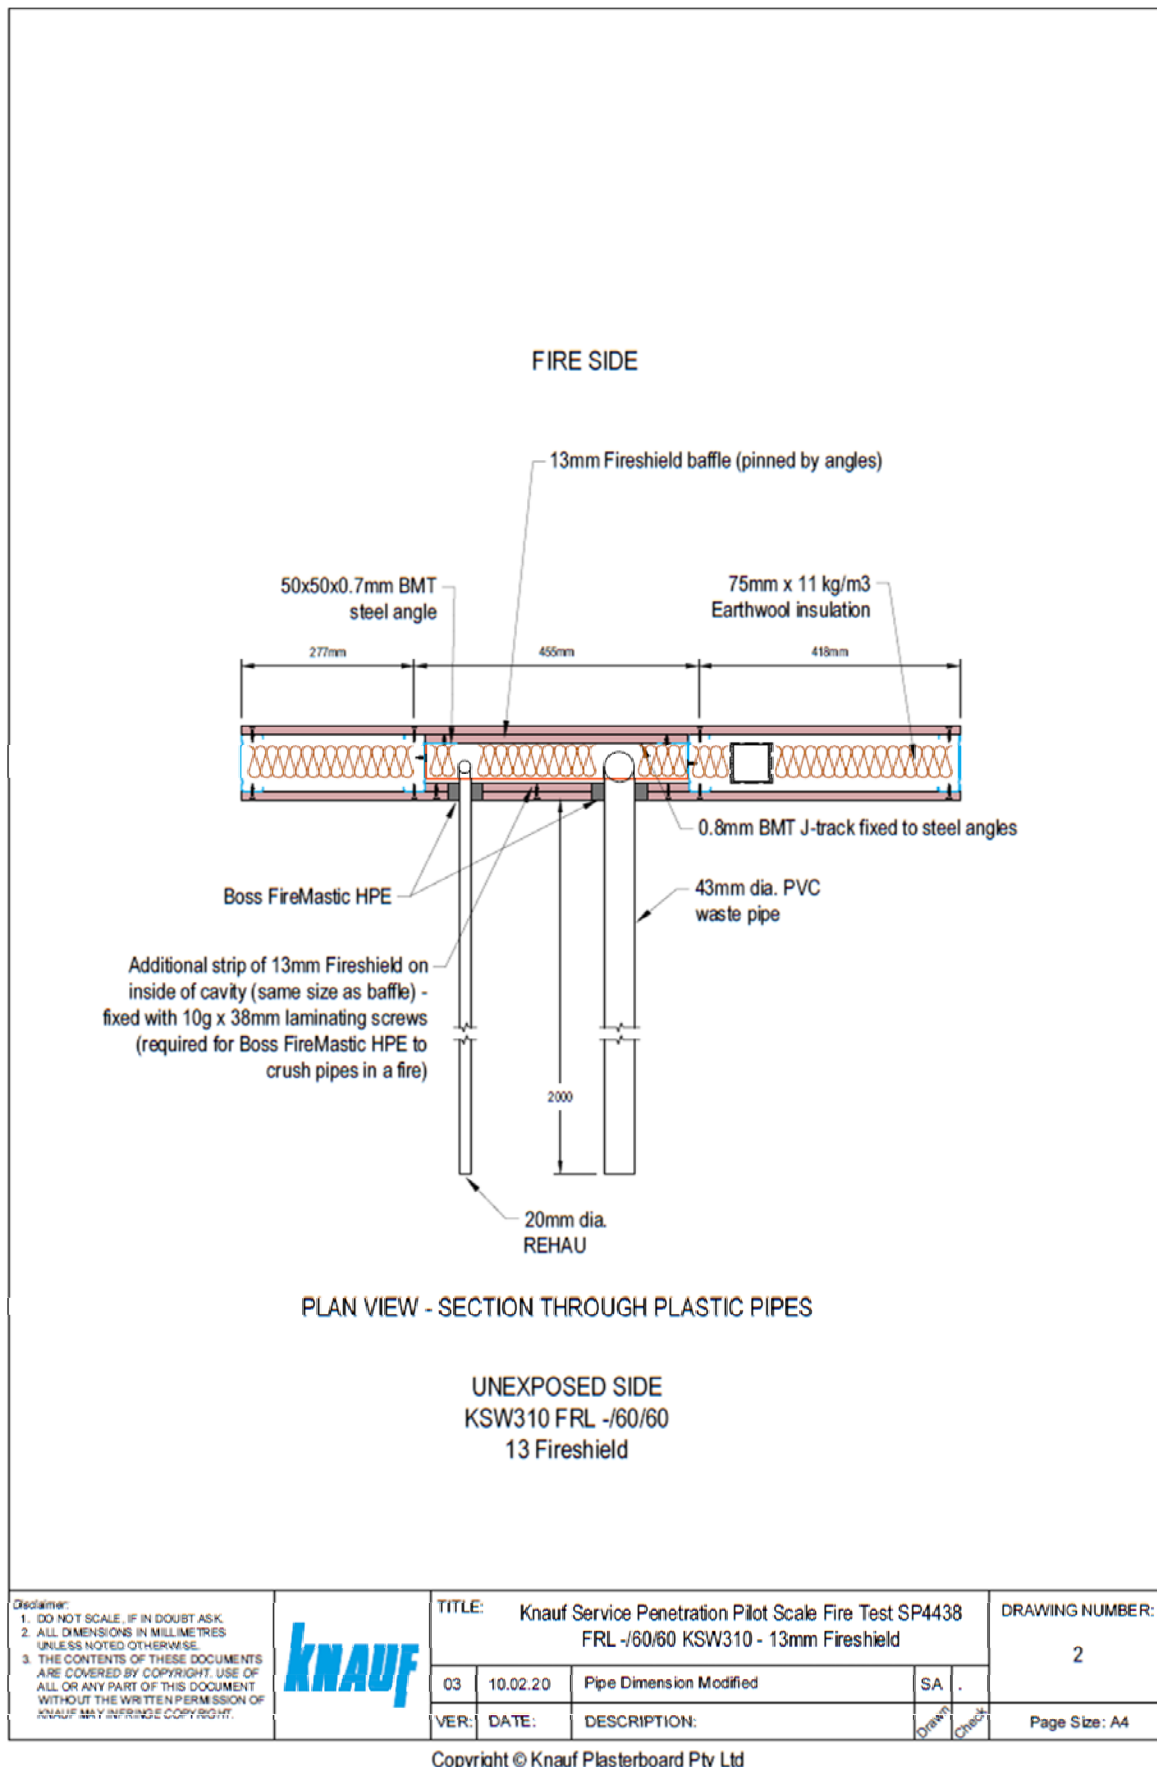
DRAWING NUMBER 2, TITLED “KNAUF SERVICE PENETRATIONS PILOT SCALE FIRE TEST SP4438 FRL-/60/60 KSW310 – 13-MM FIRESHIELD”, DATED 10 FEBRUARY 2020 BY KNAUF

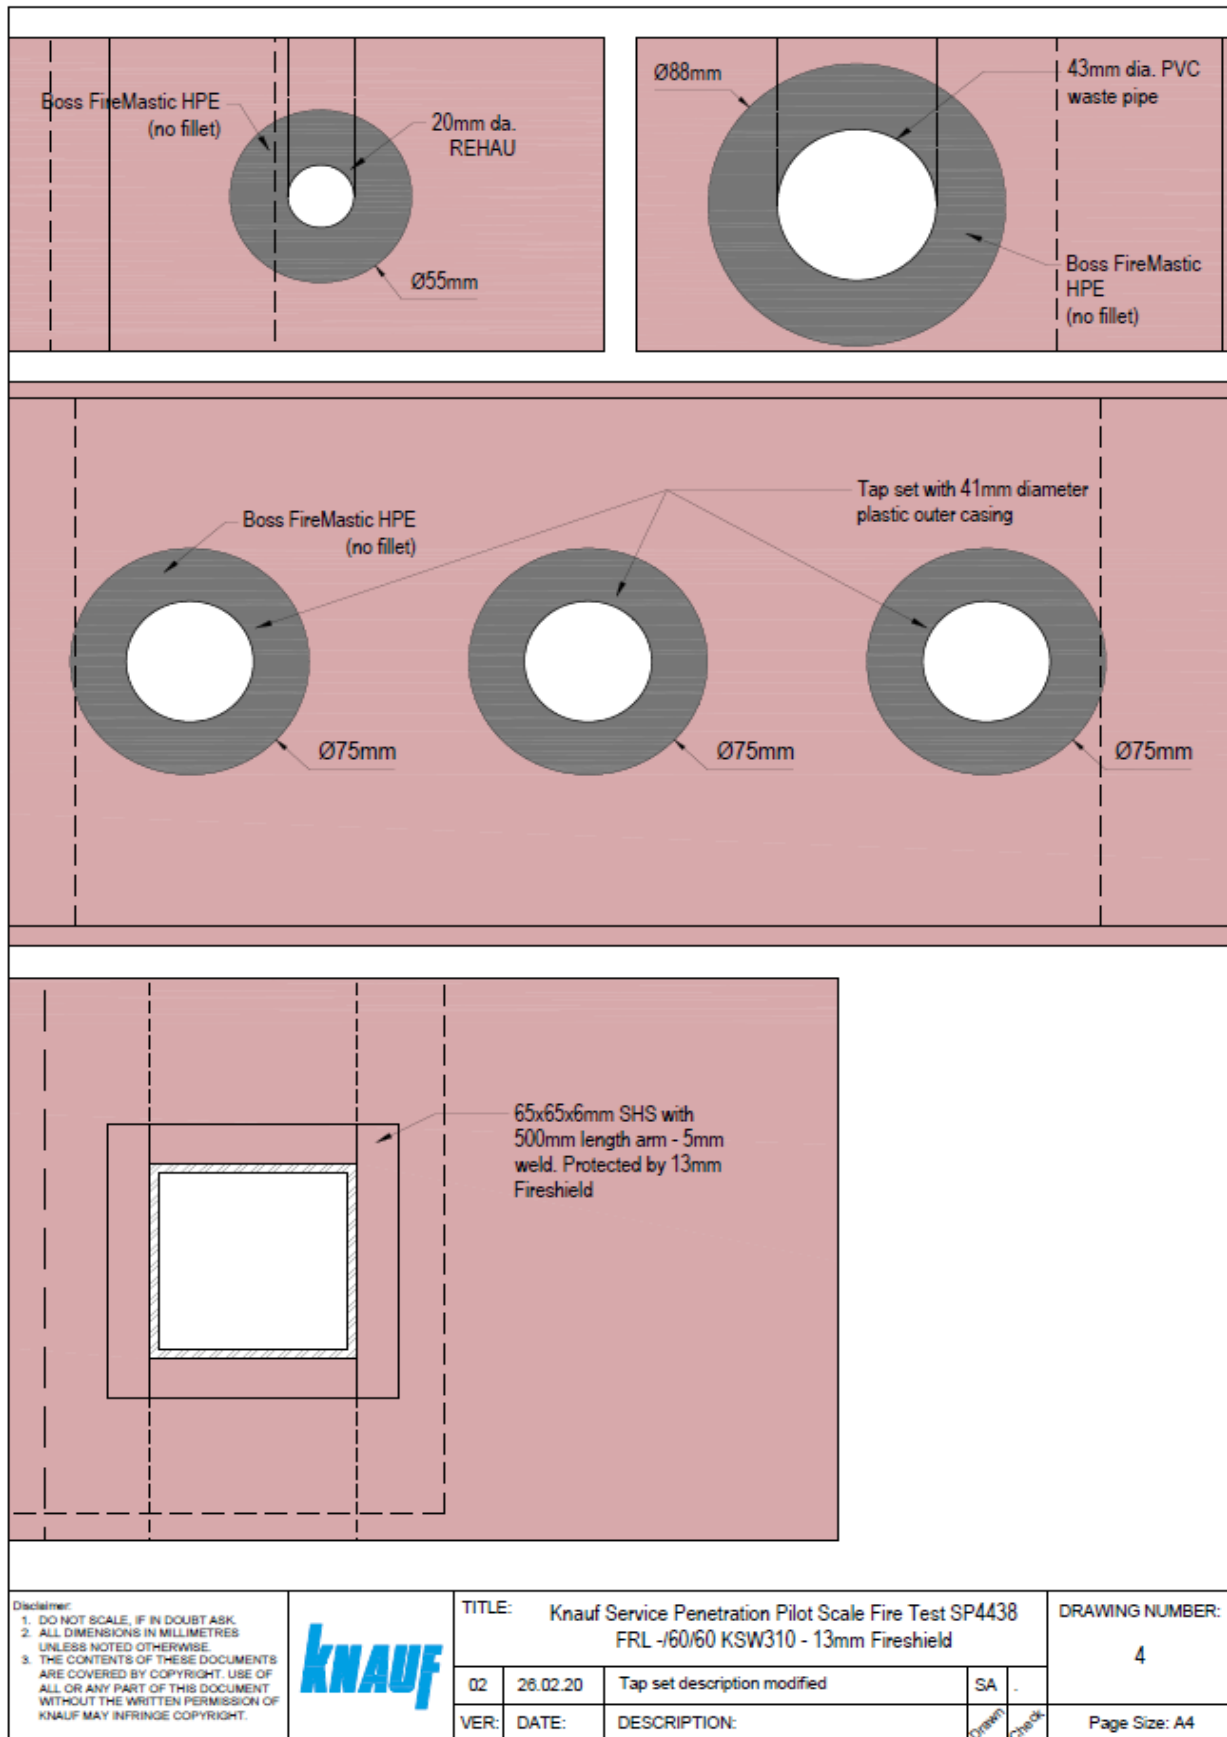
DRAWING NUMBER 4, TITLED “KNAUF SERVICE PENETRATIONS PILOT SCALE FIRE TEST SP4439 FRL-/60/60 KSW310 – 13-MM FIRESHIELD”, DATED 26 FEBRUARY BY KNAUF
