Fire-resistance test on service penetrations in a framed wall system

Test Report

Author: Peter Gordon
Report number: FSP 1791
Date: 14 March 2017

Sponsored Investigation No. FSP 1791

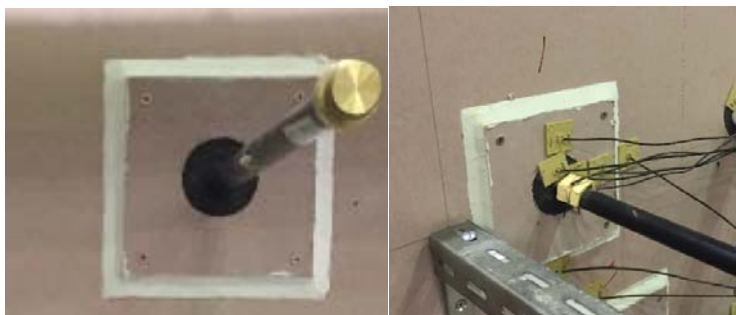
Photograph

Specimen 1 – FireMastic-HPE sealant protecting a 60-mm round opening penetrated by PEX Cross Linked Polyethylene plumbing pipe 20mm diameter.

SEPERATING ELEMENT	
Plasterboard wall system – 13-mm plasterboard wall, with an established FRL of -/60/60	
TYPE AND SIZE OF CONSTRUCTION	
60-mm ID opening in a 90 mm thick wall.	
PENETRATING SERVICE	
Description	PEX Cross Linked Polyethylene plumbing pipe. The service penetrated the non-exposed side by 2000-mm and the exposed side by 500-mm.
Size	PEX Cross Linked Polyethylene plumbing pipe 20-mm diameter with a 20-mm annular gap sealed with BOSS FireMastic-HPE intumescent sealant to a depth of 26-mm.
End conditions	Sealed on the exposed end using SmarteX P 20-mm Push fit brass Pex cap and left open on the unexposed end.
Supports	Approximately 500-mm and 1500-mm away from the wall on the non exposed face.
FIRE STOPPING SYSTEM	
Trade name	FireMastic-HPE sealant
Manufacturer	Boss Fire & Safety Pty Ltd
Description	High Pressure Exerting graphite-based, thixotropic, one-part acrylic sealant
Application	A second layer of plasterboard 150-mm x 150-mm was placed over the penetration (on both sides) and secured to the wall with 4 x 25-mm long plasterboard screws. The edges of the plasterboard build up was coated with a 13-mm x 13-mm fillet of BOSS FireMastic-300 sealant. The annular gap of 20-mm between the pipe and the plasterboard on the non-exposed face was sealed with BOSS FireMastic-HPE to a depth of 26-mm and finished flush with the surface of the wall.

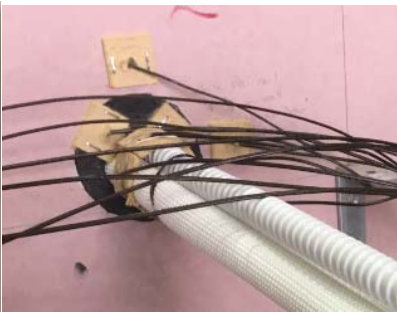
Specimen 2 – FireMastic-HPE sealant protecting a 80-mm round opening penetrated by a bundle of Paircoil, uPVC drain and Cable in a One-Sided System.

SEPERATING ELEMENT	
Plasterboard wall system – 13-mm plasterboard wall, with an established FRL of -/60/60	
TYPE AND SIZE OF CONSTRUCTION	
80-mm ID opening in a 90 mm thick wall.	
PENETRATING SERVICE	
Description	Bundle of Paircoil, uPVC drain and Cable in a One-Sided System. The PVC pipe extends 2000-mm from the non-exposed side, and all pipes and cable extend 500-mm down into the wall cavity.
Size	Polyaire Paircoil 6.35-mm/9.52-mm insulated copper pipes with non-rated insulation lagging, 1.5-mm ² 2C+E TPS power cable, and a 16-mm ² PVC flexible outlet pipe.
End conditions	The exposed face of the wall is not penetrated and pipes are left open on the unexposed face.
Supports	Approximately 500-mm and 1500-mm away from the wall on the non exposed face.
FIRE STOPPING SYSTEM	
Trade name	FireMastic-HPE sealant
Manufacturer	Boss Fire & Safety Pty Ltd
Description	High Pressure Exerting graphite-based, thixotropic, one-part acrylic sealant

Application	The annular gap around the bunch of the paircoil, conduit and cables was sealed on both sides of the wall with FireMastic-HPE sealant to a nominal depth of 13-mm controlled by foam backing rod and finished flush with the surface of the wall.
Photograph	<div>

</div> <div> Exposed Unexposed </div>

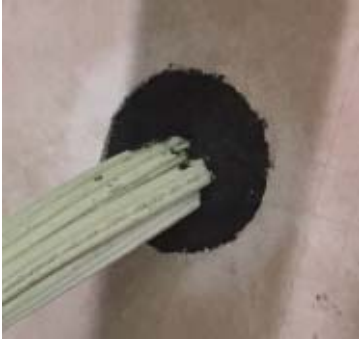
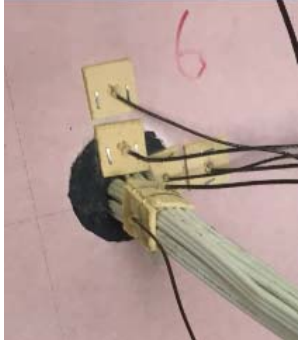
Specimen 6 – Bundle of Power Cables sealed with FireMastic-HPE.

SEPERATING ELEMENT	
Plasterboard wall system – 13-mm plasterboard wall, with an established FRL of -/60/60	
TYPE AND SIZE OF CONSTRUCTION	
60-mm ID opening in a 90-mm thick wall.	
PENETRATING SERVICE	
Description	Bundle of eight power cables.
Size	8 x 2.5mm ² , 3-core TPS cables.
End conditions	Cables on both exposed and unexposed side were left untreated.
Supports	Approximately 500-mm away from the wall on the unexposed side.
FIRE STOPPING SYSTEM	
Trade name	FireMastic-HPE sealant
Manufacturer	Boss Fire & Safety Pty Ltd
Description	High Pressure Exerting graphite-based, thixotropic, one-part acrylic sealant
Application	The remaining 10-mm annular gap was sealed with BOSS FireMastic-HPE intumescent sealant to a depth of 13-mm on each face of the wall and finished flush with the surface of the plaster board on both faces.
Photograph	<div style="display: flex; justify-content: space-around; align-items: center;">

</div> <div style="display: flex; justify-content: space-around; margin-top: 5px;"> Exposed Side Unexposed side </div>

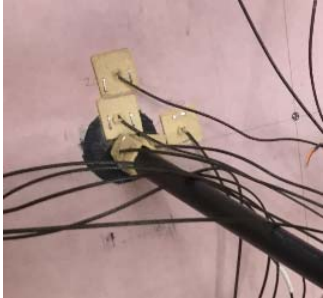
Photograph

Specimen 7 – 20-mm PEX pipe sealed with FireMastic-HPE.

SEPERATING ELEMENT	
Plasterboard wall system – 13-mm plasterboard wall, with an established FRL of -/60/60	
TYPE AND SIZE OF CONSTRUCTION	
60-mm ID opening in a 90-mm thick wall.	
PENETRATING SERVICE	
Description	PEX Cross Linked Polyethylene plumbing pipe. The service penetrated the non-exposed side by 2000-mm and the exposed side by 500-mm.
Size	20-mm diameter
End conditions	Exposed end sealed using a Brass 20-mm cap and left open on the unexposed end.
Supports	Approximately 500-mm and 1500-mm away from the wall on the non - exposed side.
FIRE STOPPING SYSTEM	
Trade name	FireMastic-HPE sealant
Manufacturer	Boss Fire & Safety Pty Ltd
Description	High Pressure Exerting graphite-based, thixotropic, one-part acrylic sealant
Application	The FireMastic-HPE fills the void between the pipe and the plasterboard sheet with an annular gap of 20-mm and a depth of 13-mm. The FireMastic-HPE is finished flush with the surface of the plasterboard wall on both faces.

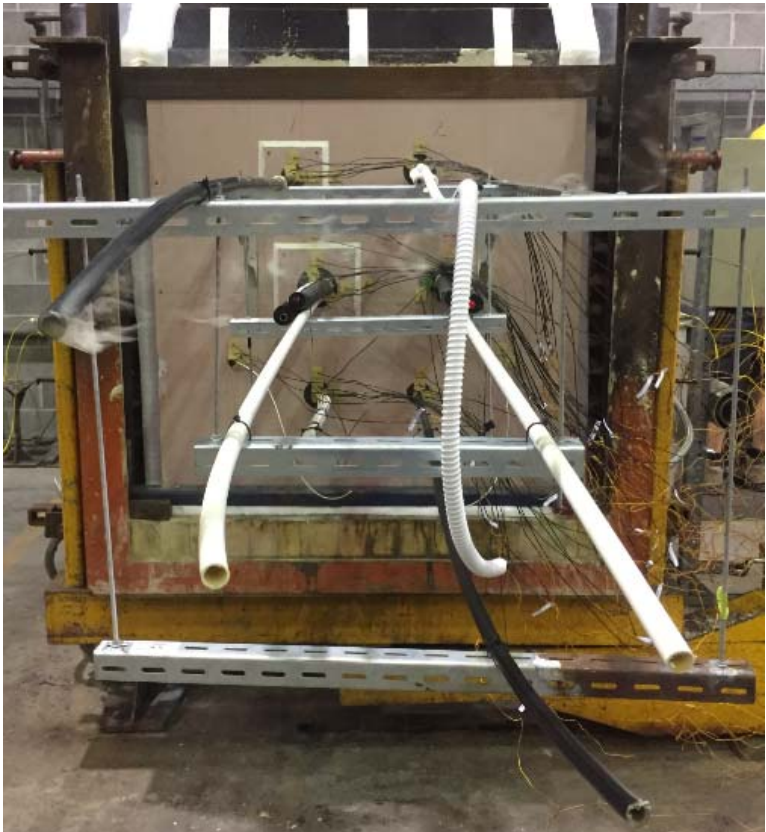
PHOTOGRAPH 2 – UNEXPOSED SIDE OF THE SPECIMENS PRIOR TO TESTING

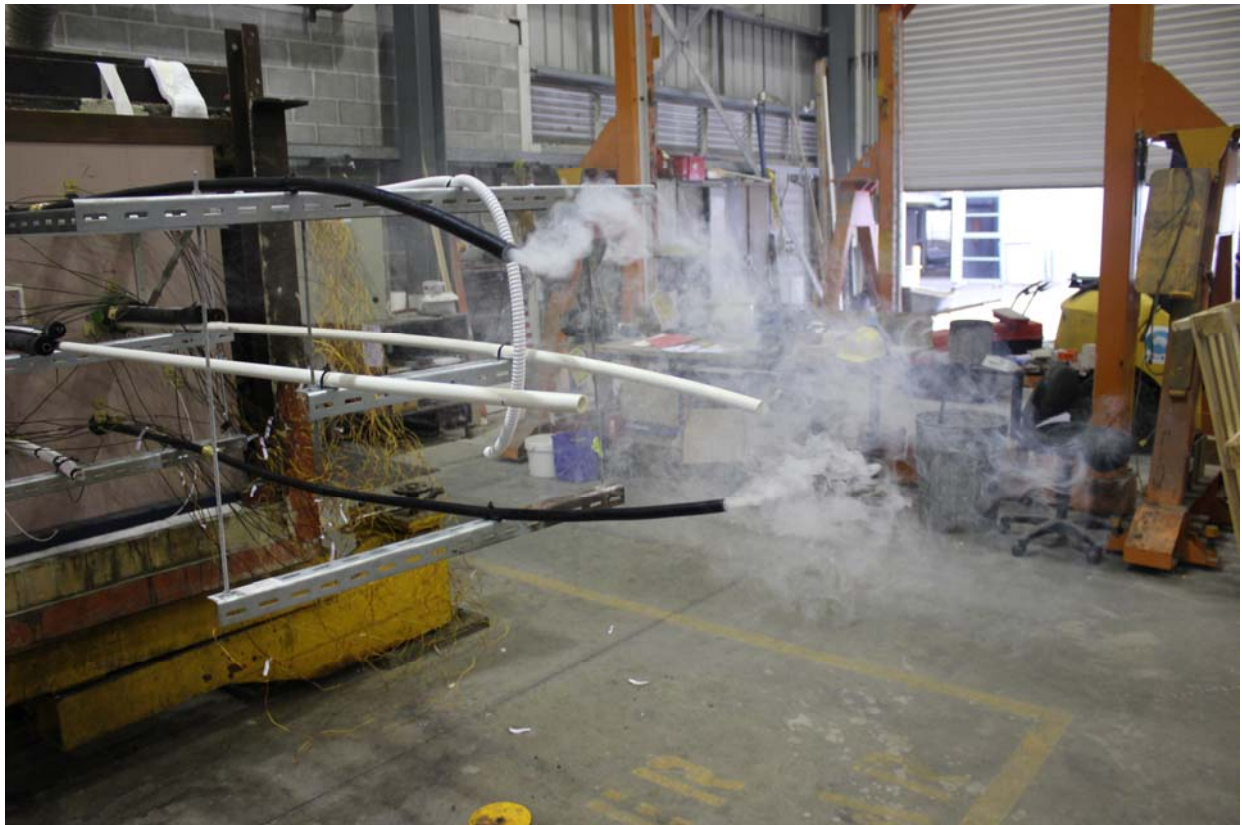
PHOTOGRAPH 3 – SPECIMENS AFTER 4 MINUTES OF TESTING

- 1 minute - Smoke emitted from the ends of penetrations # 3 and #4.
- 2 minutes - Penetration # 3 stopped fluing.
- 3 minutes - Smoke fluing from the ends of penetrations #1 and #7.
- 20 minutes - Smoke emitted from the end of the flexible PVC pipe in penetration #2.
Smoke fluing reduced from the ends of penetrations #1 and #7
- 23 minutes - Fluing from the end of penetration #2 ceased.
- 25 minutes - Fluing from the end of penetration #7 ceased.
- 30 minutes - Insulation on penetrations #3 and #4 showing signs of becoming heat affected near the unexposed wall.
- 37 minutes - Fluing from the end of penetration #2 – copper pipes.
- 48 minutes - Insulation on the cables of penetration # 6 softening and sagging.
- 55 minutes - The mastic swelled on the exposed face of penetration #6.
- 61 minutes - Test terminated at clients request.

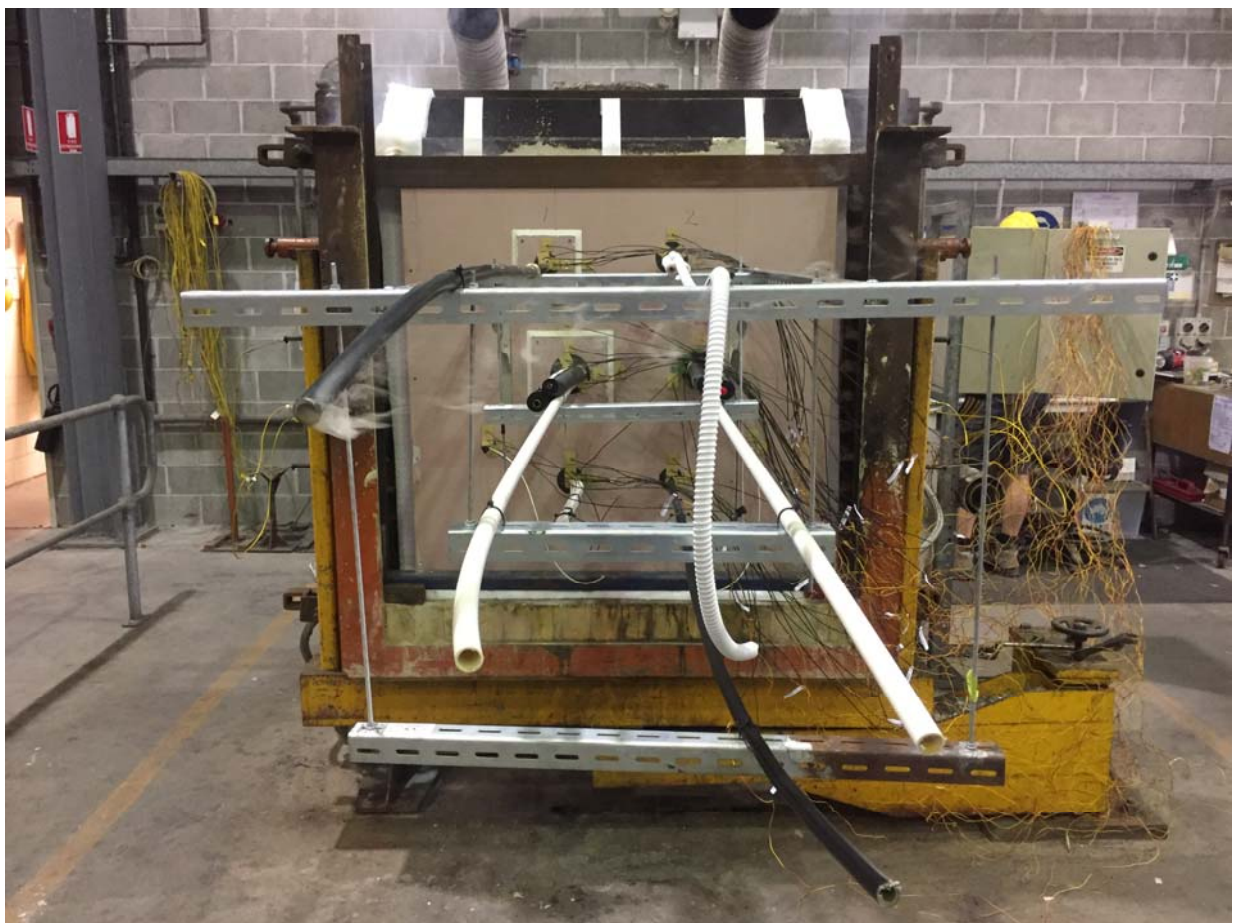
PHOTOGRAPH 4 – SPECIMENS AFTER 30 MINUTES OF TESTING

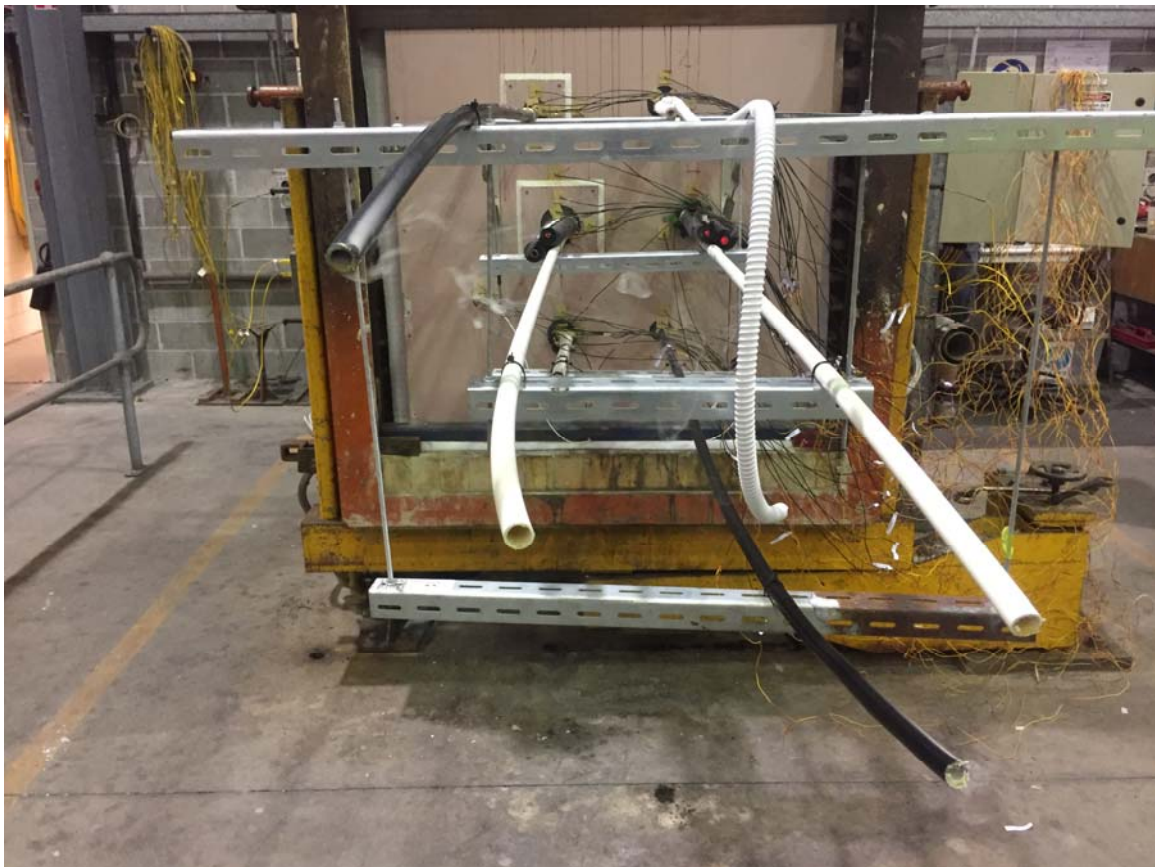
PHOTOGRAPH 6 – SPECIMENS AT THE CONCLUSION OF TESTING - 60 MINUTES

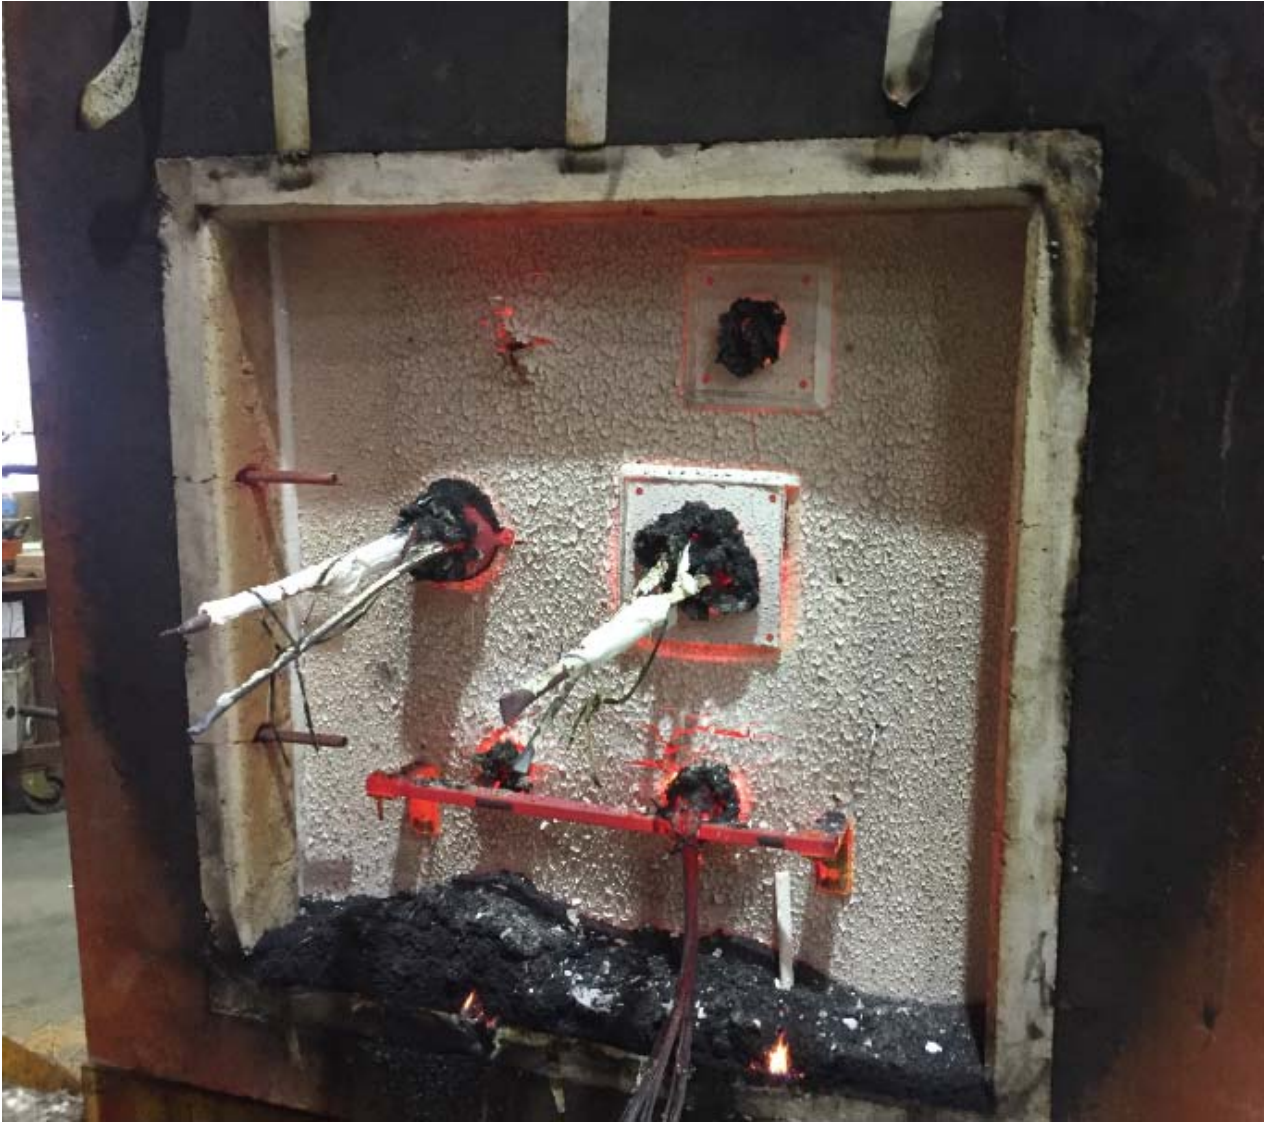
PHOTOGRAPH 7 – EXPOSED FACE OF THE SPECIMENS AFTER THE CONCLUSION OF TESTING

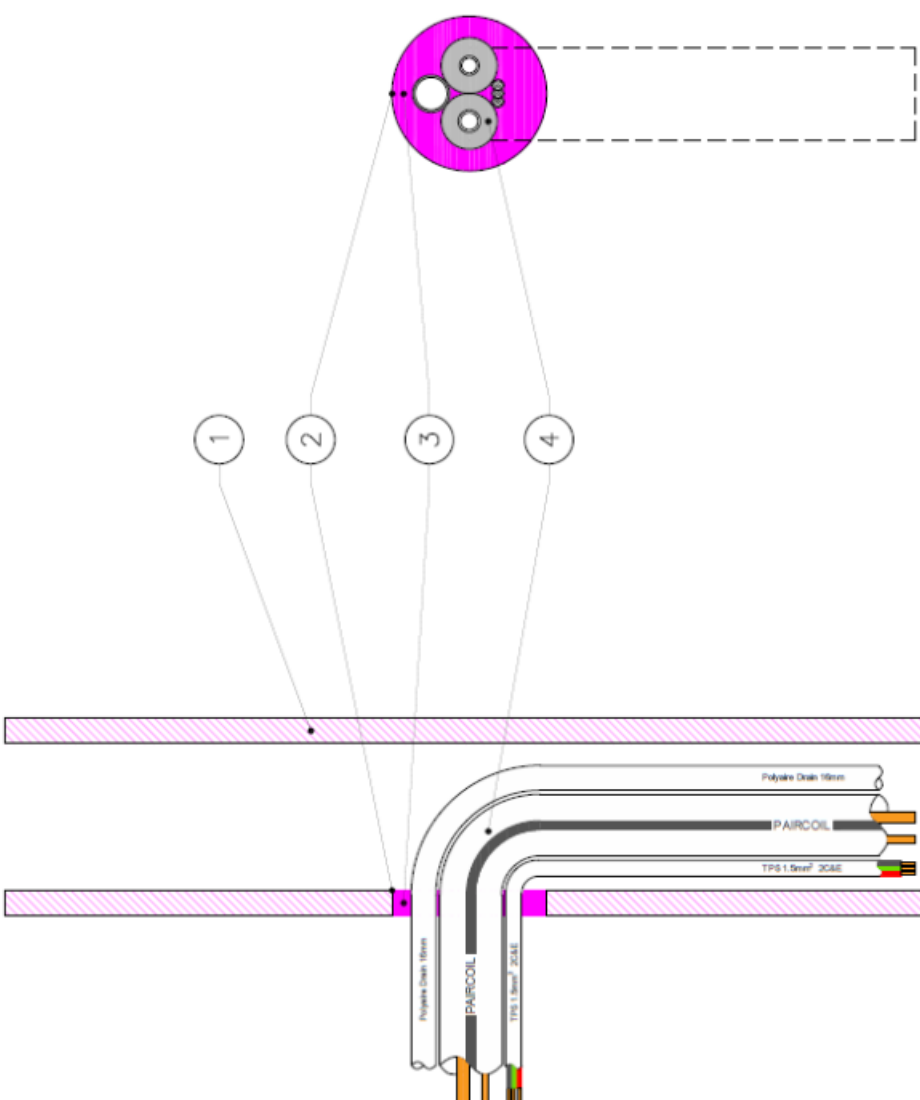
DRAWING NUMBER CSIRO 0117 -03 DATED 23 FEBRUARY, BY BOSS FIRE & SAFETY

Notes	<p>Component Summary:</p> <ul style="list-style-type: none"> (1) Plasterboard, 13mm Fire-rated (2) Hole Size 80mm minimum (3) BOSS FireMastic-HPE seal, 13mm deep (4) Services bundle comprising $\frac{1}{4}$" - $\frac{3}{8}$" paircoil with white "non-rated" insulation, 1.5mm² 3-core TPS cable and 16mm corrugated uPVC drain 	<p>BOSS FIRE AND SAFETY</p> <p>Sales & Technical Support Ph: 1300 502 677 www.bossfire.com.au</p>	<p>Drawing Title Paicoil Cluster 1-Sided Fire Seal</p>	<p>Description FireMastic-HPE installed 1 side only</p>	<p>Test Ref CSIRO 0117</p>	<p>Date of Issue 23 February 2017</p>	<p>Drawing Number CSIRO 0117 - 03</p> <p>Drawn By SL</p>

Drawing	CSIRO 0117 – 03 dated 23/02/17 by Boss Fire & Safety.
