# Fire-resistance test on service penetrations in a panel wall system

## Test Report

**Report number:** FSV 1731

**Client:** H.B. Fuller Company Australia Pty Ltd

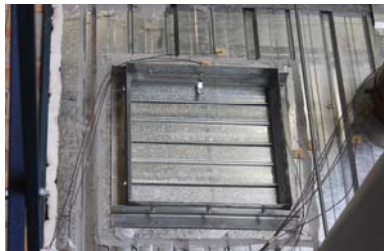
| SEPERATING ELEMENT | |
|---|---|
| Photograph | |

| SEPERATING ELEMENT | |
|---|---|
| Description | The damper casing was made from 1.5-mm thick roll formed stainless steel. The curtain consisted of 0.9-mm thick stainless steel slats. The slats were nominally 75-mm high x the full width of the damper and were positioned central to the depth of the casing. The curtain was restrained in place by a fusible link rated at 70°C. |
| Installation | The cut-out in the wall was lined with 83-mm wide x 58-mm high x 1.2-mm thick Speedpanel C-track, and the interface to the wall was sealed with Fullers Firesound sealant. The damper was retained in the opening using 35-mm x 50-mm steel angles fixed to the damper casing on both sides of the wall using 10g lag screws |

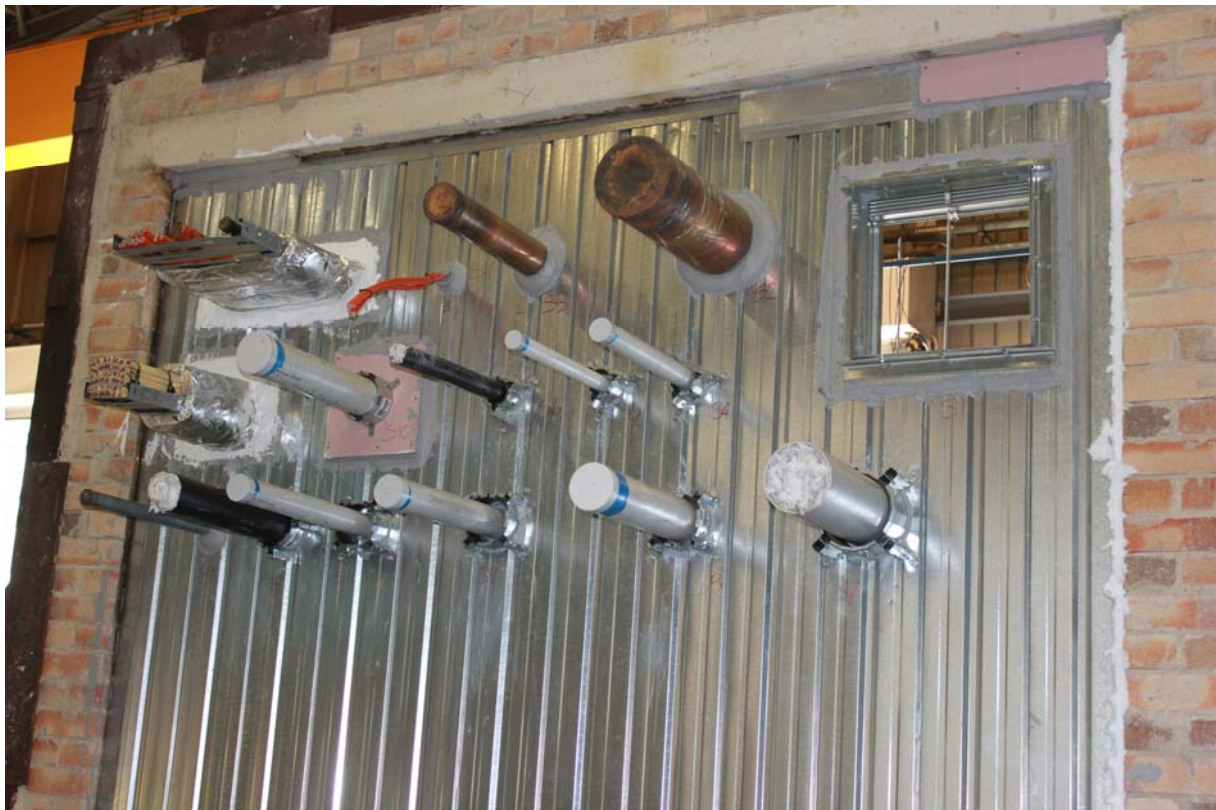
PHOTOGRAPH 1 – EXPOSED FACE OF THE SPECIMEN PRIOR TO TEST

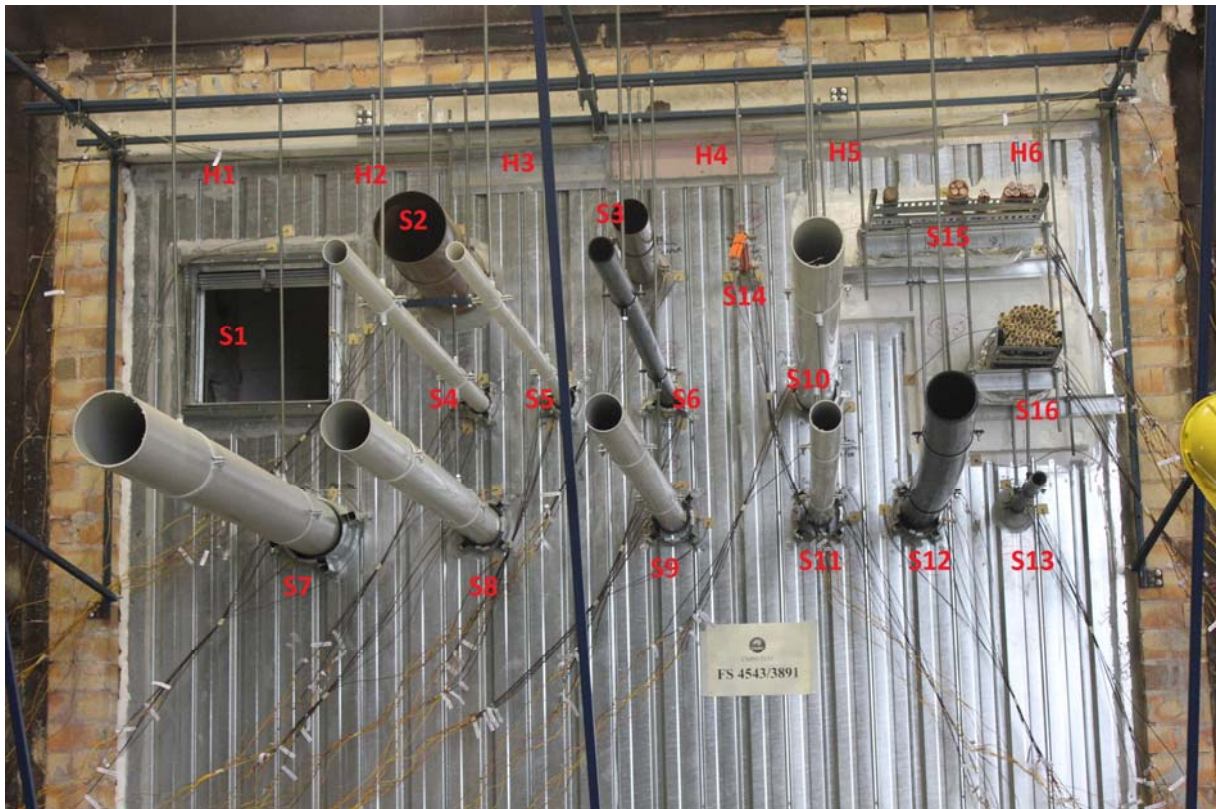
PHOTOGRAPH 2 – UNEXPOSED FACE OF THE SPECIMEN PRIOR TO TESTING

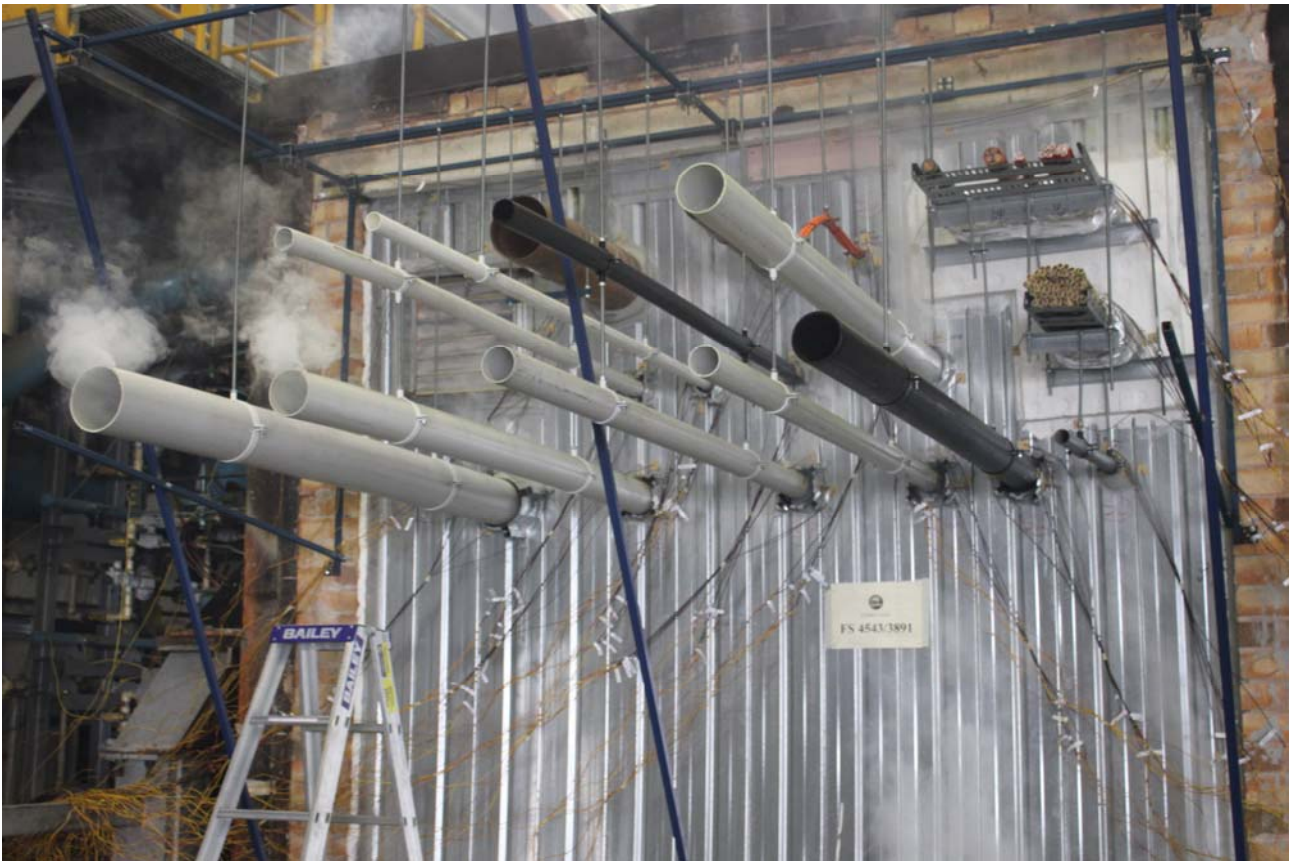
**PHOTOGRAPH 3 – SPECIMENS AT 31 MINUTES INTO THE TEST**

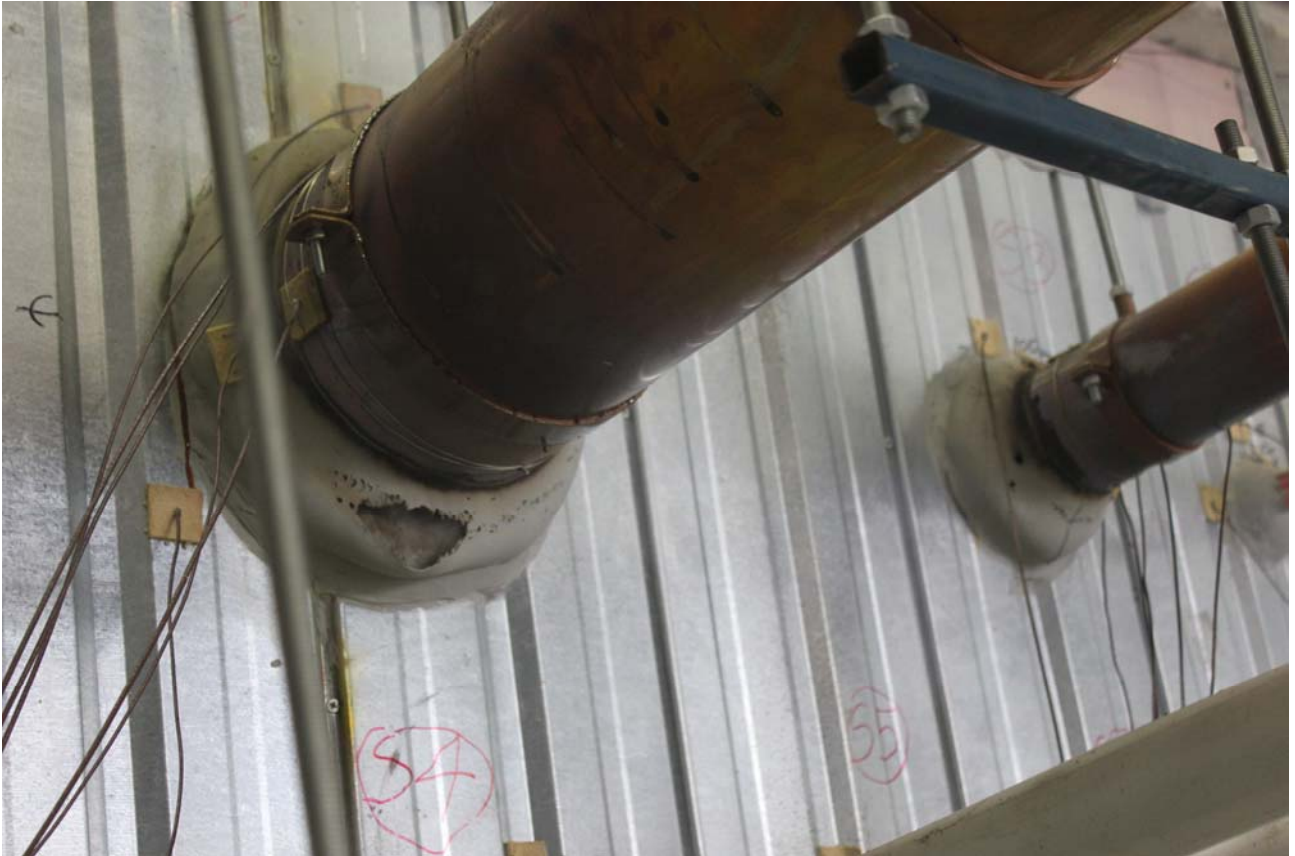
**PHOTOGRAPH 4 – SPECIMENS 2 & 3 AT 53 MINUTES INTO THE TEST**

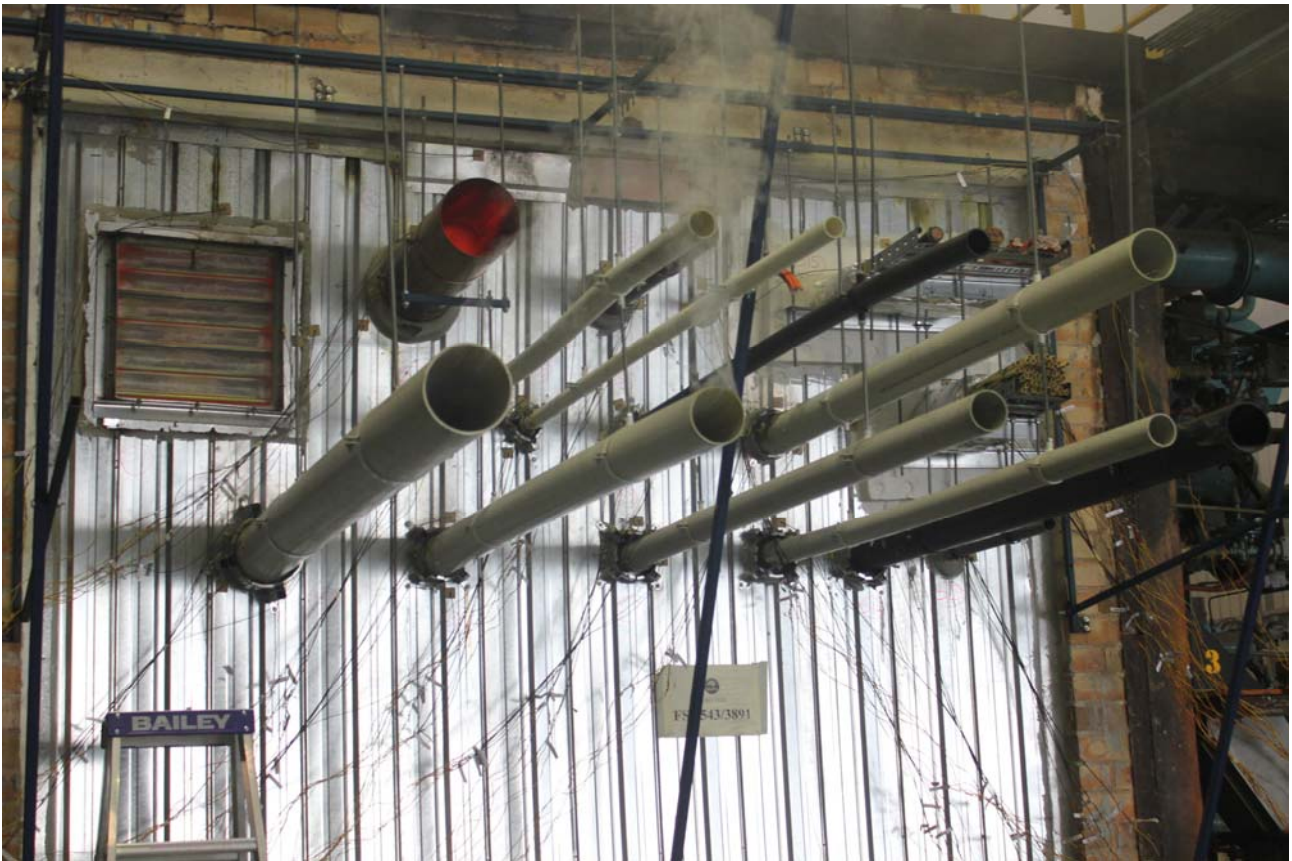
**PHOTOGRAPH 5 – SPECIMENS AT 60 MINUTES INTO THE TEST**

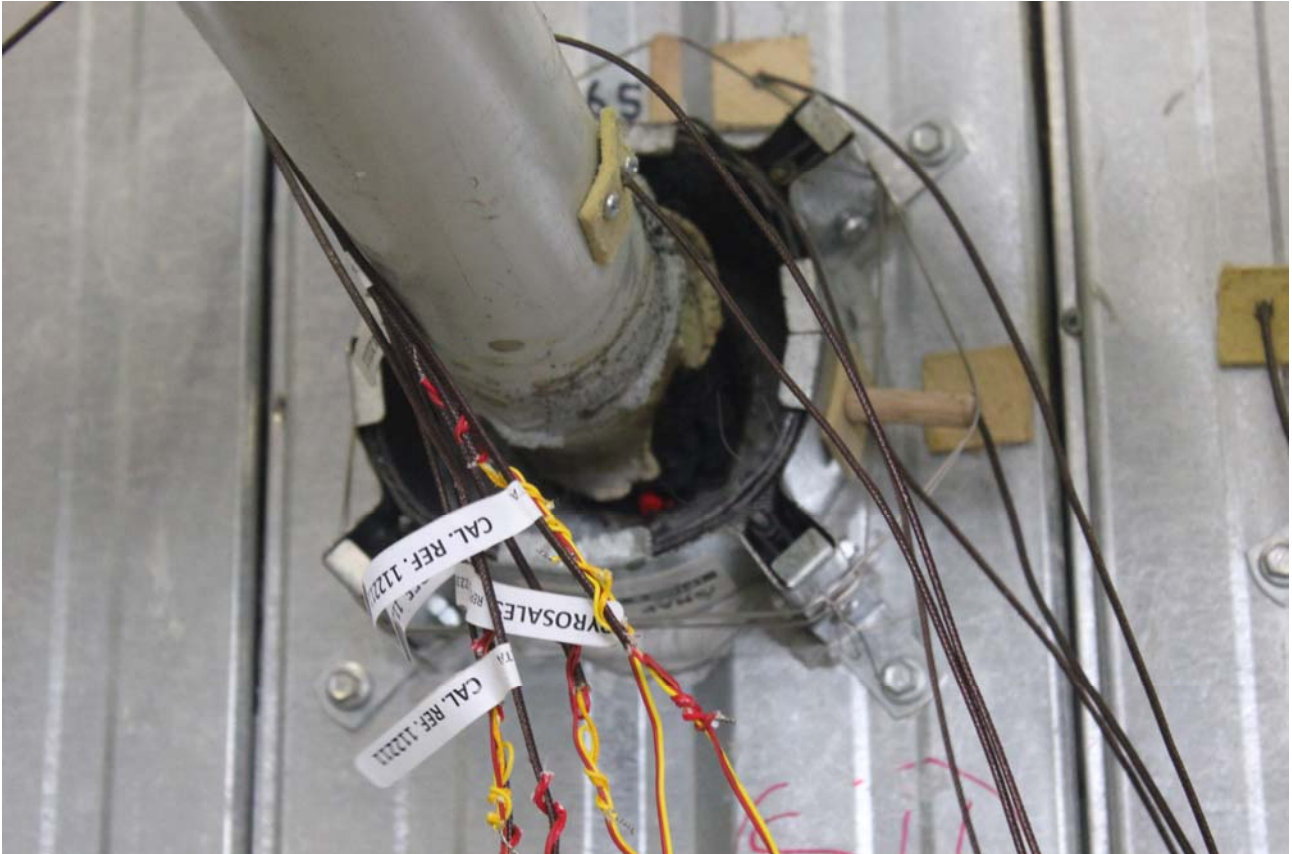
**PHOTOGRAPH 6 – SPECIMEN 11 AT 61 MINUTES INTO THE TEST**

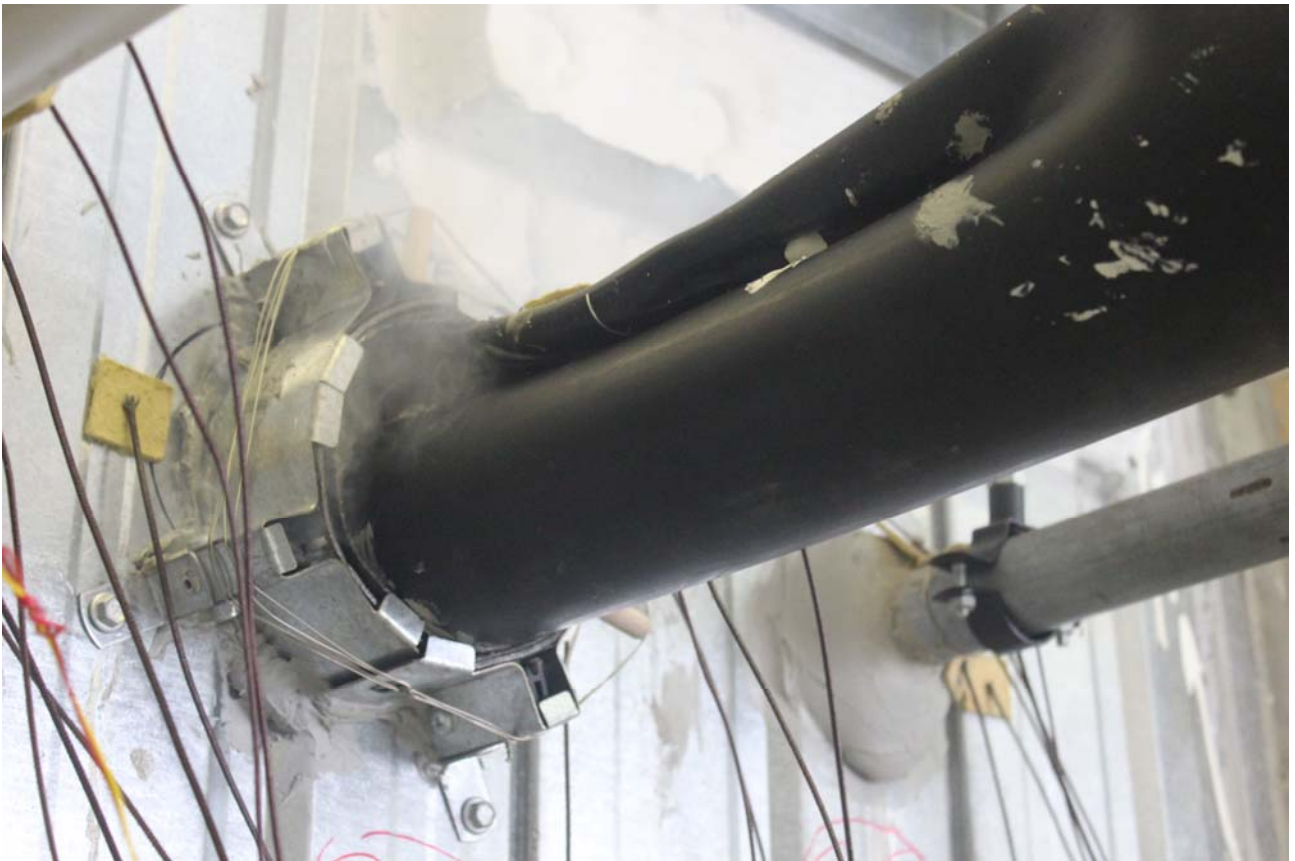
**PHOTOGRAPH 7 – SPECIMEN 12 AT 71 MINUTES INTO THE TEST**

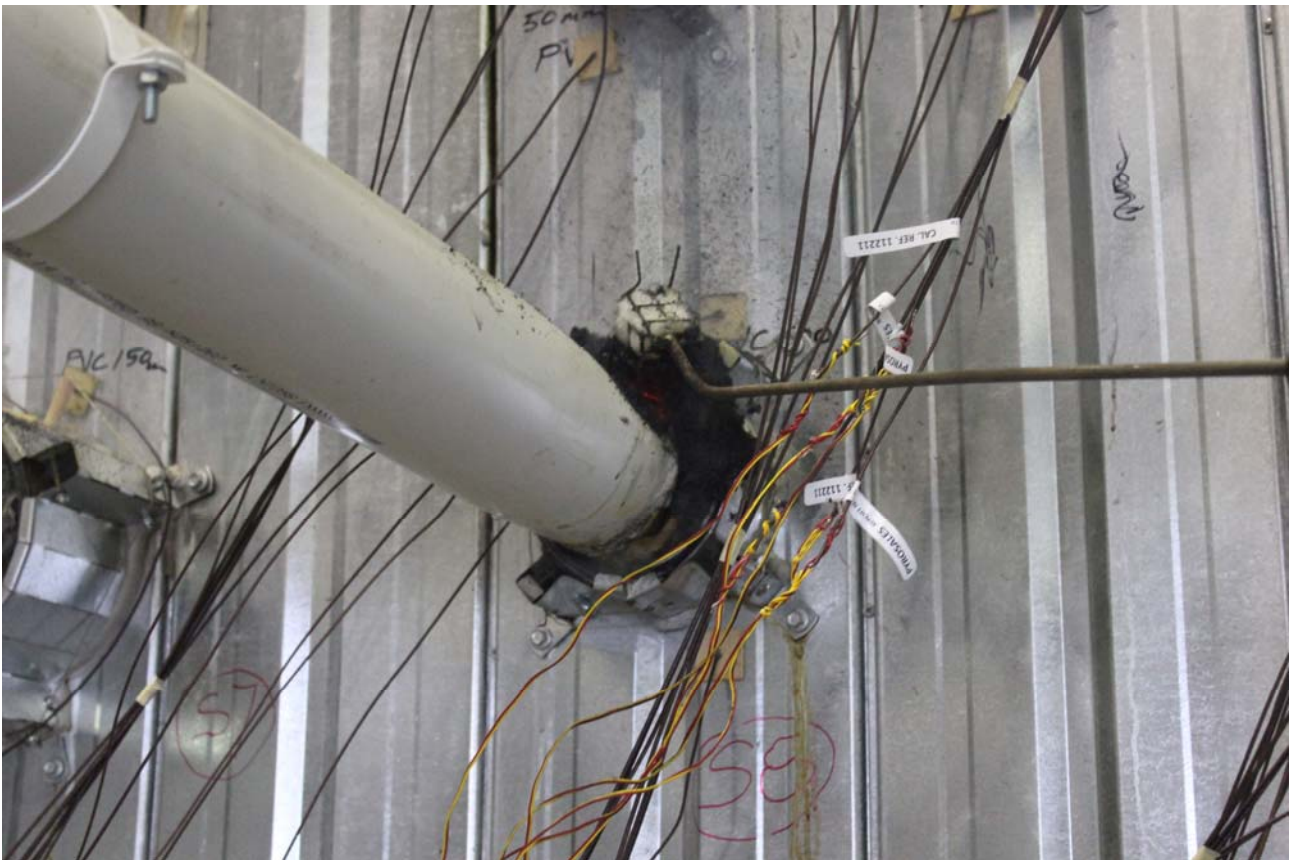
**PHOTOGRAPH 8 – SPECIMEN 8 AT 72 MINUTES INTO THE TEST**

- 74 minutes - Integrity Failure of Specimen 8 - cotton wool pad test applied over the glow near the fire collar – ignition of cotton noted.
- 76 minutes - Insulation Failure of Specimen 8 – maximum temperature rise of 180 degrees Celsius is exceeded on top of the collar.

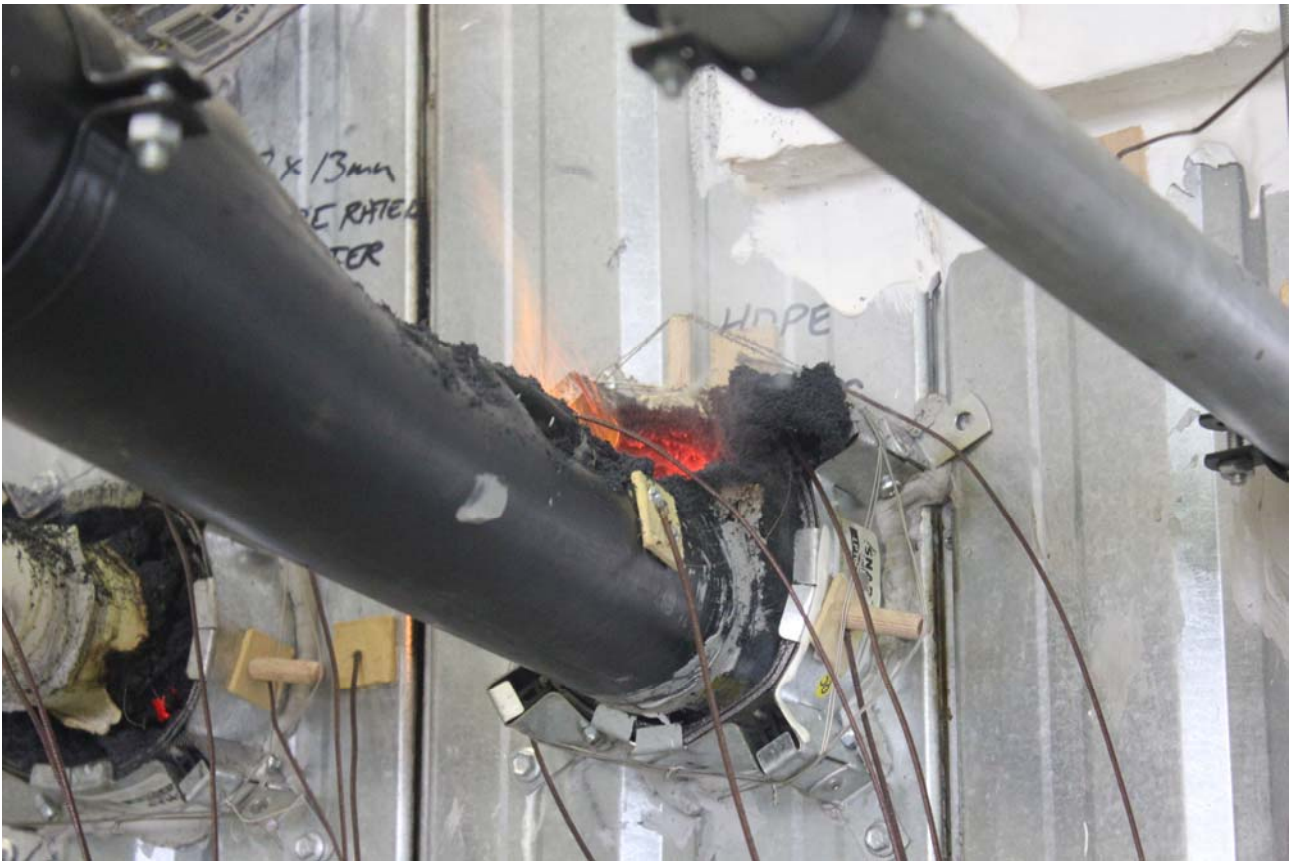
**PHOTOGRAPH 9 – SPECIMEN 12 AT 80 MINUTES INTO THE TEST**

- Intumescent in the fire collar of Specimen 5 is starting to swell.
- 77 minutes - Integrity Failure of Specimen 12 - cotton wool pad test applied over the glow near the fire collar – ignition of cotton noted (photograph 9).

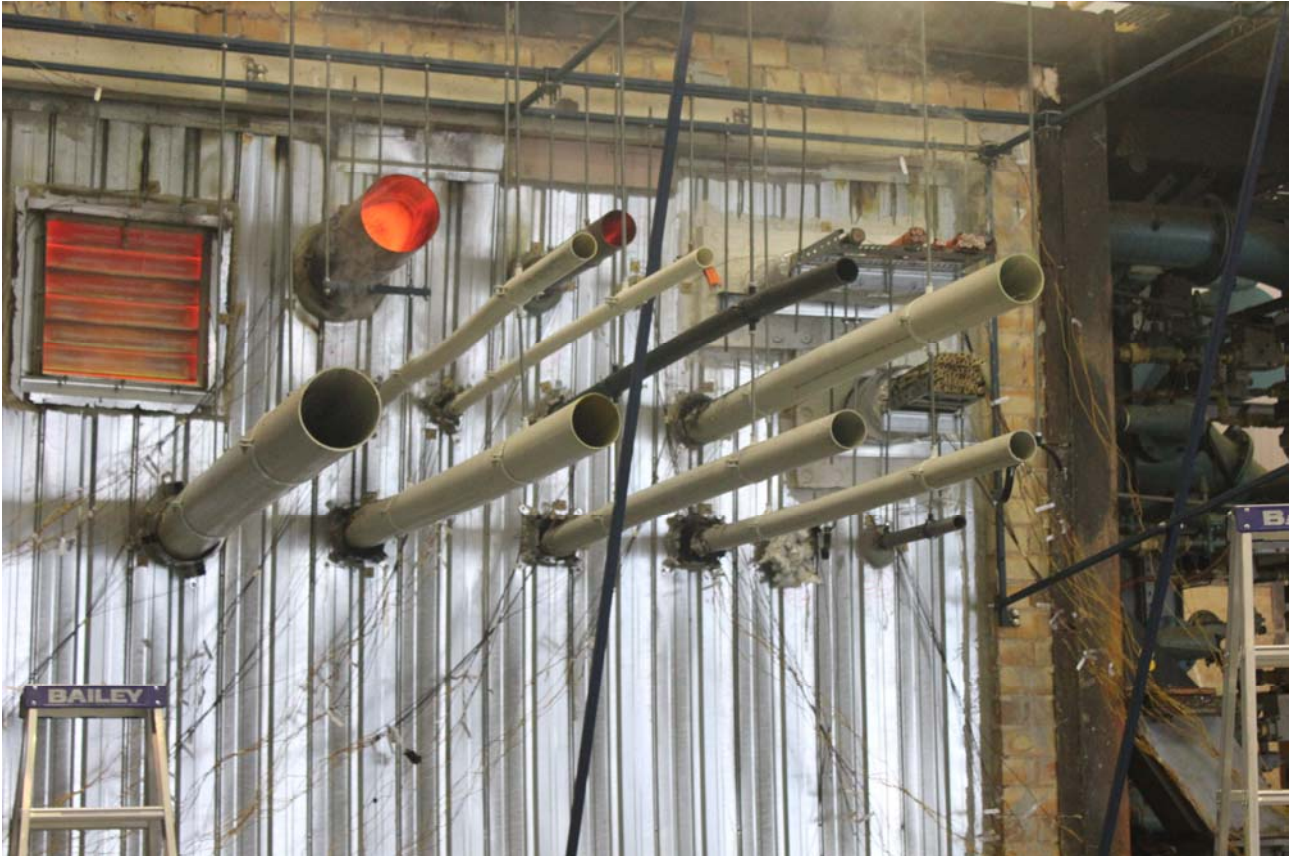
**PHOTOGRAPH 10 – SPECIMENS AT 90 MINUTES INTO THE TEST**

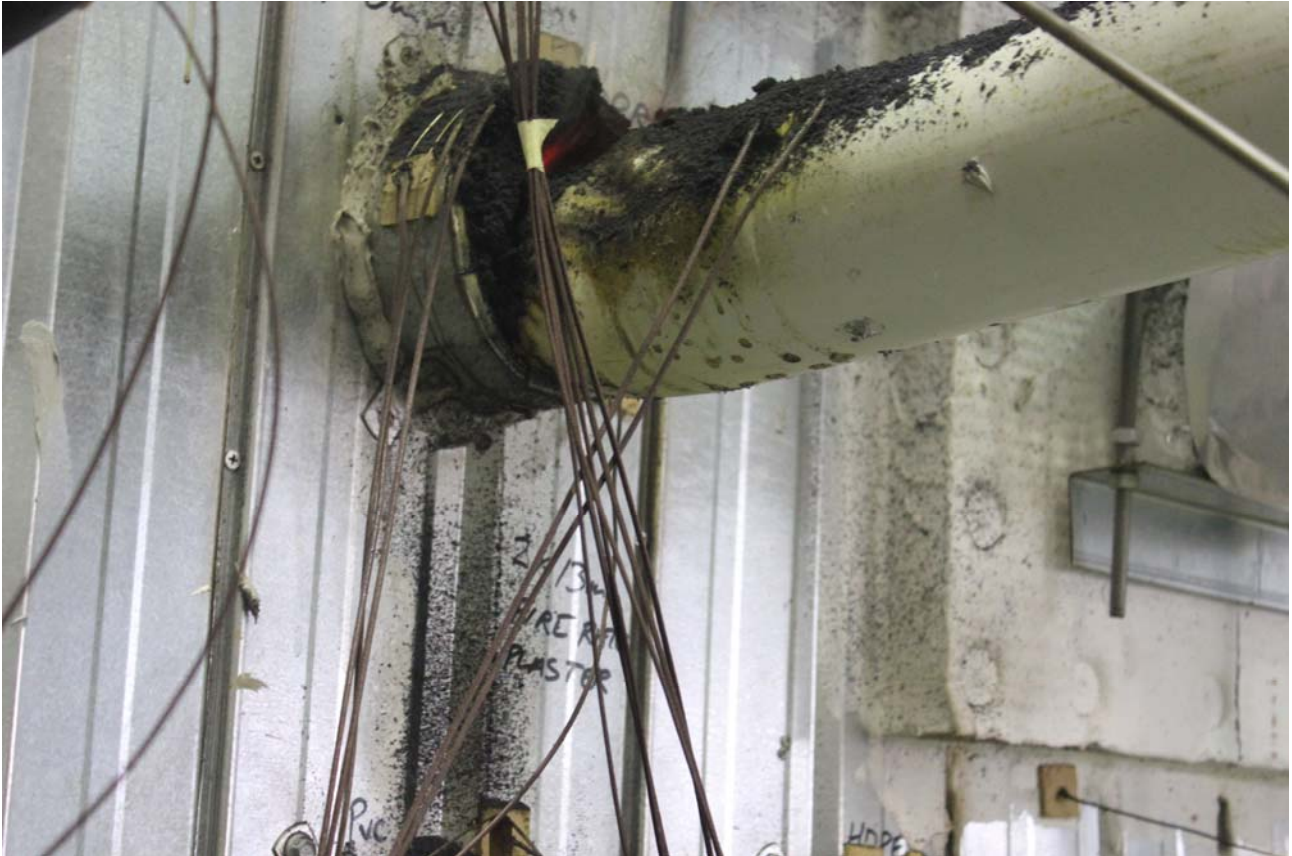
**PHOTOGRAPH 12 – SPECIMEN 10 AT 113 MINUTES INTO THE TEST**

- 114 minutes - Cotton wool pad test applied over the glow near the fire collar of Specimen 10 – no ignition of cotton noted.
- 115 minutes - Insulation Failure of Specimen 7 – maximum temperature rise of 180 degrees Celsius is exceeded on the wall, 25-mm above the sealant.

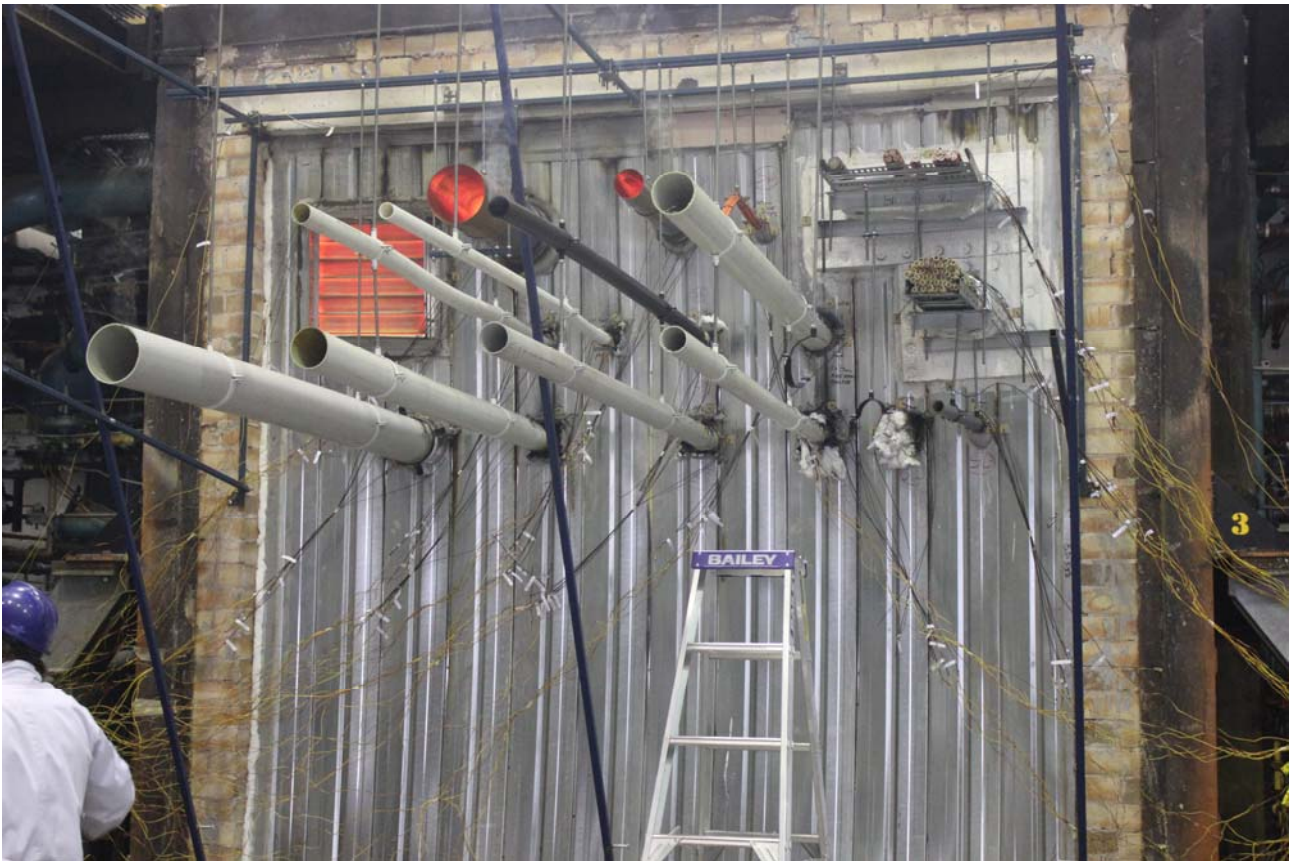
**PHOTOGRAPH 13 – SPECIMENS AT THE CONCLUSION OF TESTING**

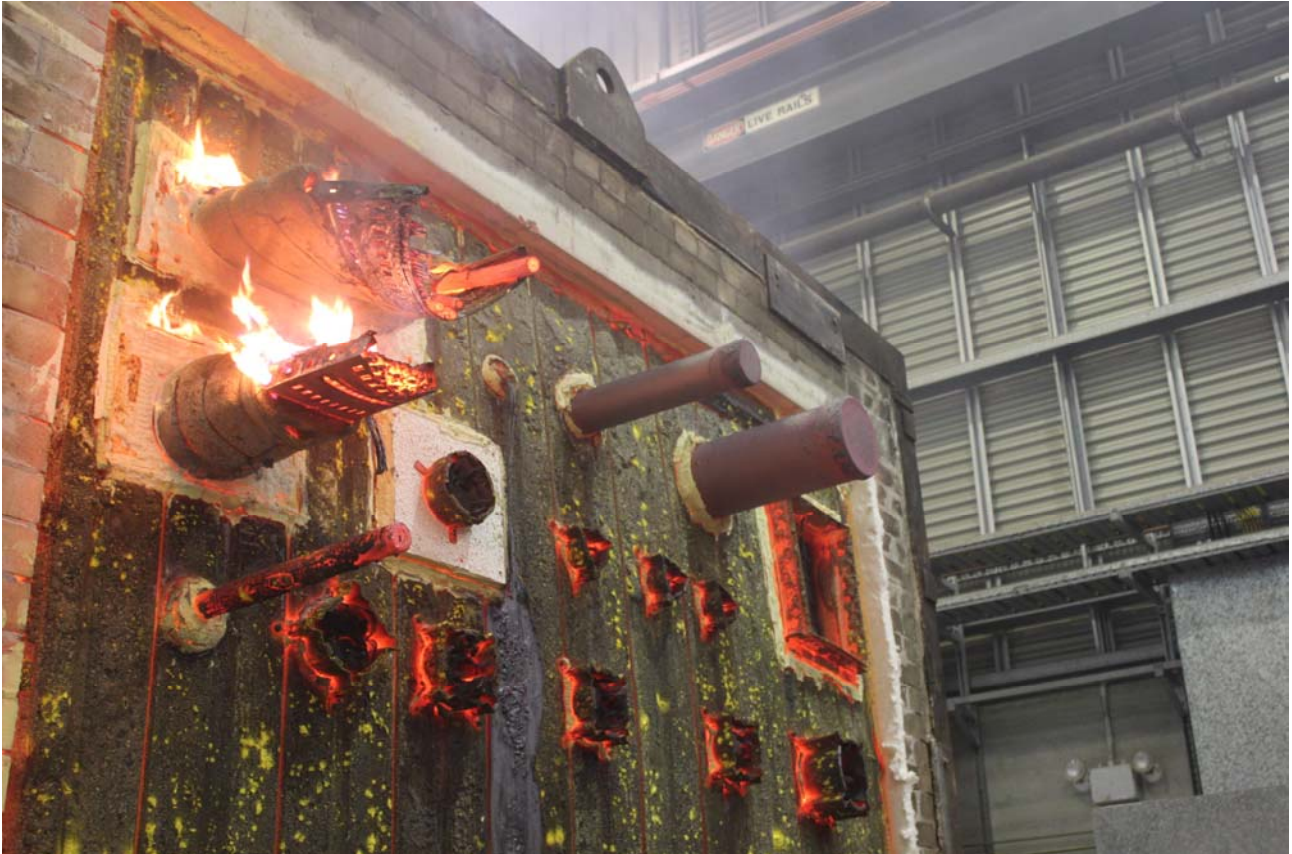
**PHOTOGRAPH 14 – EXPOSED FACE OF THE SPECIMEN AFTER THE CONCLUSION OF TESTING**
