Test report # PF22053

Client: Boss Products (Australia) Pty Ltd

**Fire resistance test for service penetrations
through vertical separating element**

Test method: AS 1530.4:2014

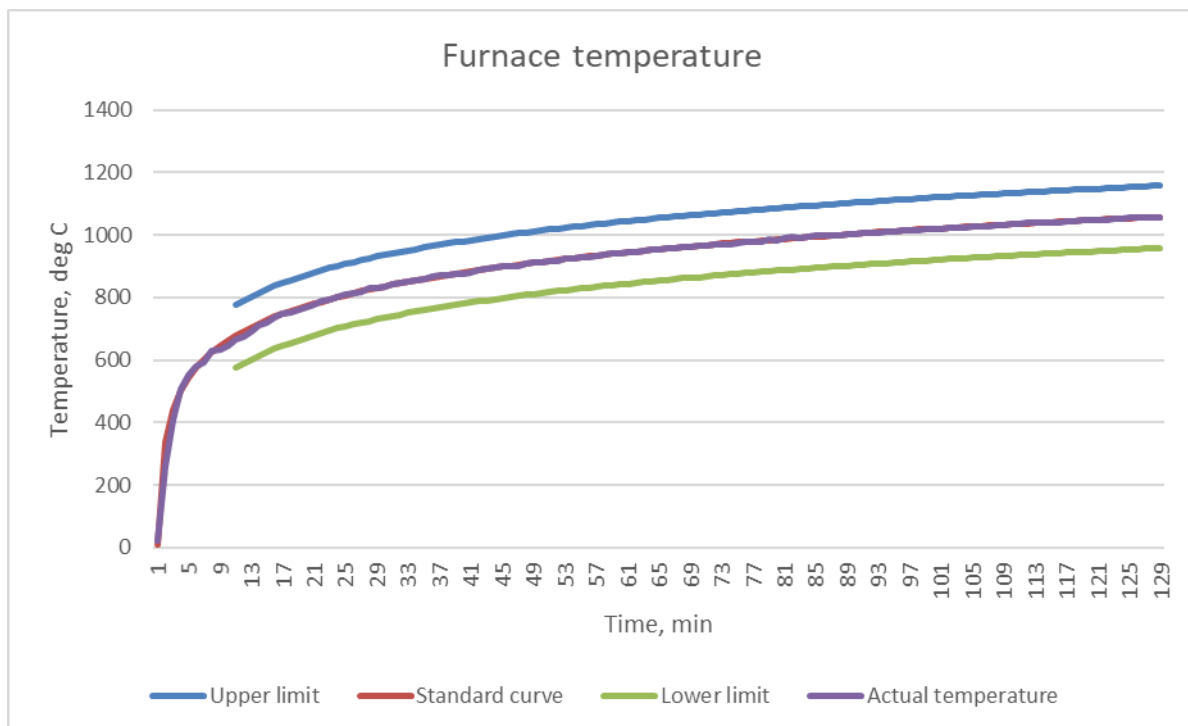
The furnace was controlled to follow the temperature/time relationship specified in AS 1530.4-2014.

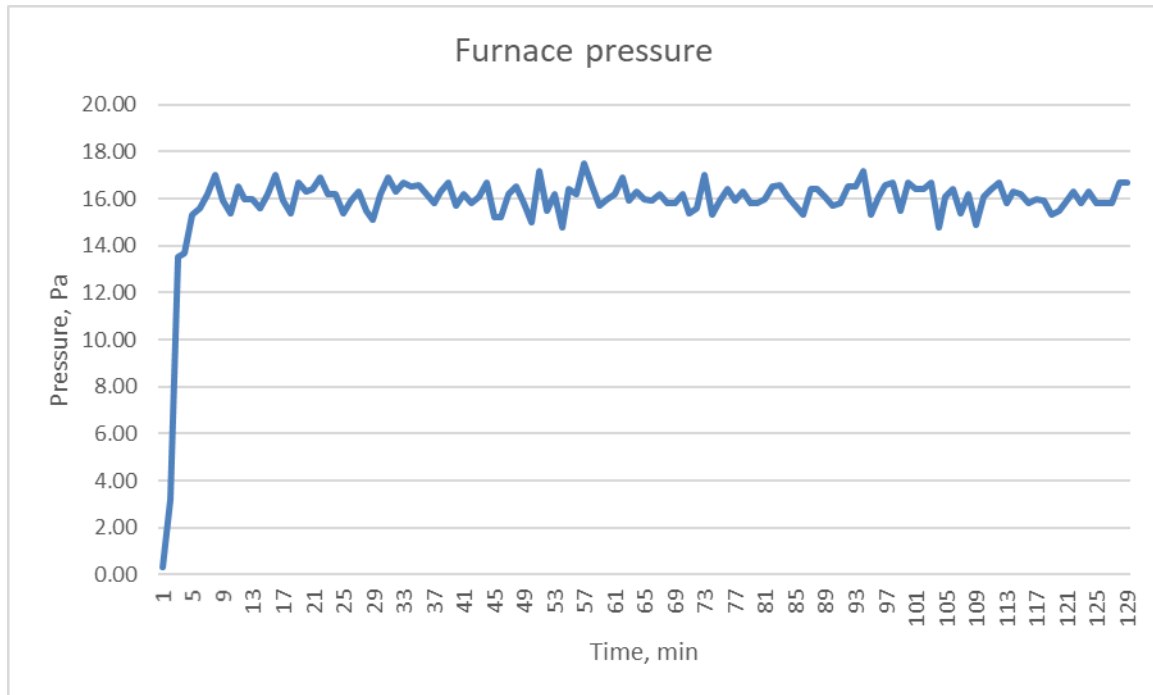
The probe was located 500mm above the furnace floor.

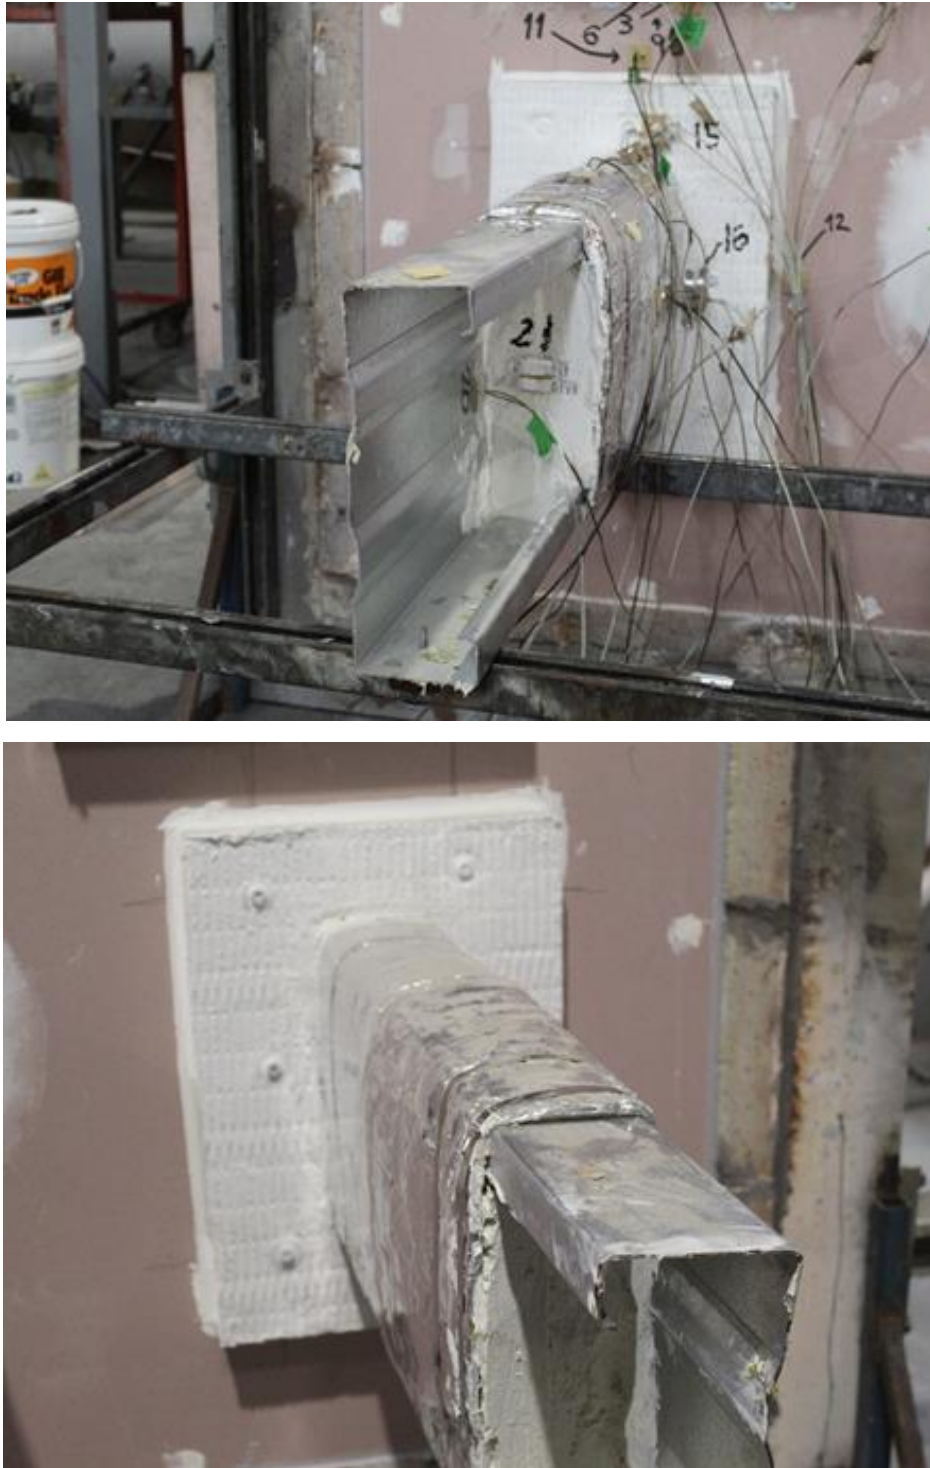
Fig. 3 – Unexposed and exposed face.

Penetration System		
	Service	HST300/15 C-Purlin
	Service Details	Purlin (2.2), Sealant (3.1), Sealant (3.2), Screws (4.6), Screws (4.7), Batt (5.1), Wrap (5.2)
	Service Support	Unistrut structure at 300mm and 750mm from separating element
	Aperture Size	170mm x 325mm
	Annular Spacing	Min: 0mm, Max: 35mm
	Local Fire-stopping Protection	
	Application	Symmetrical
	Protection Used	<p>The specimen was installed by client representatives, and observed by the laboratory. The Purlin (2.2) was inserted into the aperture, resting on the separating element, protruding 820mm from both faces of the separating element. Two batts (5.1) were trimmed to a size of 350mm x 475mm. The profile of the purlin was traced onto the batt, and cut along the profile. The exposed edges of the batt were painted with ablative coating (3.2). The batts were then placed around the purlin, pressed against the separating element. A bead of sealant (3.1) was applied between the batt and the separating element, beneath the batt. The batts were fixed to the separating element using six screws (4.6) and washers (4.7), approximately 125mm from the vertical edges of the batt. A bead of sealant was applied around the perimeter of the batt and the separating element.</p> <p>Two batts were inserted into the purlin opening, extending 580mm from the batt around the purlin. Exposed edges were painted with ablative coating. A bead of sealant was applied between the batts and the inside of the purlin.</p> <p>The purlin was wrapped with 1 layer of wrap (5.2), overlapping by 50mm. The wrap extended 300mm from the separating element. A second layer of wrap was installed on the purlin, overlapping the first layer by 20mm, and overlapping itself by 50mm. The junction between layers was joined with aluminium foil tape. The total length of the wrap extended 580mm from the batt around the purlin. The wrap was secured around the purlin with steel cable ties at 100mm, 480mm and 530mm from the batt around the purlin. A bead of sealant was applied between the wrap and the batt fixed to the separating element.</p>

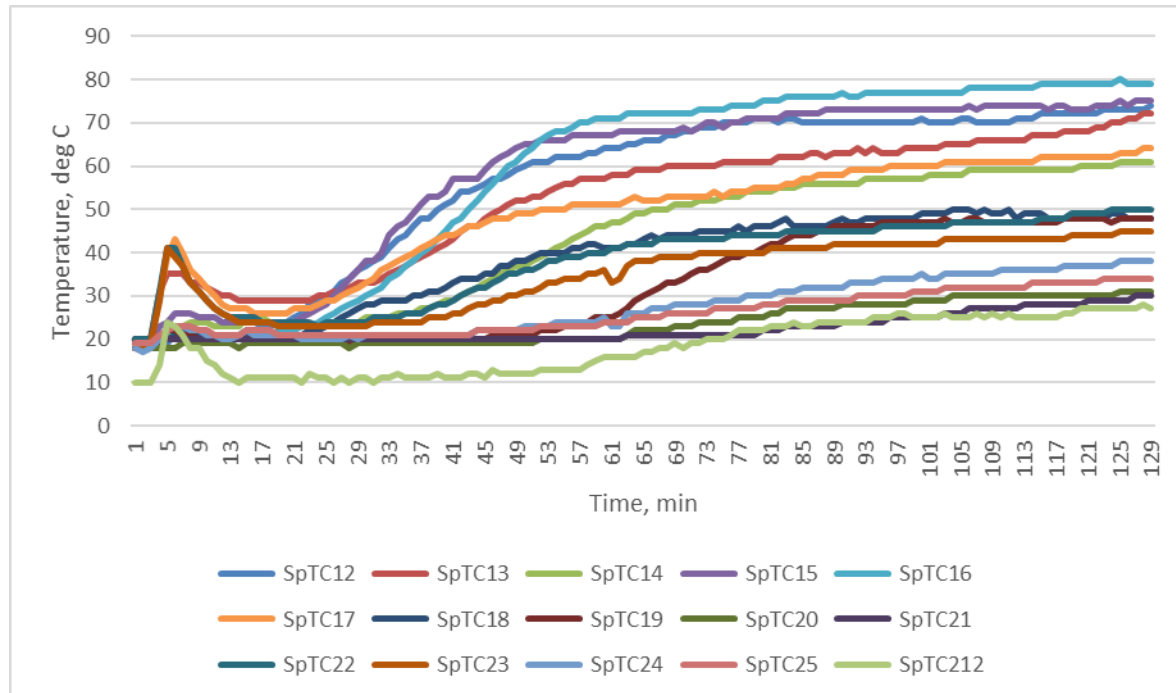
Fig. 4 –Thermocouples readings.

Structural adequacy	Not applicable
Integrity	No failure at 128 min
Insulation	No failure at 128 min

TC#	THERMOCOUPLE LOCATION DESCRIPTION
11	On separating element, mid-width of Batt, 25mm above the Batt
12	On separating element, mid-height of Batt, 25mm left of the Batt
13	On top edge of Batt, mid-width of batt, mid-depth of batt
14	On right edge of Batt, mid-height of batt, mid-depth of batt
15	On Batt, mid-width of batt, 25mm below top edge of batt
16	On Batt, mid-height of batt, 25mm left of right edge of batt
17	On top side of wrap, mid-width of purlin, 25mm from the batt
18	On right side of wrap, mid-height of purlin, 25mm from the batt
19	On top side of purlin, mid-width of purlin, 25mm from end of wrap
20	On right side of purlin, inside channel opening, mid-height of purlin, 25mm from end of wrap
21	On batts within purlin, mid-width of batts, mid height of batts
22	On top side of wrap, mid-width of purlin, 255mm from the batt
23	On right side of wrap, mid-height of purlin, 255mm from the batt

24	On top side of wrap, mid-width of purlin, 305mm from the batt
25	On right side of wrap, mid-height of purlin, 305mm from the batt
212	On top side of wrap, mid-width of purlin, 555mm from the batt
211	On separating element, mid-width of Specimen C, mid-height of specimen A
