Regulatory information report

Penetration systems tested in accordance with AS 1530.4:2014

Test sponsor: BOSS Fire & Safety P/L

Job number: RIR-FRT180137

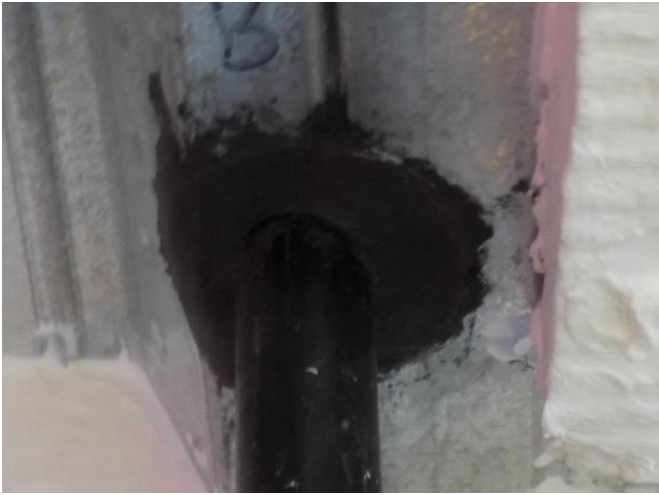
Penetration system B		
B	Service	32mm PEX-A pipe
	Service detail	The service protruded 500mm on the exposed side and 2000mm on the unexposed side. The pipe was capped with BOSS FireMastic – 300™ on the exposed side. The service penetrated the thickest part of the separating element. The location of the service related to the composite floor deck is shown below:

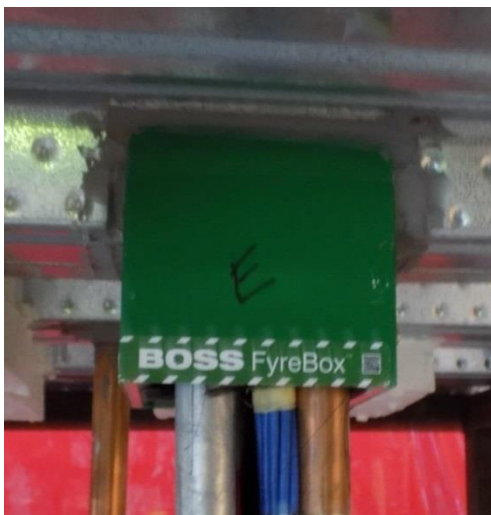
Item	Description	
	Installation	<p>The annular gap between the service and the separating element was filled with BOSS FireMastic -300™ at the depth of 5mm and finished flush on the unexposed side.</p> <p>The annular gap between the service and the BOSS Batt was filled with BOSS FireMastic – 300™ at the depth of 5mm and finished flush on the exposed side.</p> <p>BOSS 100mm MaxiCollar™ were installed on the exposed and secured to the BOSS Batt with pig tail screws.</p> <p>See Figure 2 and Figure 7 in Appendix A for more details.</p>
Penetration System E		
E	Service	Bundle of cables and pipes in BOSS Fire box
	Service component	<ul style="list-style-type: none"> • 8 x Power cable – 3 Core 2.5mm² • 15 x CAT6 data cables • 15 x FireSense cables • Ardent Copper Fire Rated Pair Coil 13mm 1/4" x 3/825mm UPVC conduit • Power cable – 3 Core 2.5mm² • 32mm galvanised sprinkler pipe • 32mm copper pipe
	Service detail	<p>The services protruded 500mm on the exposed side and 530mm (galvanised sprinkler pipe), 570mm (pair coil), 600mm (cables) & 2025mm (uPVC conduit) on the unexposed side.</p> <p>The galvanised sprinkler pipe was capped with metal plate on the exposed side.</p> <p>The pair coil was crimped at the end on the exposed side and sealed with BOSS FireMastic -300™.</p> <p>The uPVC conduit was capped with BOSS FireMastic – 300™.</p> <p>The service penetrated the thickest part of the separating element. The location of the service related to the composite floor deck is shown below:</p>

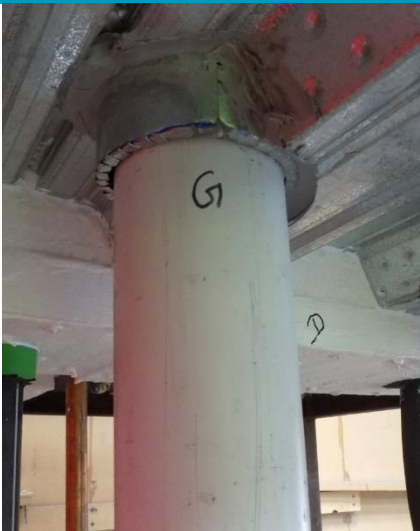
Service support	The service was supported by the pipe clamp at 300mm and 500mm from the separating element
	Aperture size	Ø34mm
	Annular gap	Nominal 1mm
	Local fire-stopping protection	
	Protection	BOSS FireMastic – 300™
	Installation	<p>The annular gap between the service and the separating element was filled with BOSS FireMastic – 300™ to a depth of 25mm and finished with 10mm x 10 fillet on both the exposed and unexposed side.</p> <p>See Figure 2 and Figure 9 in Appendix A for more details.</p>
	Penetration system G	
G	Service	100mm uPVC DWV pipe
	Service detail	<p>The service protruded 500mm on the exposed side and 2000mm on the unexposed side. The pipe was capped with uPVC cap on the exposed side.</p> <p>The service penetrated the on the web of the composite floor deck where half of the service penetrated on the top rib and half of the service penetrated on the bottom rib. The location of the service related to the composite floor deck is shown below.</p>

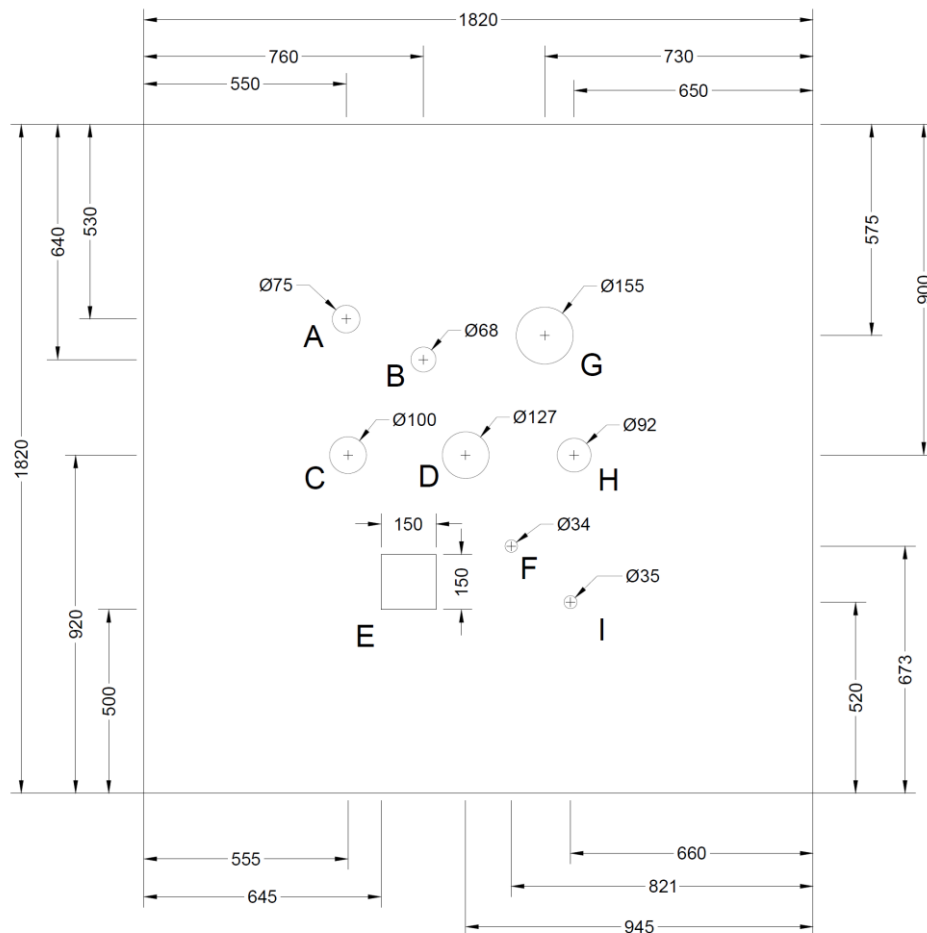
Figure 1 Plan view of test specimen (Core hole size and location on unexposed side)

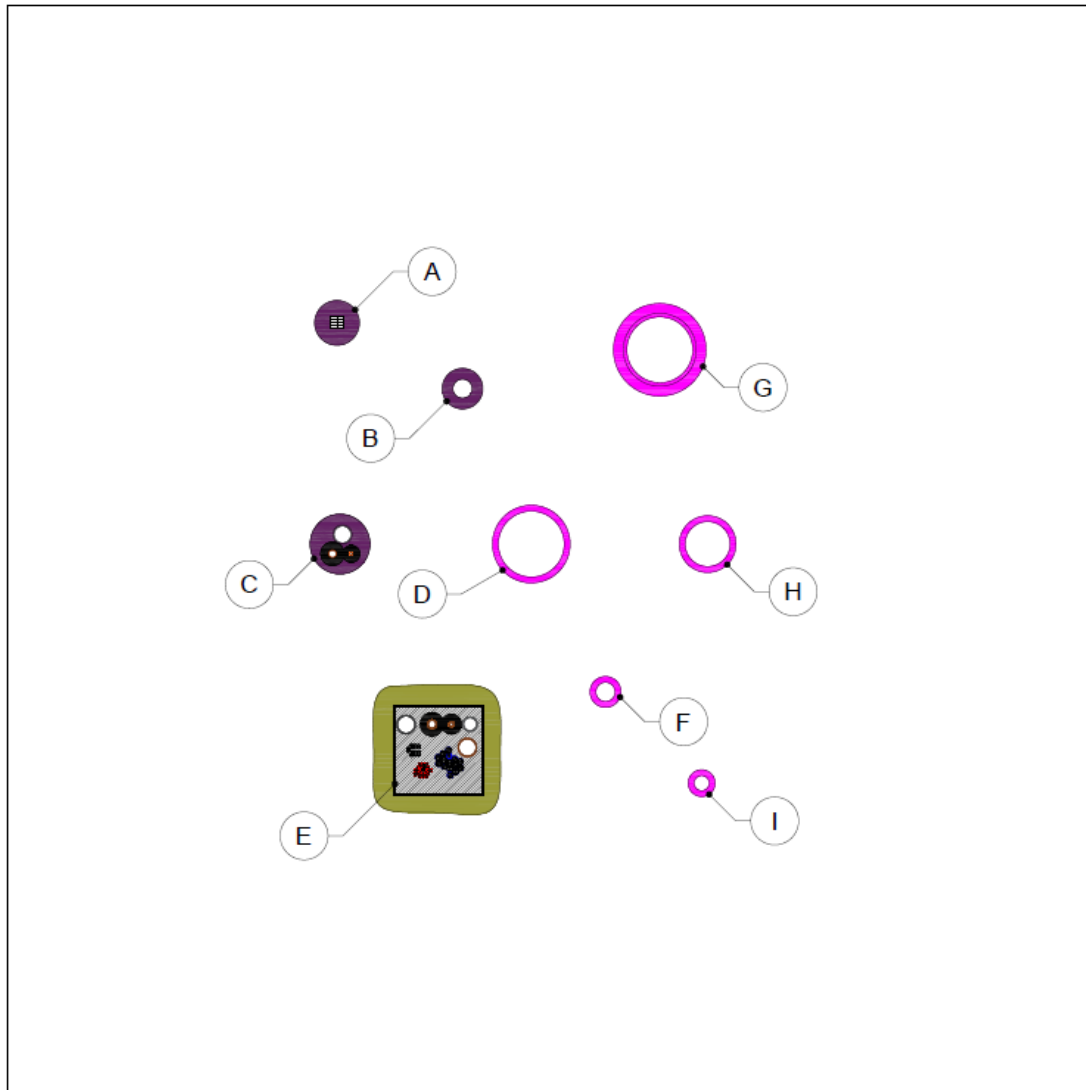
Figure 2 Plan view of test specimen (Unexposed side)

Item	Description	
	Service support	The service was supported by the pipe clamps on the unexposed side at 300mm and 500mm from the separating element
	Aperture size	Ø76mm
	Annual gap	Nominal 11.5mm
	Primary local fire-stopping protection	
	Protection	BOSS Batt
	Installation	270mm x 270mm BOSS Batt was installed on the bottom rib of the separating element. The gap between the Boss Batt and the top rib of the separating element was covered with trapezoid shape BOSS Batt. There was a Ø90mm x 25mm deep recess at the centre of the core hole at the exposed side.
	Secondary local fire-stopping protection	
	Protection	BOSS FireMastic – HPE™
	Installation	The annular gap between the service and the separating element was filled with BOSS FireMastic – HPE™ to a depth of 5mm and finished flush on the unexposed side. The recess between the service and the BOSS Batt was filled with BOSS FireMastic-HPE™ to a depth of 25mm (full depth of the recess) and finished flush on the exposed side. See Figure 2 and Figure 4 in Appendix A for more details.

Service support	The service was supported by the pipe clamp at 300mm and 1500mm from the separating element
	Aperture size	Ø155mm
	Annular gap	Nominal 27.5mm
	Local fire-stopping protection	
	Protection	BOSS DROP Collar (Three layers BOSS Intumescent strip) & BOSS FireMastic – 300™
	Installation	<p>The BOSS Drop in Collar was placed in from unexposed side & fixed with mechanical fixings.</p> <p>The BOSS FireMastic – 300™ was installed into the annular gap between the separating element, the service and the metal sleeve to a depth of 25mm. The mastic was finished flush on the unexposed side.</p> <p>The BOSS FireMastic – 300™ was installed into the annular gap between the separating element and the metal sleeve to a depth of 5mm depth. The mastic was finished following the profile of the composite floor deck.</p> <p>See Figure 2 and Figure 10 in Appendix A for more details.</p>

Protection	BOSS Batt
	Installation	265mm x 265mm BOSS Batt was installed on the bottom rib of the separating element. The gap between the Boss Batt and the top rib of the separating element was covered with trapezoid shape BOSS Batt
	Secondary local fire stopping protection	
	Protection	BOSS 32mm MaxiCollar™ & BOSS FireMastic - 300™
	Installation	<p>The annular gap between the service and the separating element was filled with BOSS FireMastic -300™ to a depth of 5mm and finished with 10mm x 10mm fillet on the unexposed side.</p> <p>The annular gap between the service and the BOSS Batt was filled with BOSS FireMastic – 300™ to a depth of 5mm and finished flush on the exposed side.</p> <p>BOSS 32mm MaxiCollar™ were installed on the exposed and secured to the BOSS Batt with pig tail screws.</p> <p>See Figure 2 and Figure 12 in Appendix A for more details.</p>

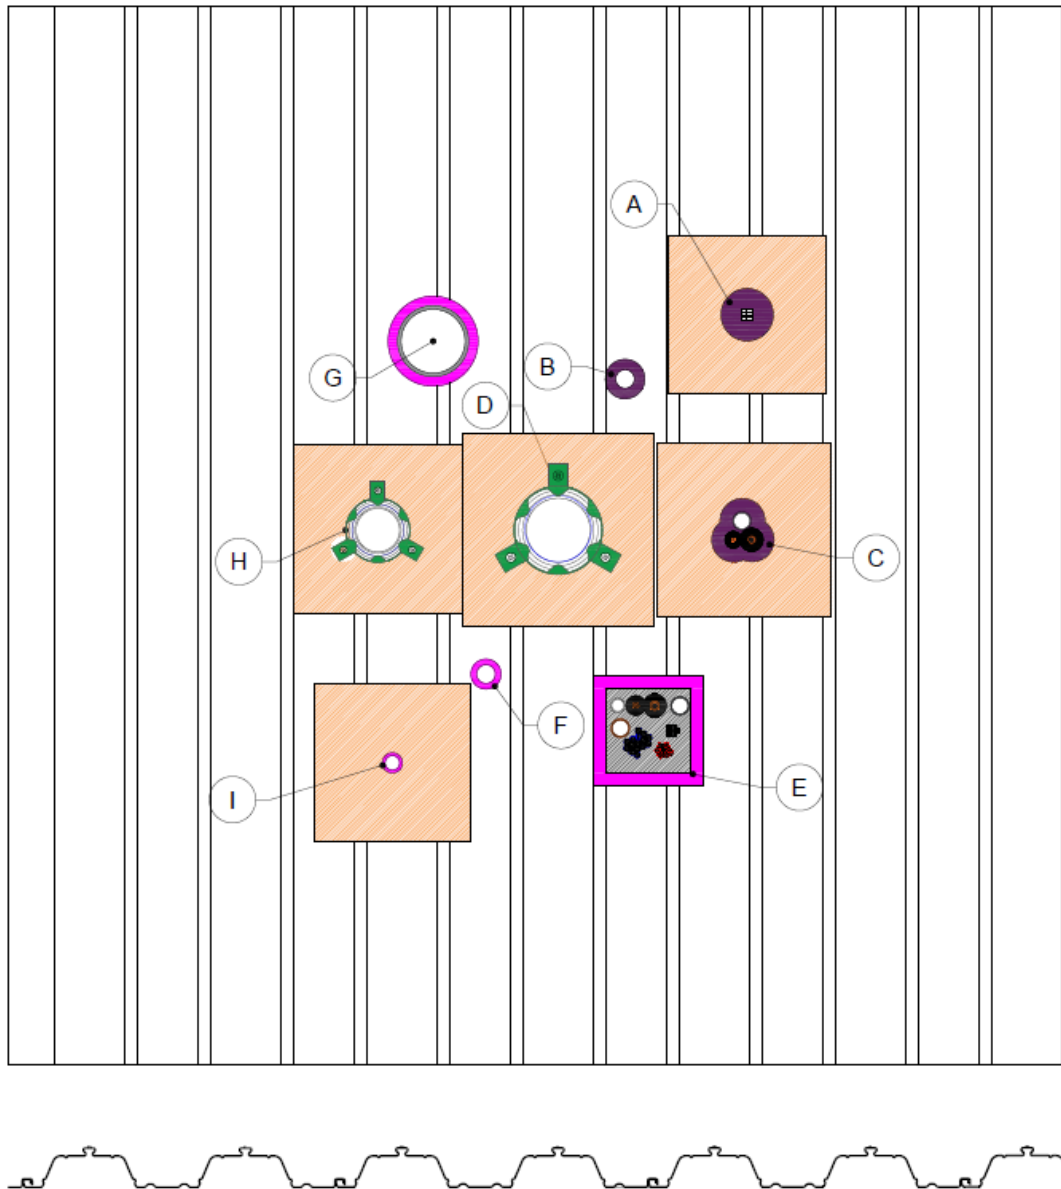
Figure 3 Plan view of test specimen (Unexposed side)

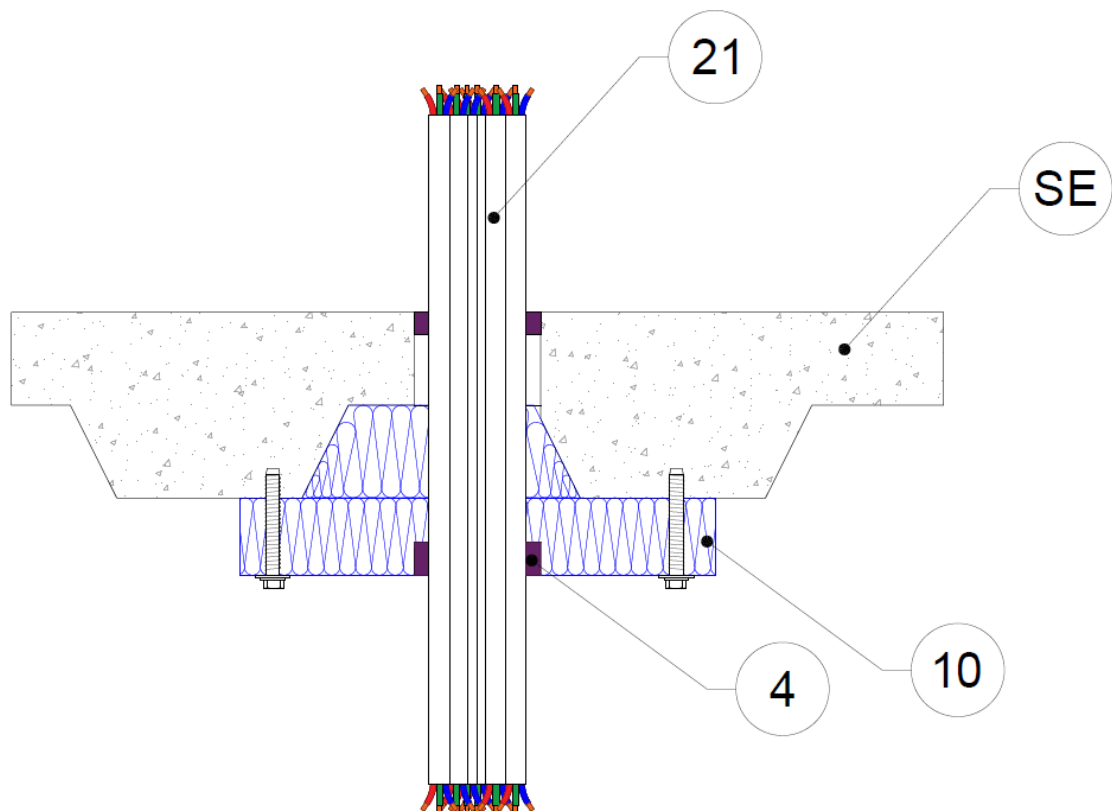
Figure 4 Cross-section Service A (drawing provided by client)

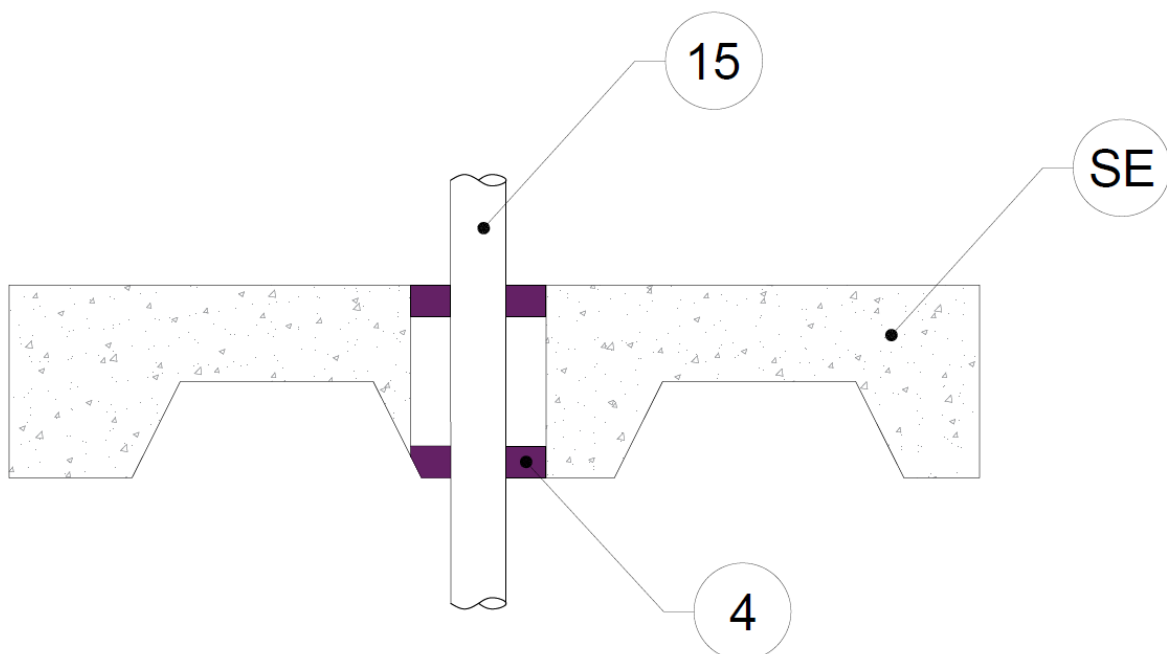
Figure 5 Cross-section Service B (drawing provided by client)

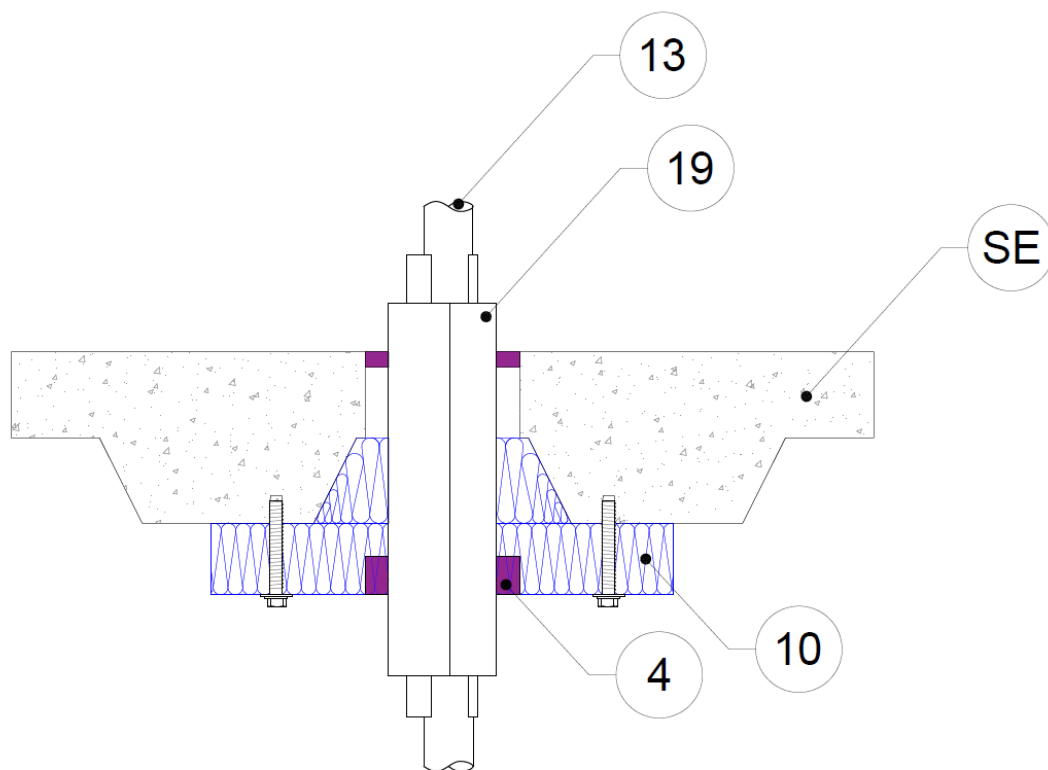
Figure 6 Cross-section Service C (drawing provided by client)

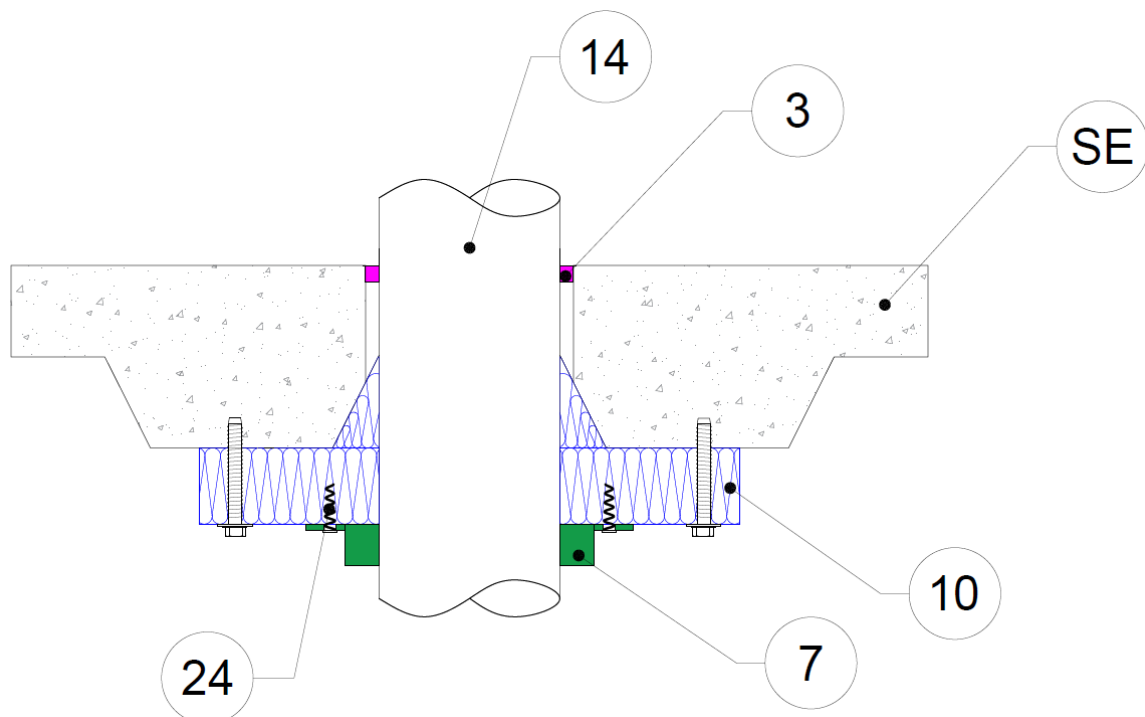
Figure 7 Cross-section Service D (drawing provided by client)

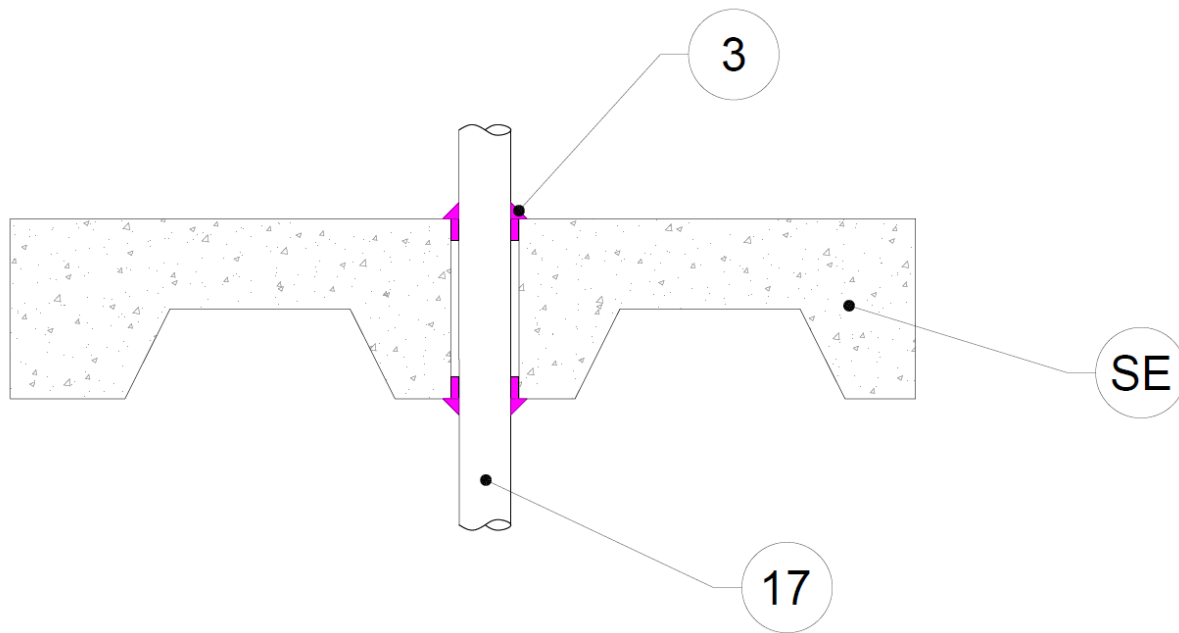
Figure 9 Cross-section Service F (drawing provided by client)

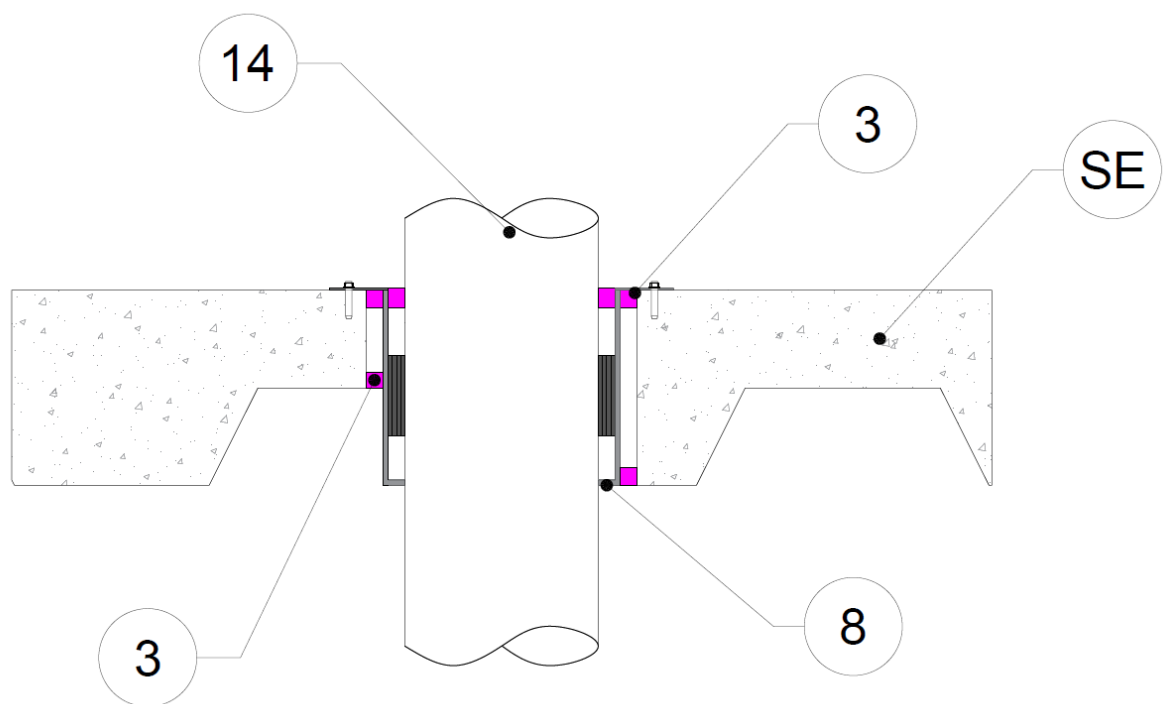
Figure 10 Cross-section Service G (drawing provided by client)

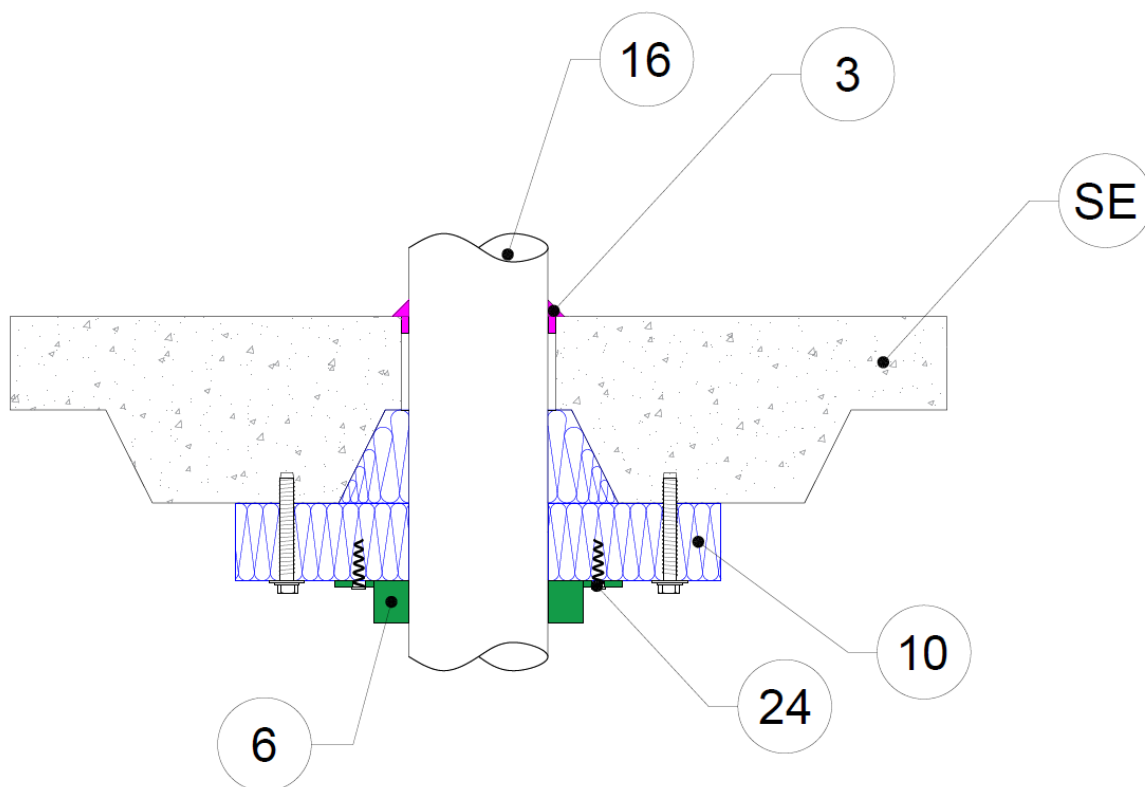
Figure 11 Cross-section Service H (drawing provided by client)

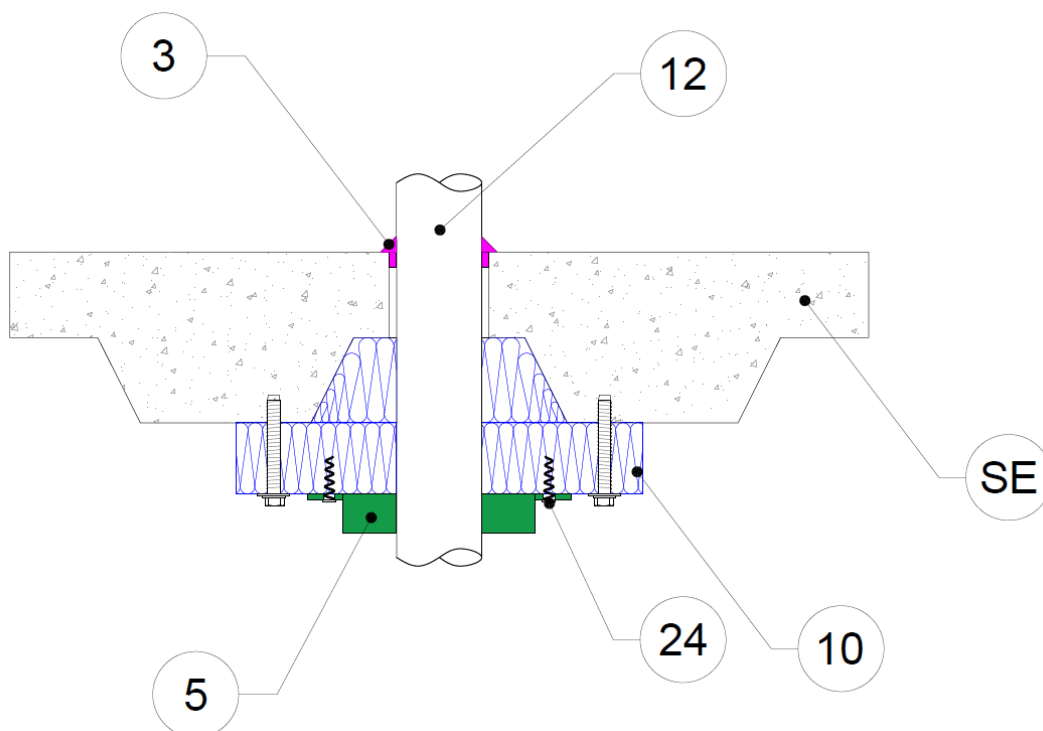
Figure 12 Cross-section Service I (drawing provided by client)

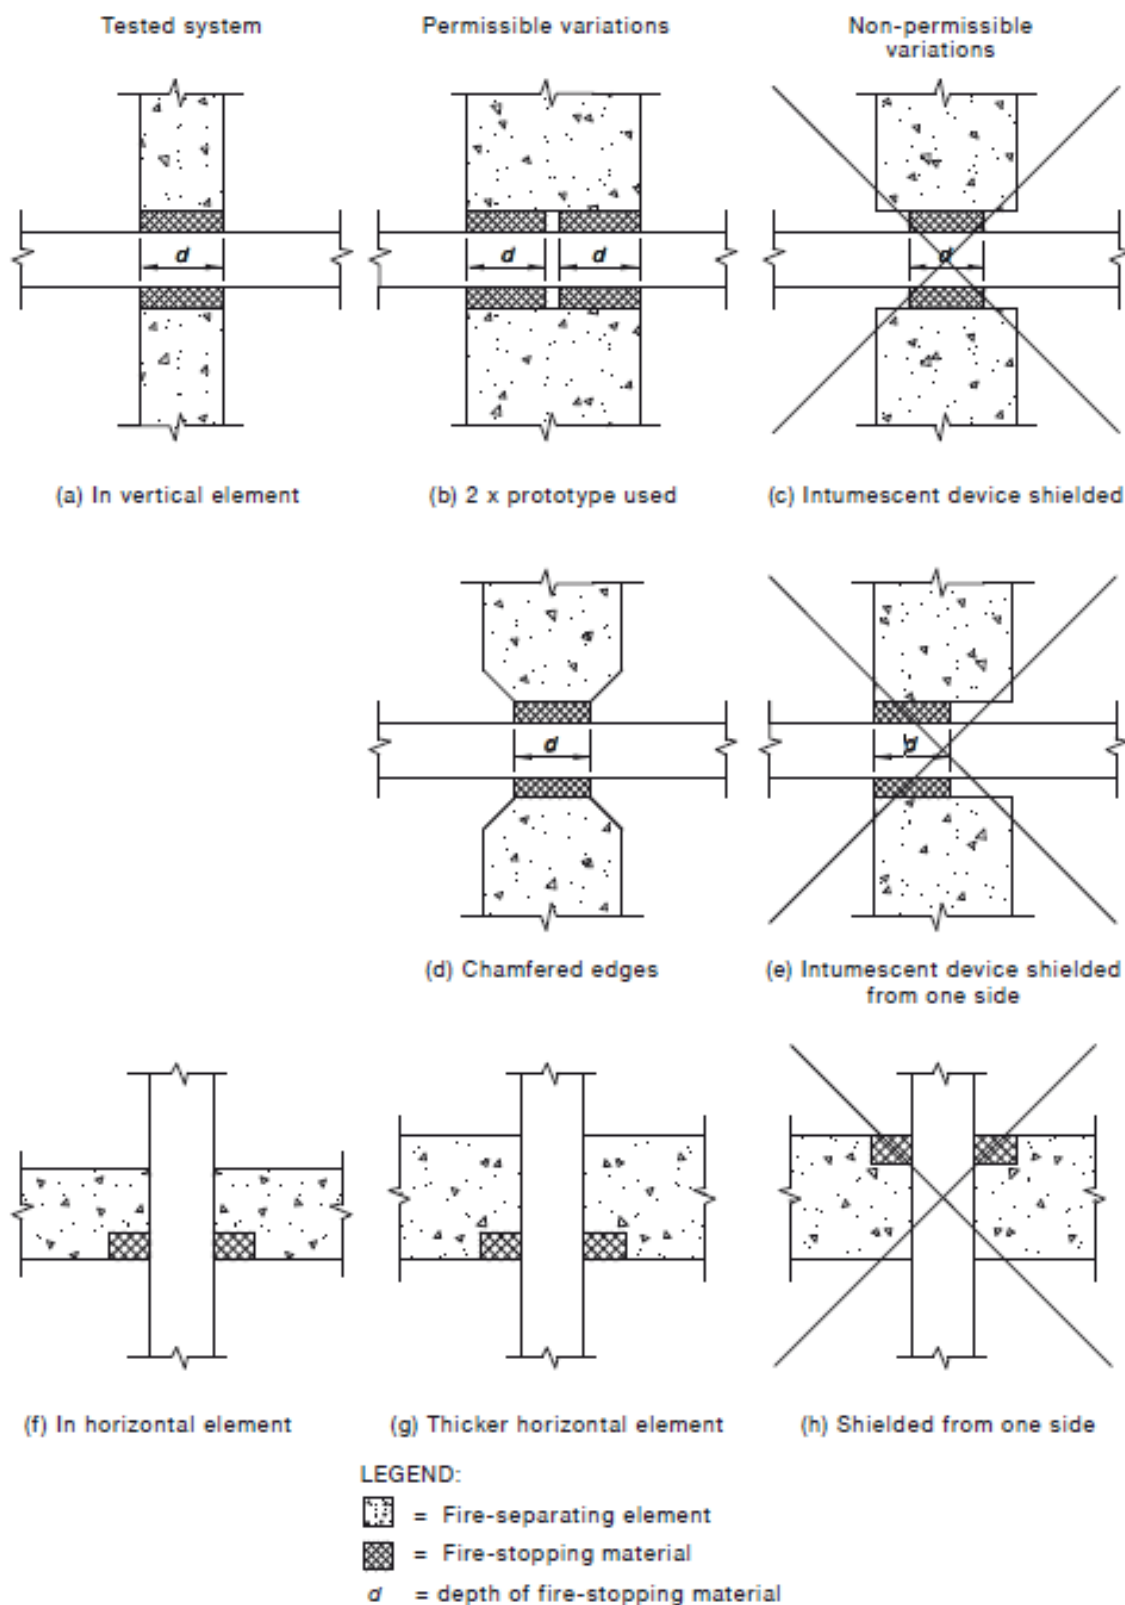
As penetration seals for plastic pipes are dependent for activation upon exposure to fire conditions, they shall always be installed with the same orientation and fire exposure as was established in the fire resistance test.

FIGURE 10.12.5.1 EQUIVALENT EXPOSURE OF UPVC PIPE FIRE-STOPPING SYSTEMS

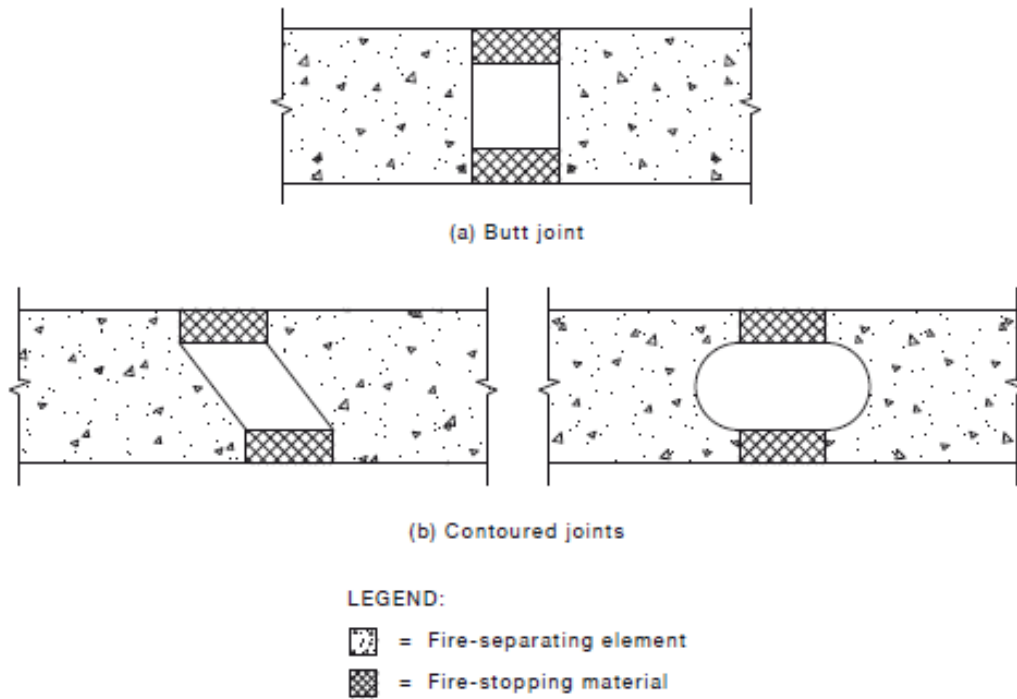
FIGURE 10.12.6 CONTOURED CONTROL JOINTS
